**RE: Onondaga Lake, Supernatant Treatment Plant,  
Town of Geddes and City of Syracuse,  
Onondaga County, NY  
Order on Consent: Index #D7-0002-01-09**

This letter describes the proposed integrity investigation of the 30-inch and 24-inch force mains that currently convey leachate from the Settling Basins 9-15 retention ponds to the Metropolitan Syracuse Wastewater Treatment plant (Metro) for treatment.

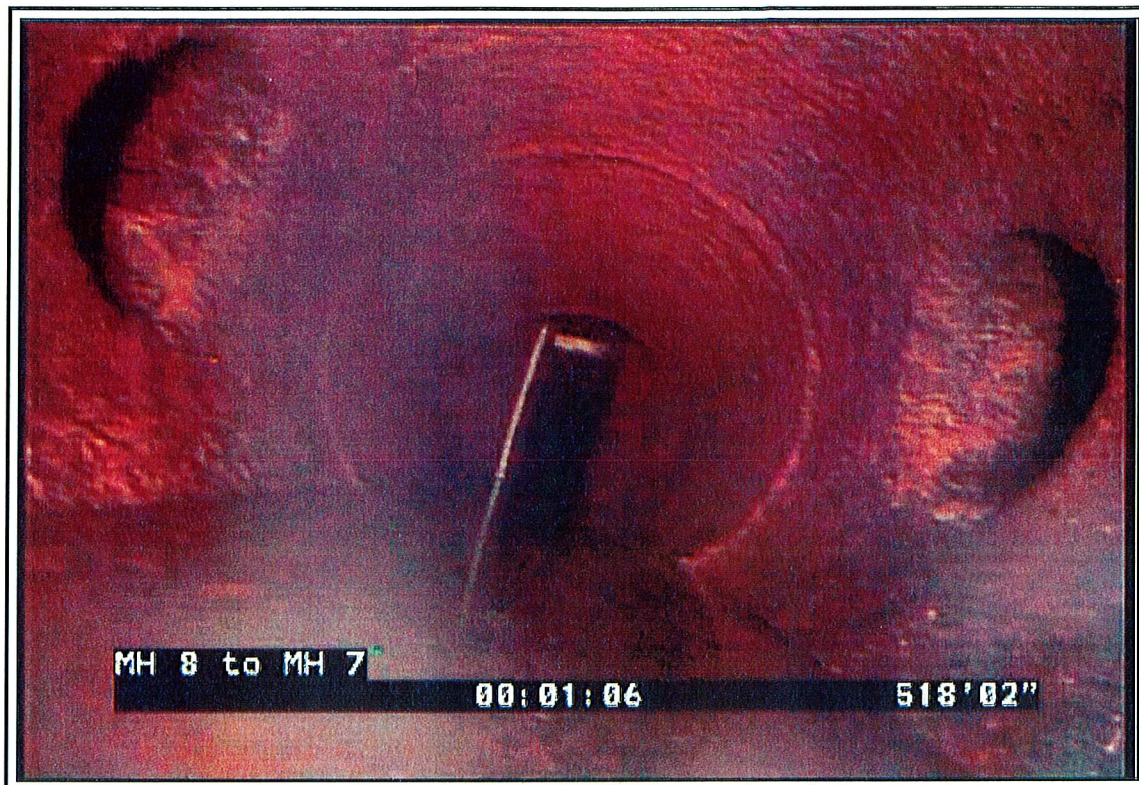
**Photo 1:** Image of lateral connections and plug valve at MH-7 in 30-Inch Force Main.

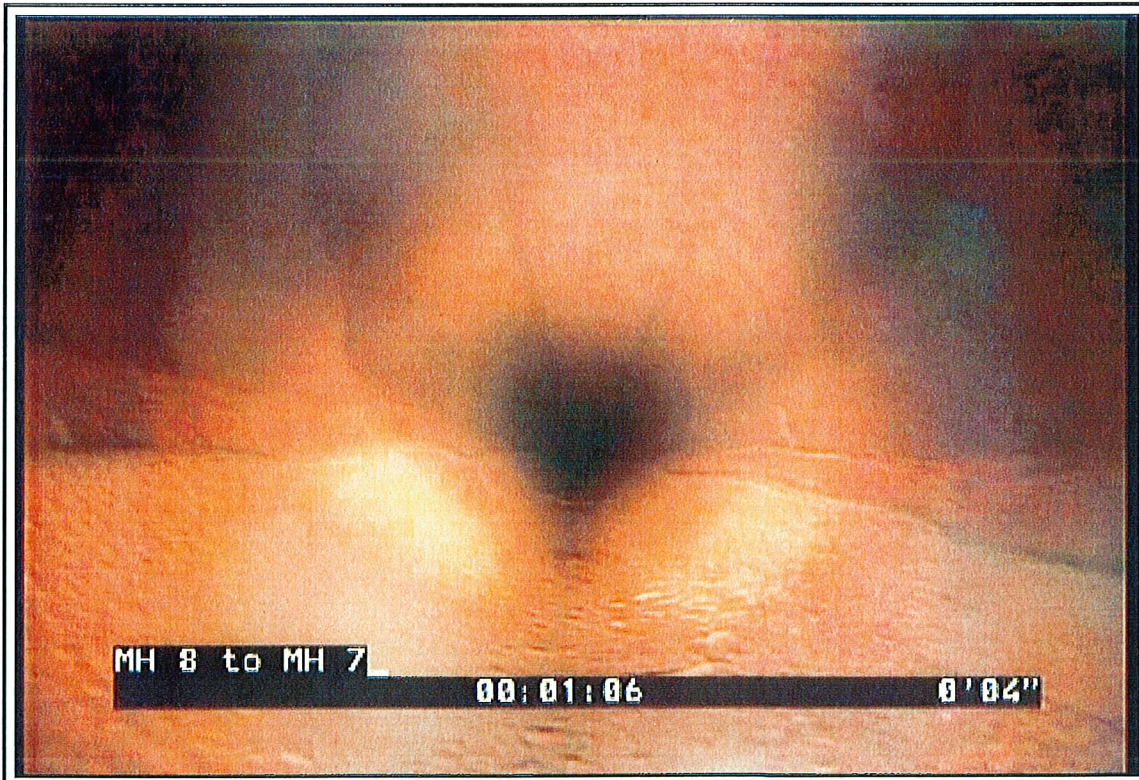
**Photo 2:** Section of the 30-Inch Force Main in the direction of MH-7 taken at MH-8. The section shown is a high point in the Force Main, and water does not routinely sit in this location.

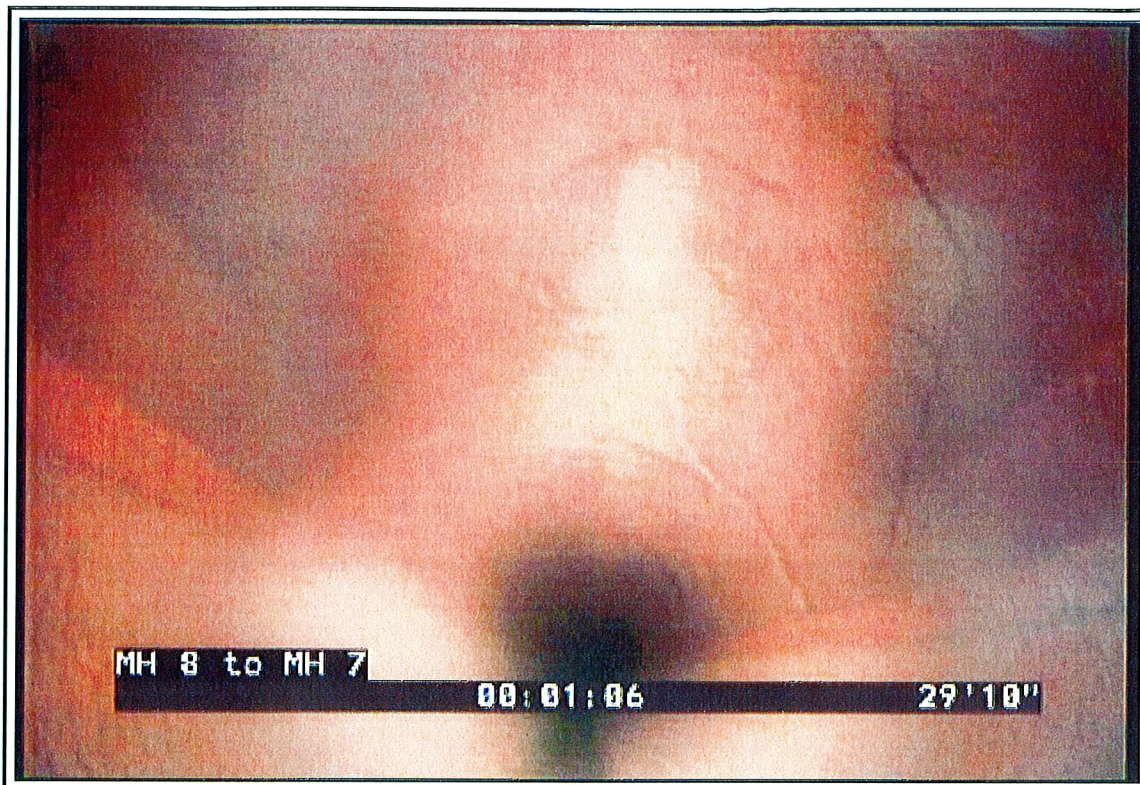
**Photo 3:** Section of the 30-Inch Force Main in the direction of MH-7 taken 29'-10" from MH-8.

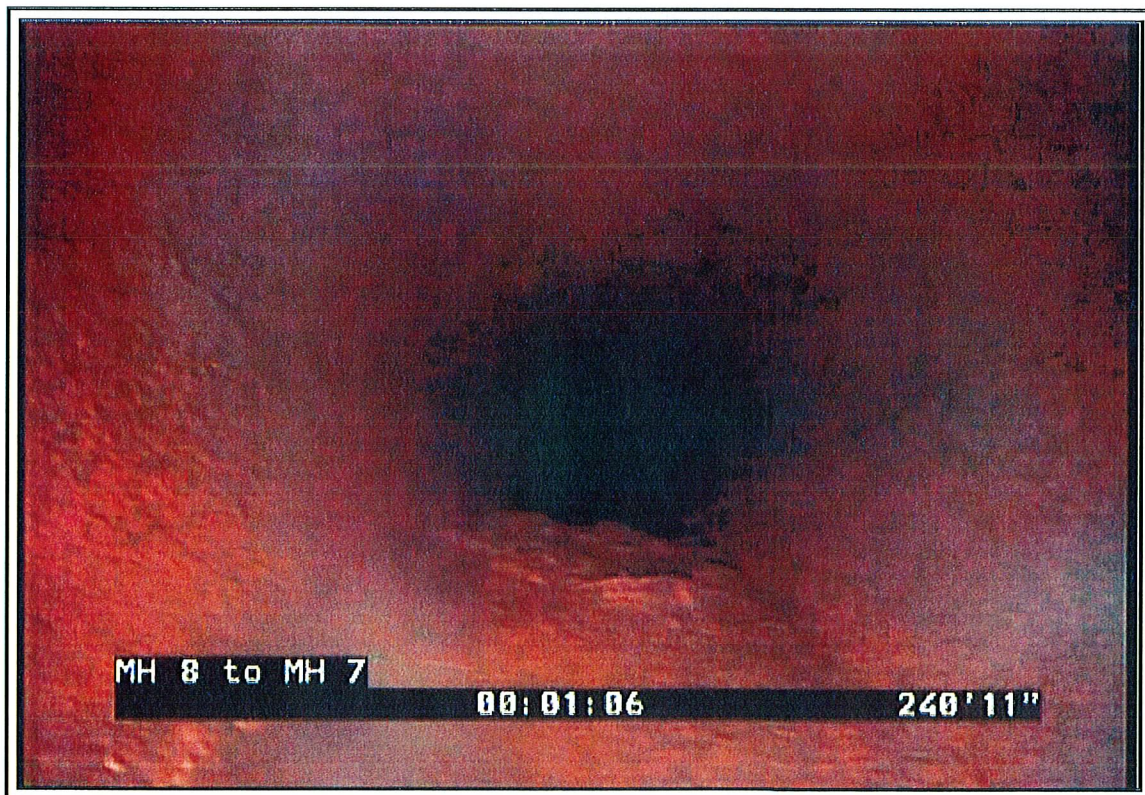
**Photo 4:** Section of the 30-Inch Force Main in the direction of MH-7 taken 240'-11" from MH-8. This section has standing water after pumps were shut off.

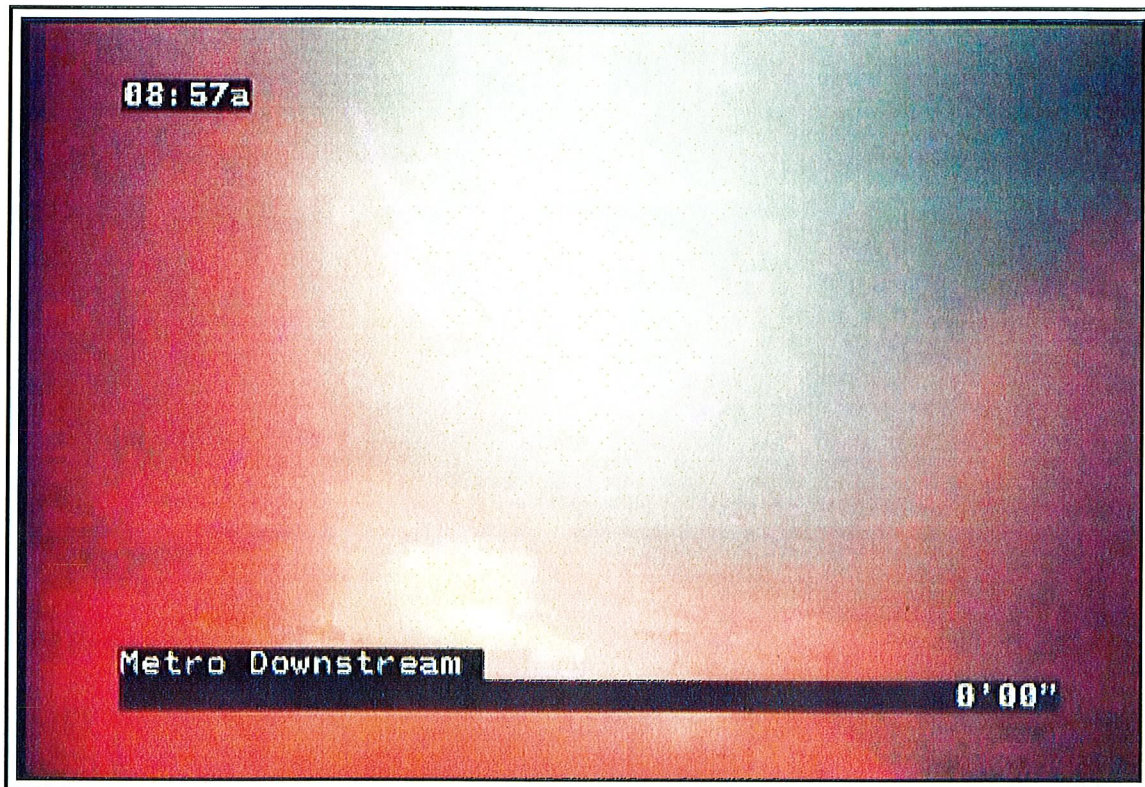
- The 24-inch force main is approximately 20 years older than the 30-inch force main.
- The slope of the 24-inch force main (in the vicinity of Metro) is relatively flat, resulting in lower flow velocity, and an increased potential for sedimentation and scaling.
- Sedimentation and scaling were documented during the initial investigations ( Appendix A).

**Photo 5:** Section of the 24-Inch Force Main in the direction of METRO from the monitoring station. The distance shown on the photo is incorrect, and the actual distance is approximately 250 ft. Sediment accumulation can be seen at the bottom of the pipe, and scaling appears to have caused relatively square sides in this section of the Force Main.

The CCTV rover/crawler unit will view the interior of the force main for debris, scaling, as well as obvious signs of deterioration. Based on preliminary investigation results included in Appendix A, it is anticipated that the 24-inch force main will be hydraulically or mechanically cleaned from Relief Manhole RMH-2 to Metro prior to CCTV efforts as indicated on Figure 3. The remaining portions of the force mains will not be cleaned unless appreciable amounts of sediment/debris are encountered elsewhere in the force main. The water generated from the cleaning will be recycled back into the pipeline while the accumulated debris is removed and disposed of in an appropriate fashion. The CCTV unit is to be equipped with a radar unit (or

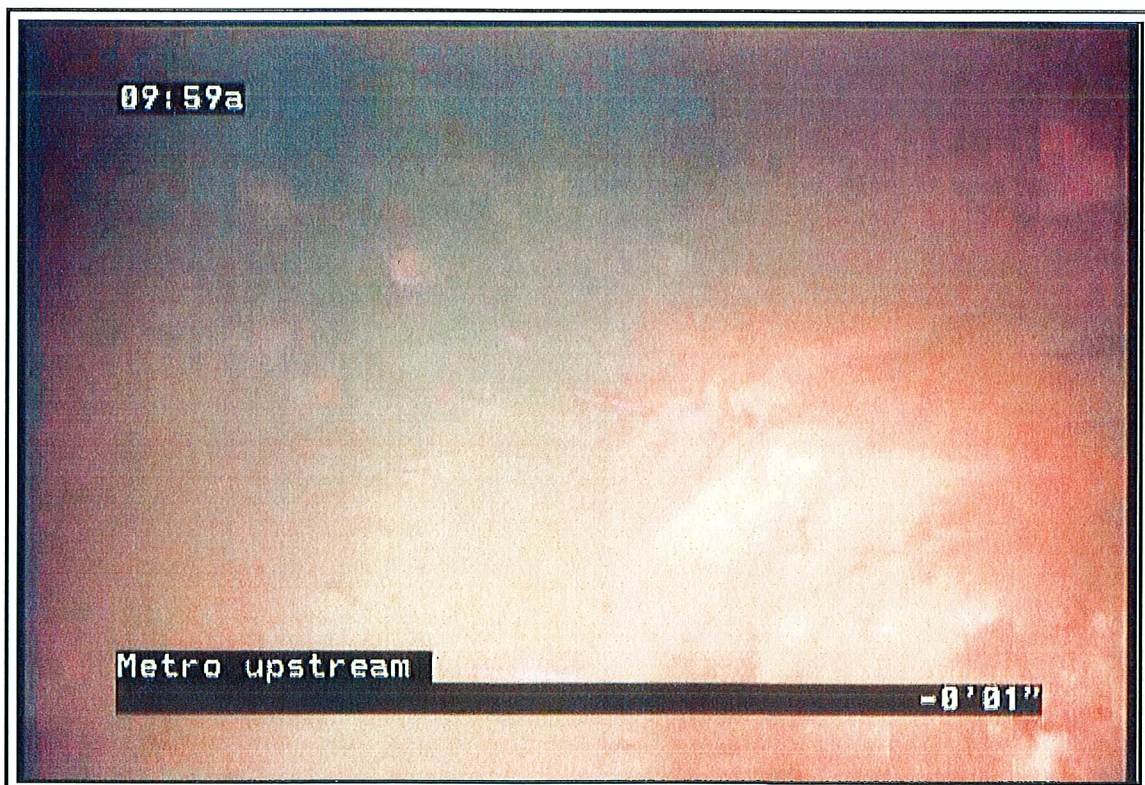
**Photo 6:** Section of the 24-Inch force main upstream of the monitoring station. Note that the distance shown on the photo is incorrect, and the actual distance is approximately 100 ft.
