Re: Documentation of Anomaly 13 (A13), Subsite of the Onondaga Lake Superfund Site
Onondaga County, New York, Dated November 2016

**Documentation
of Anomaly 13 (A13),
Subsite of the Onondaga Lake Superfund Site,
Onondaga County, New York**

**Phase 3 Underwater Archaeological
Documentation of Anomaly 13 (A13),
Subsite of the Onondaga Lake Superfund Site,
Onondaga County, New York**

November, 2016

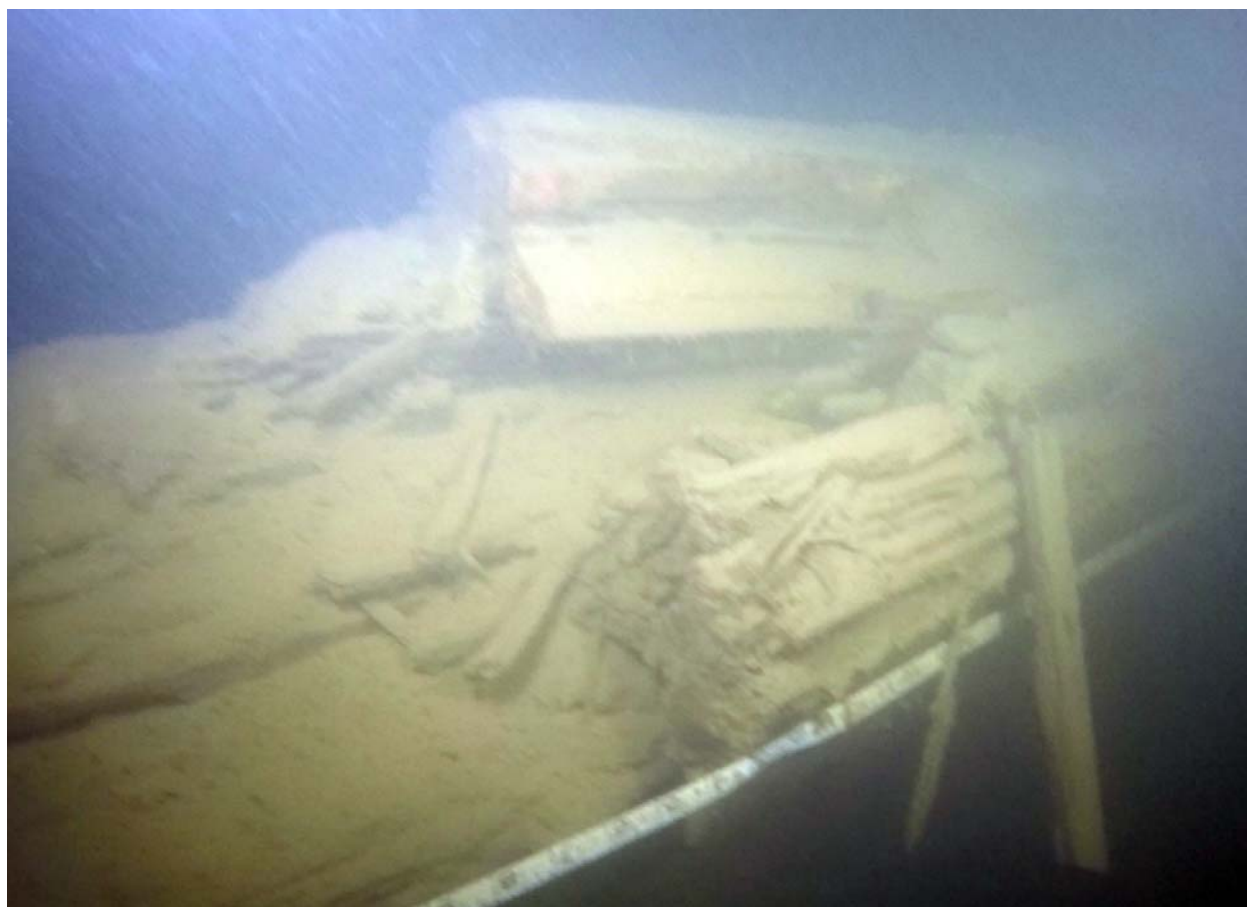
Generally speaking, wreck A13 is extremely well preserved. The wood, which makes up the majority of the vessel structure, is still hard and joints between extant timbers are tight. However, the vessel is not completely intact and careful examination of the wreck, and of the various forms of documentation that have been captured of it since it was first discovered in 2005 (video, sides scan sonar, and archaeological documentation were all consulted), demonstrate that the vessel was subjected to both historic impacts and damaged caused by remedial actions that are related to the Superfund cleanup operations.

Historic damage, while significant, is limited to the port side and the above deck structures of the cargo hold and stern. On the forward half of the port side a large section of hull planking is missing or severely damaged. This is also true of the above deck structures like the cargo hatch coaming and the cabin trunk which are also believed to have been damaged historically. These missing structures and the damage to the port side are visible in the side scan sonar image captured in 2005 well before the commencement of remedial actions.

More recent impacts associated with the remediation activities were mostly caused by a dredge spoil pipe sinking to the lake bottom when full and coming to rest on the wreck. This pipe was often maneuvered with powerful tugboats pulling it across the lake bottom. In doing so this pipe appears to have snagged on, and broken free of, the wreck a large number of times causing a significant amount of damage. Along the port side the historic damage, which produced a lot of lose and jagged timbers, was particularly impacted as many of the loose pieces and protruding bolts were torn free or bent over by the pipe impact (Figure 15).

Figure 15: A portion of the rail damage on the port side of A13 (LCMM Collection)

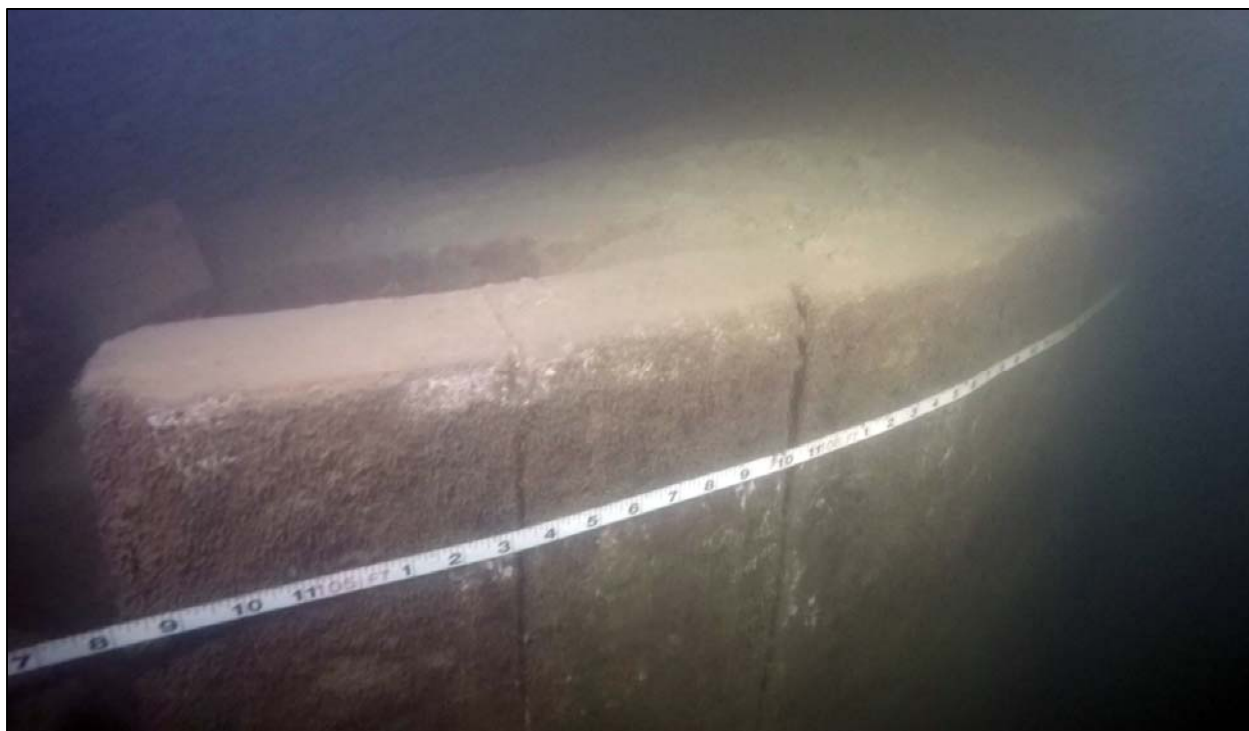
The bow of A13 is one of its most interesting features. The vertical arrangement of the bow planking on canal boats has been observed in a number of historic photographs and described in some historical sources but it is a feature that has not been documented archaeologically. The bow planking consists of 48 vertical boards that measure 8 inches (20.3cm) wide and 5 inches (12.7m) thick with chamfered edges (Figure 17). This planking begins on either side of the vessel where it is connected to the traditional horizontal planking of the rest of the hull. This juncture occurs 6 ½ feet (2m) aft of the forward most portion of the bow. The “shoulders” of the bow are very bluff leading to a flat on the front of the vessel that is completely perpendicular to the sides. Numerous traces of white paint can be seen on the lower portions of the bow planking.

Figure 17: Top of Bow staves, starboard bow quarter (LCMM Collection)

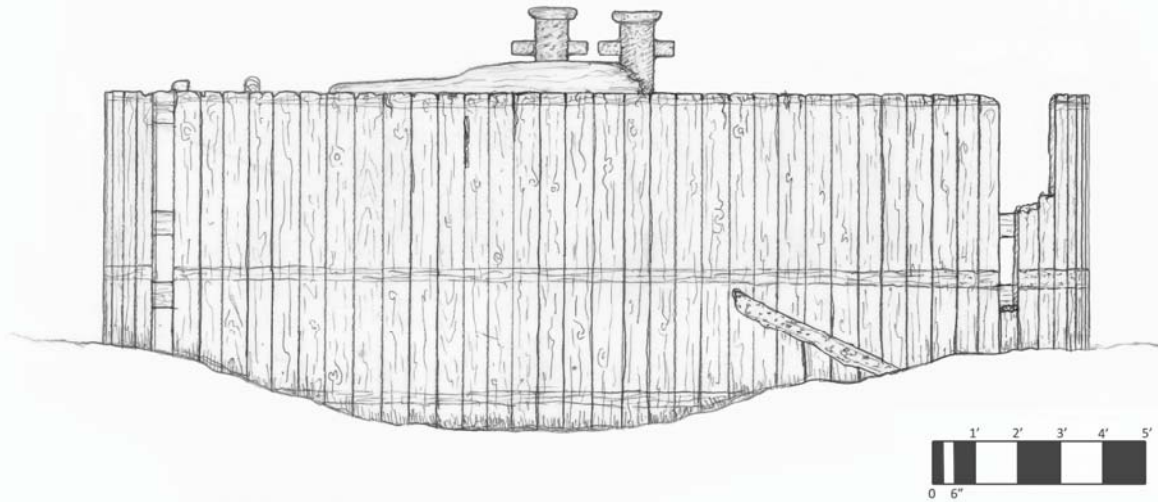
Figure 18: A13 Bow profile drawing displaying stave planking (Christopher R. Sabick)

On the port bow quarter three of the stave planks are broken off about halfway to the mud line. There is also one missing plank on the starboard “corner” of the bow. It is through these spaces left by these damaged planks, which are broken down close to the mudline, that the few observations of the internal bow structure were made.

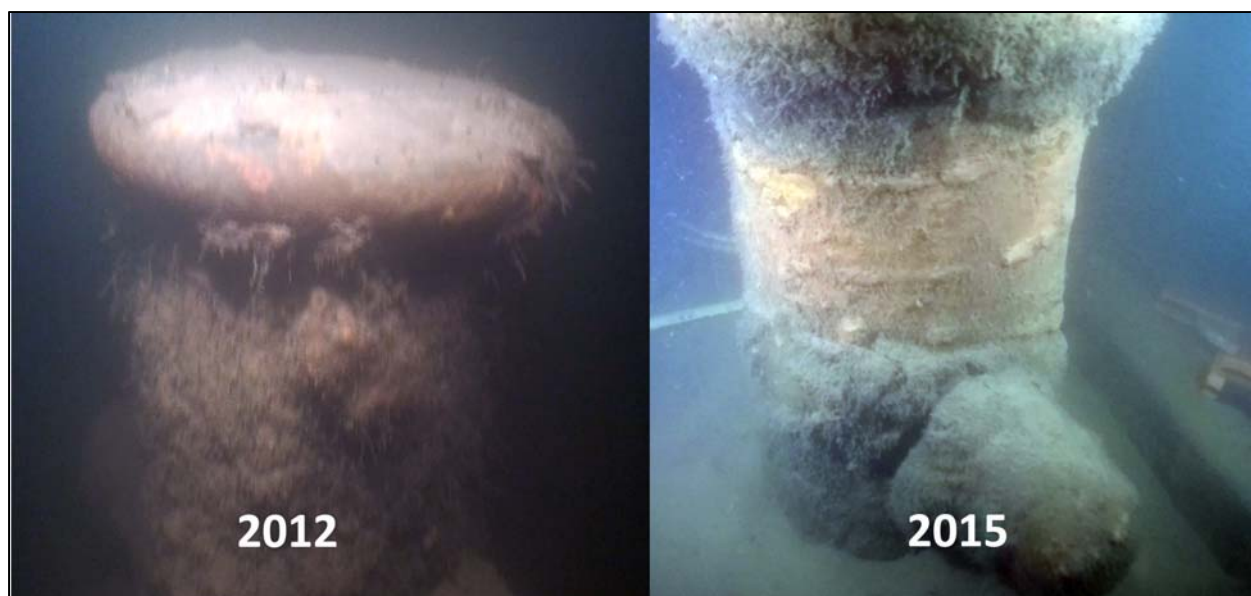
In the bow it appears that the large chock that is positioned forward of the bollards has also been broken and dislocated by this same activity. It has also been noted that several of the vertical bow planks have been disarticulated, possibly at the same time that the bow chock was impacted. Along the starboard side damage to the cap rail and its associated structures was also inflicted upon A13 in recent years. As can be seen on the site plan a portion of the starboard cap rail is missing all together while another section has been pulled up from the deck and is left protruding into the water column.

Directly aft of the chock are two large cast iron bollards. These are arranged so that the horizontal bars practically touch amidships. The drum for each bollard is 11 ½ inches (29cm) in diameter at the top though the main body of the bollard is 9 inches (22.9cm) in diameter. The horizontal arms of the bollards are each 6 inches (15.2cm) long and 3 ½ inches (8.9cm) in diameter. These bollards would have been used in handling tow cables and mooring lines. Both bollards show recent, extensive, abrasion damage where the old rust and concretion have been worn away (Figure 19). In addition to the bollards there is also a large iron cleat (38 inches [.96m] long) located on the starboard side of the bow near the juncture with the sides. There may have been a similar cleat on the port side but would have been located in one of the areas with significant historic damage and is no longer present.

Figure 19: Comparison of bollard condition in 2012 vs. 2015 (LCMM Collection)

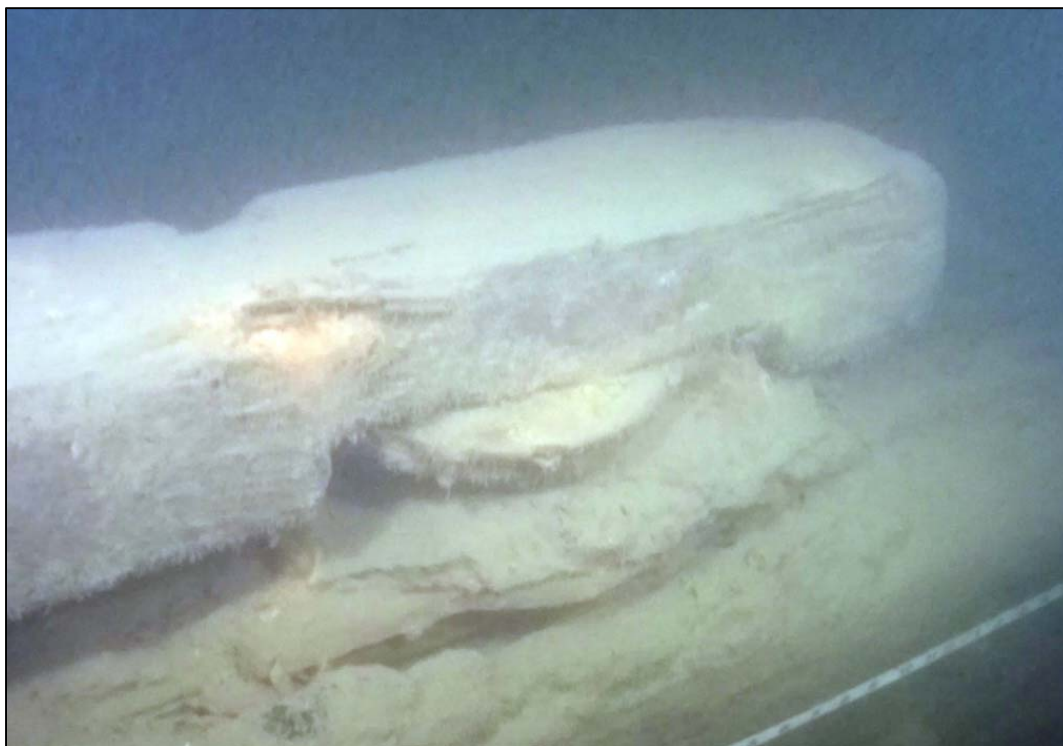
This cap rail is damaged in a number of places particularly in the forward half of the vessel on the port side. Significant damage is also present on the starboard side though the underlying structures are still present, which is not the case in portions of the port side. On the forward end of the starboard side coaming there is a sheave built into the timber directly outboard of the large iron cleat that is found on the foredeck (Figure 21). This 8 inch (20.3cm) diameter sheave would have been used to in line handling. It was probably mirrored on the port side, though the extensive damage in that portion of the hull has destroyed any evidence of a second sheave.

Figure 21: Sheave at the forward end of the starboard cap rail (LCMM Collection)

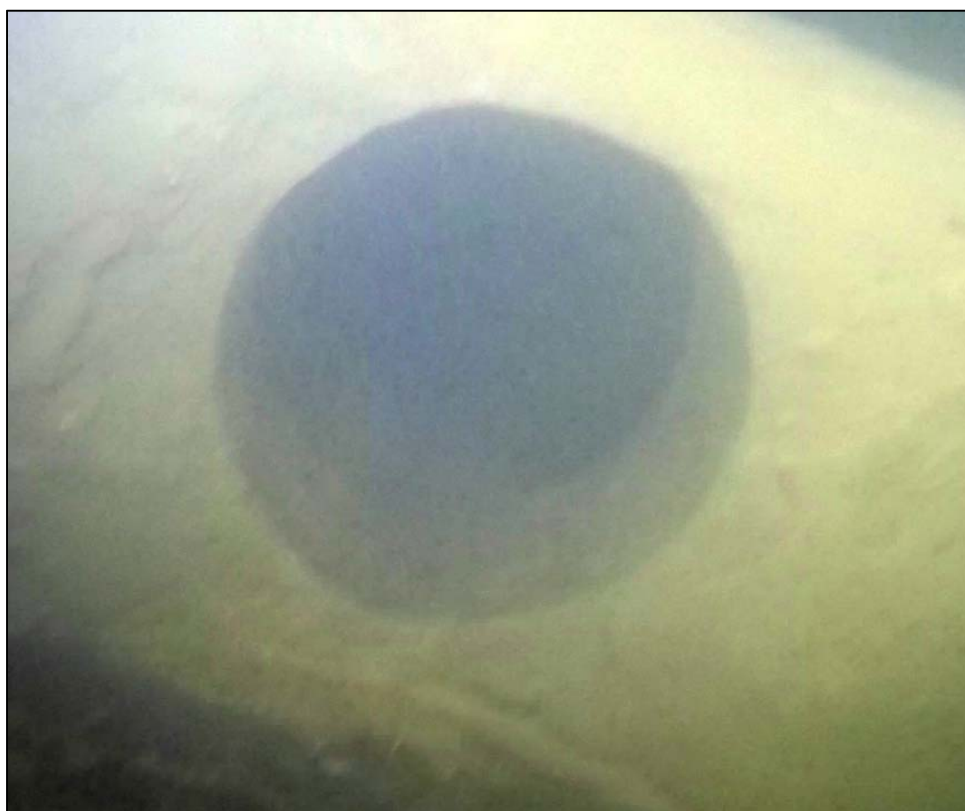
The top transom timber is 12 inches (30.5cm) wide and 11 inches (28cm) thick. Across the transom are three horizontal bustle timbers that are curved in shape and supported the rudderpost and rudder. The first of these timbers is located 16 inches (40.6cm) below the top of the transom (Figure 25). The others are spaced 16 inches (40.6cm) apart below the first. On their outboard edges these timbers are 4 inches (10.2cm) wide, this swells to 13 inches (33cm) wide amidships before diminishing gradually again on the opposite side. These bustle timbers are 5 inches (12.7cm) thick. The outboard corners of the bustle timbers are protected by a vertical timber that is 4 feet (1.2m) long and 6 inches (15.2cm) wide. The top two transom timbers are pierced by a 9 inch (22.9cm) diameter hole amidships that would have once housed the rudder post (Figure 26). The central portion of the lower transom timber is broken out amidships but presumably also contained this hole for the rudder post when it was intact. No evidence of the rudder or rudder post have been located on site.

Figure 26: Hole through the top stern buttress timber for the (absent) rudderpost (LCMM Collection)
