**Phase 1B Underwater Archaeological Report
for the Onondaga Lake Bottom,
Subsite of the Onondaga Lake Superfund Site,
Onondaga County, New York**

Final Report • October 10, 2011

EXECUTIVE SUMMARY

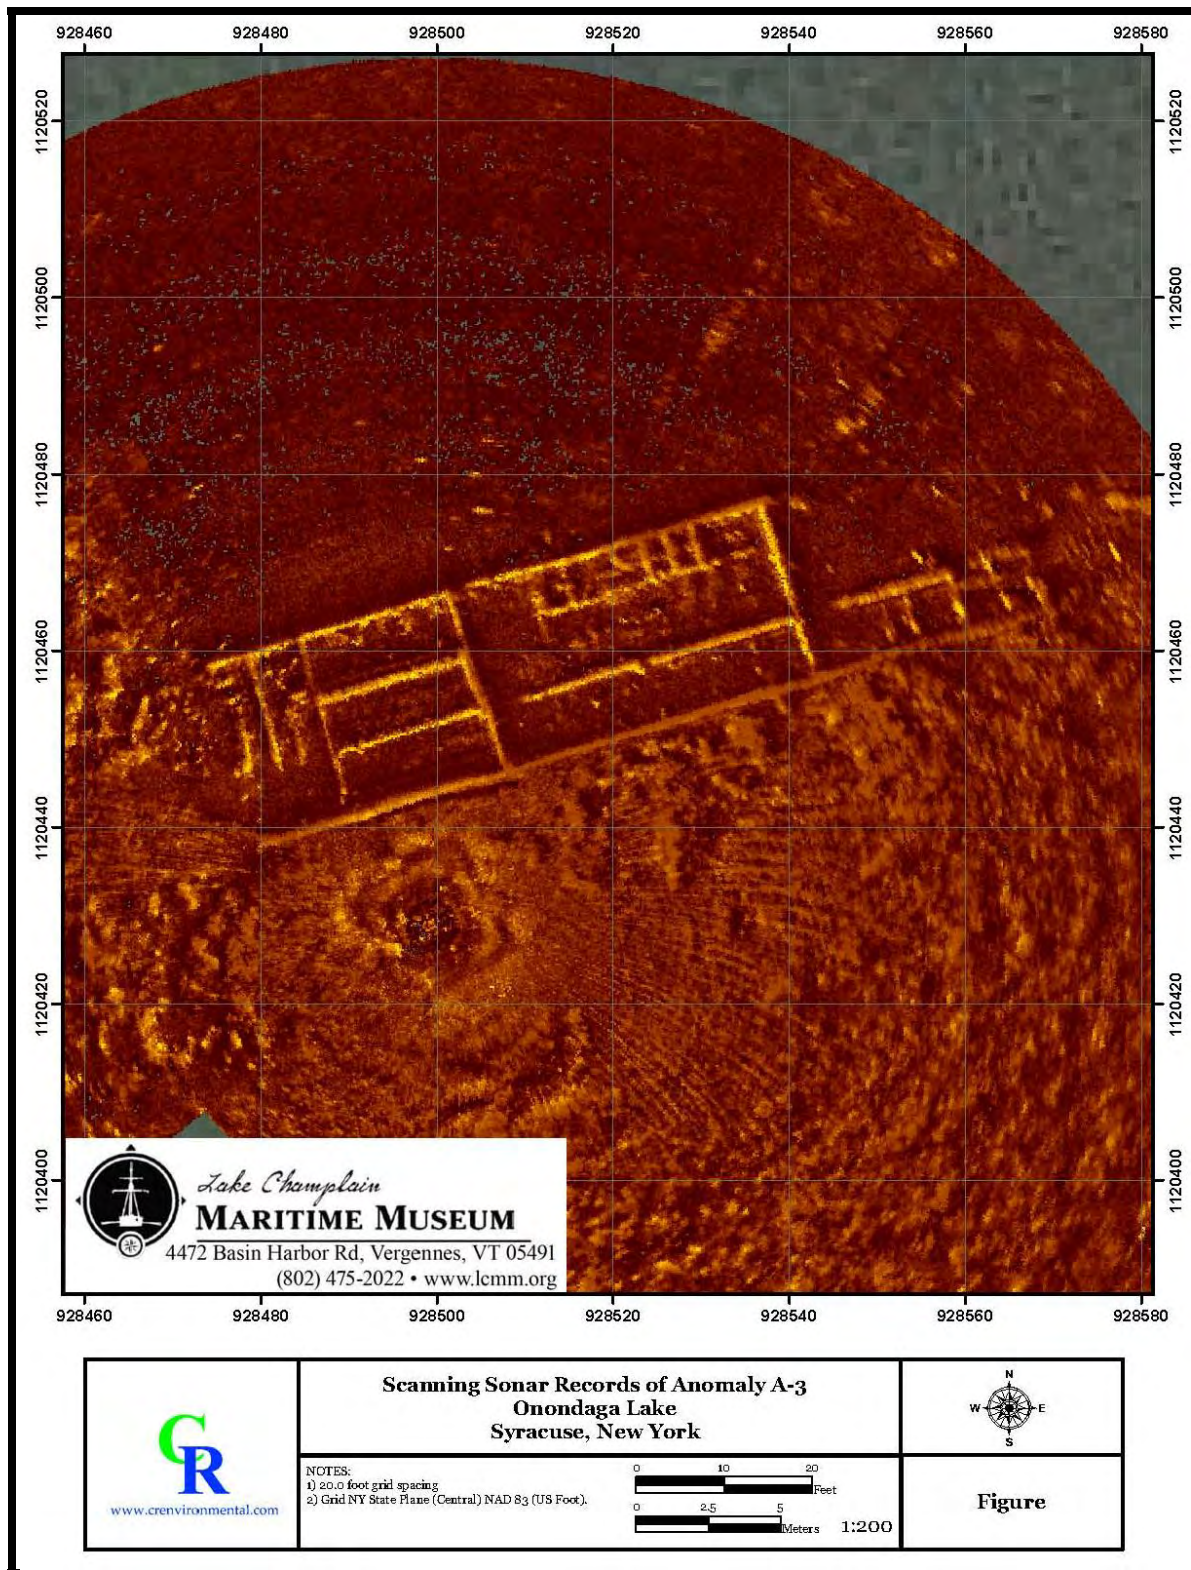
A3's construction technique suggests a use such as carrying bulk heavy deck cargoes which would necessitate such a heavily-built structure. The vessel's bulkhead arrangement is similar to that of dump scows A4-1 and A4-2, however, no evidence of a dump door was seen inside the hull.

Figure 41. Scanning sonar image of A3.

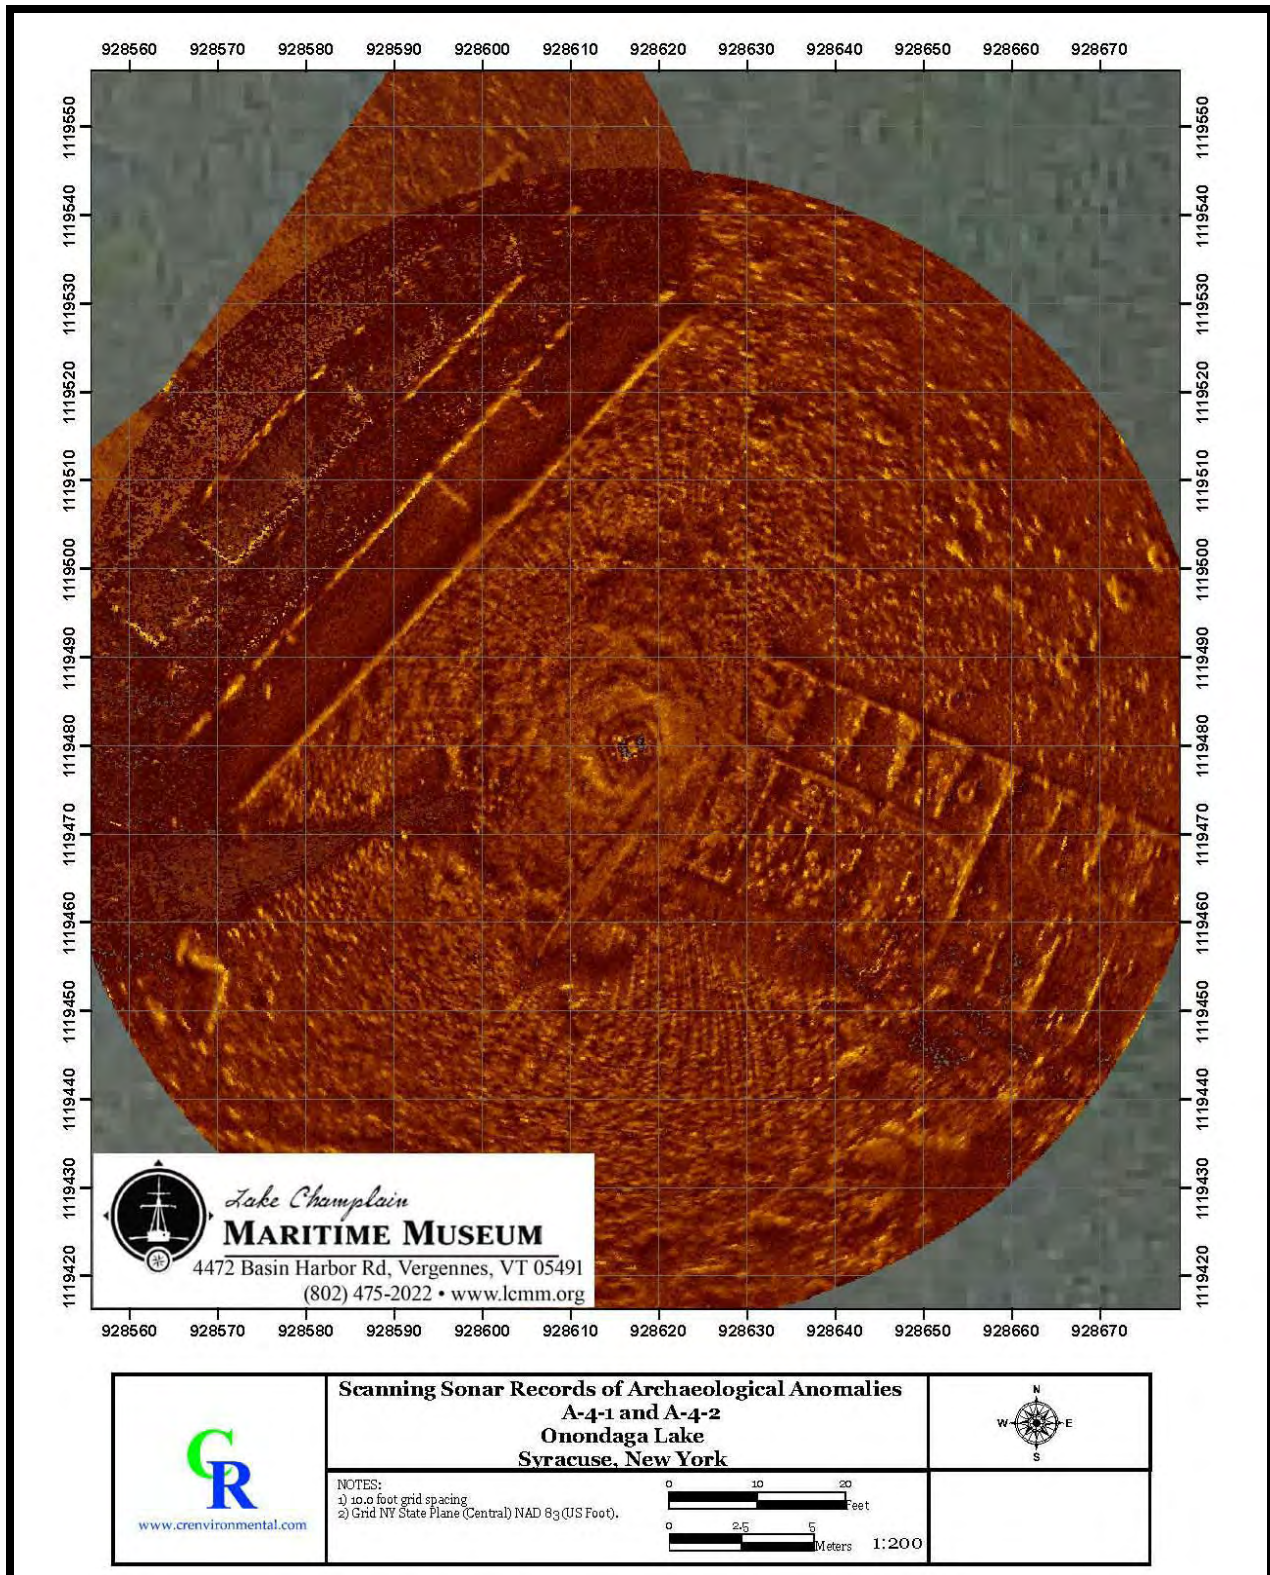
Figure 45. Scanning sonar image showing Anomaly A4-1 (left) and A4-2 (right).

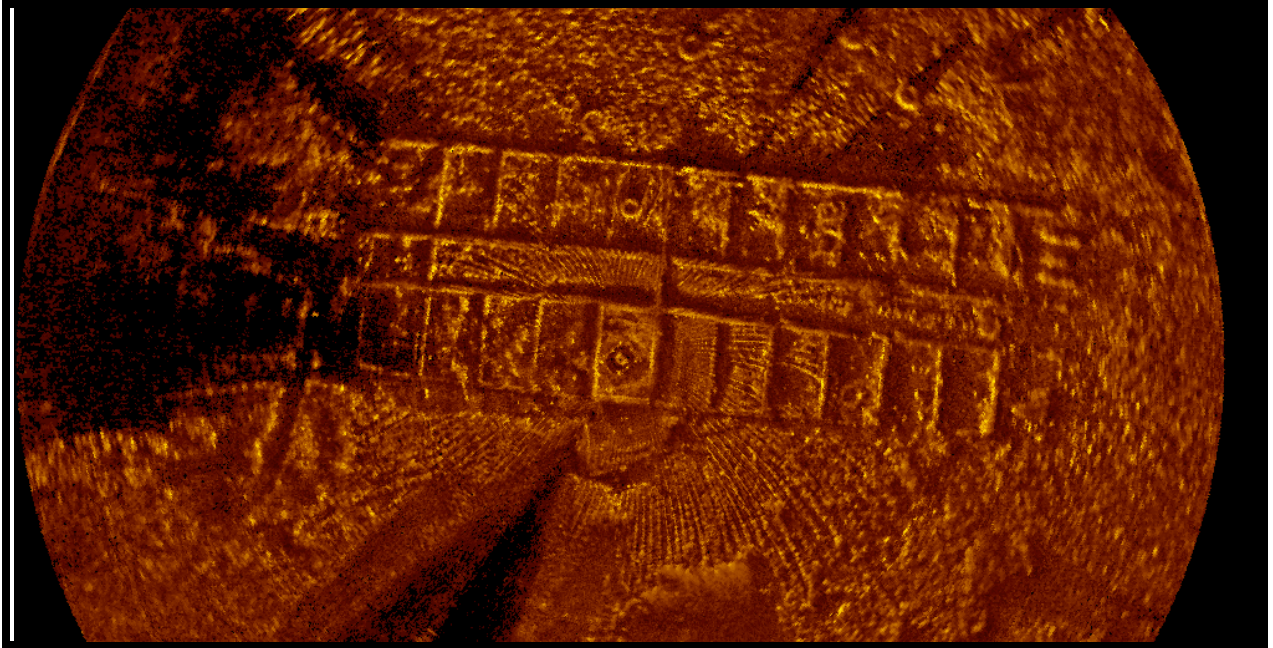
During the Phase 1B fieldwork, excellent surface visibility conditions allowed for a detailed visual and videographic inspection of the barge's interior structure. However, the lower two thirds of the vessel is buried, limiting the extent to which the site could be evaluated. The barge has two longitudinal bulkheads which divide the hull into three longitudinal compartments. Three transverse bulkheads which span the entire breadth of the vessel were recorded, and at least 11 smaller transverse bulkheads which span only the outboard longitudinal compartments were noted. With the exception of the bulkhead arrangement, the barge lacked diagnostic features. The bulkheads were similar in their arrangement to the adjacent barge (A4-1), which was identified as a dump scow. Although not conclusive, it is likely that A4-2 is also a dump scow. The proximity of such similar vessels suggests that they were deposited contemporaneously.

Figure 47. Sector scan image of Anomaly A4-2.

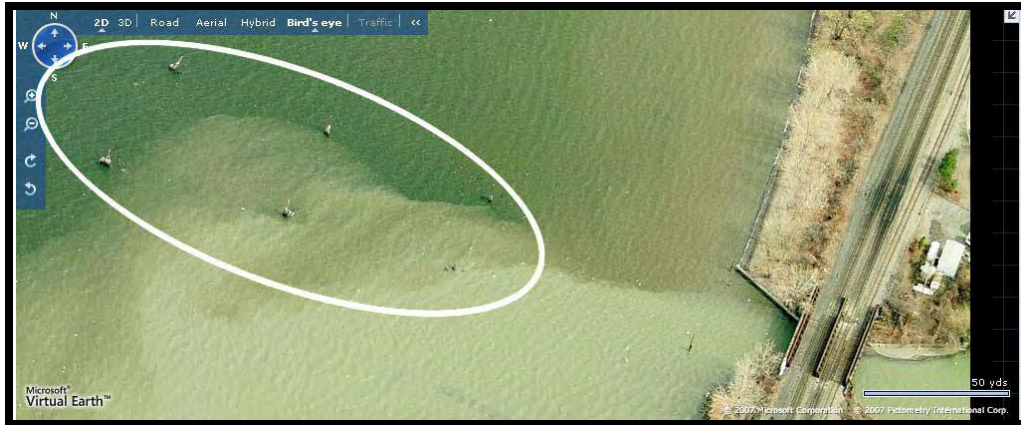
Although it is unlikely that anomaly A7 meets the minimum 50 year threshold for a contributing property to the NHRP, these pilings are a contemporary extension of historic transportation facilities and aides to navigation which were routinely replaced. This taken into account with A7's location within the Syracuse Maritime Historic District, LCMM recommends that A7 is a contributing property to this District.

Figure 48. Canal entrance related structures creating Anomaly 7 (courtesy Microsoft® Virtual Earth).

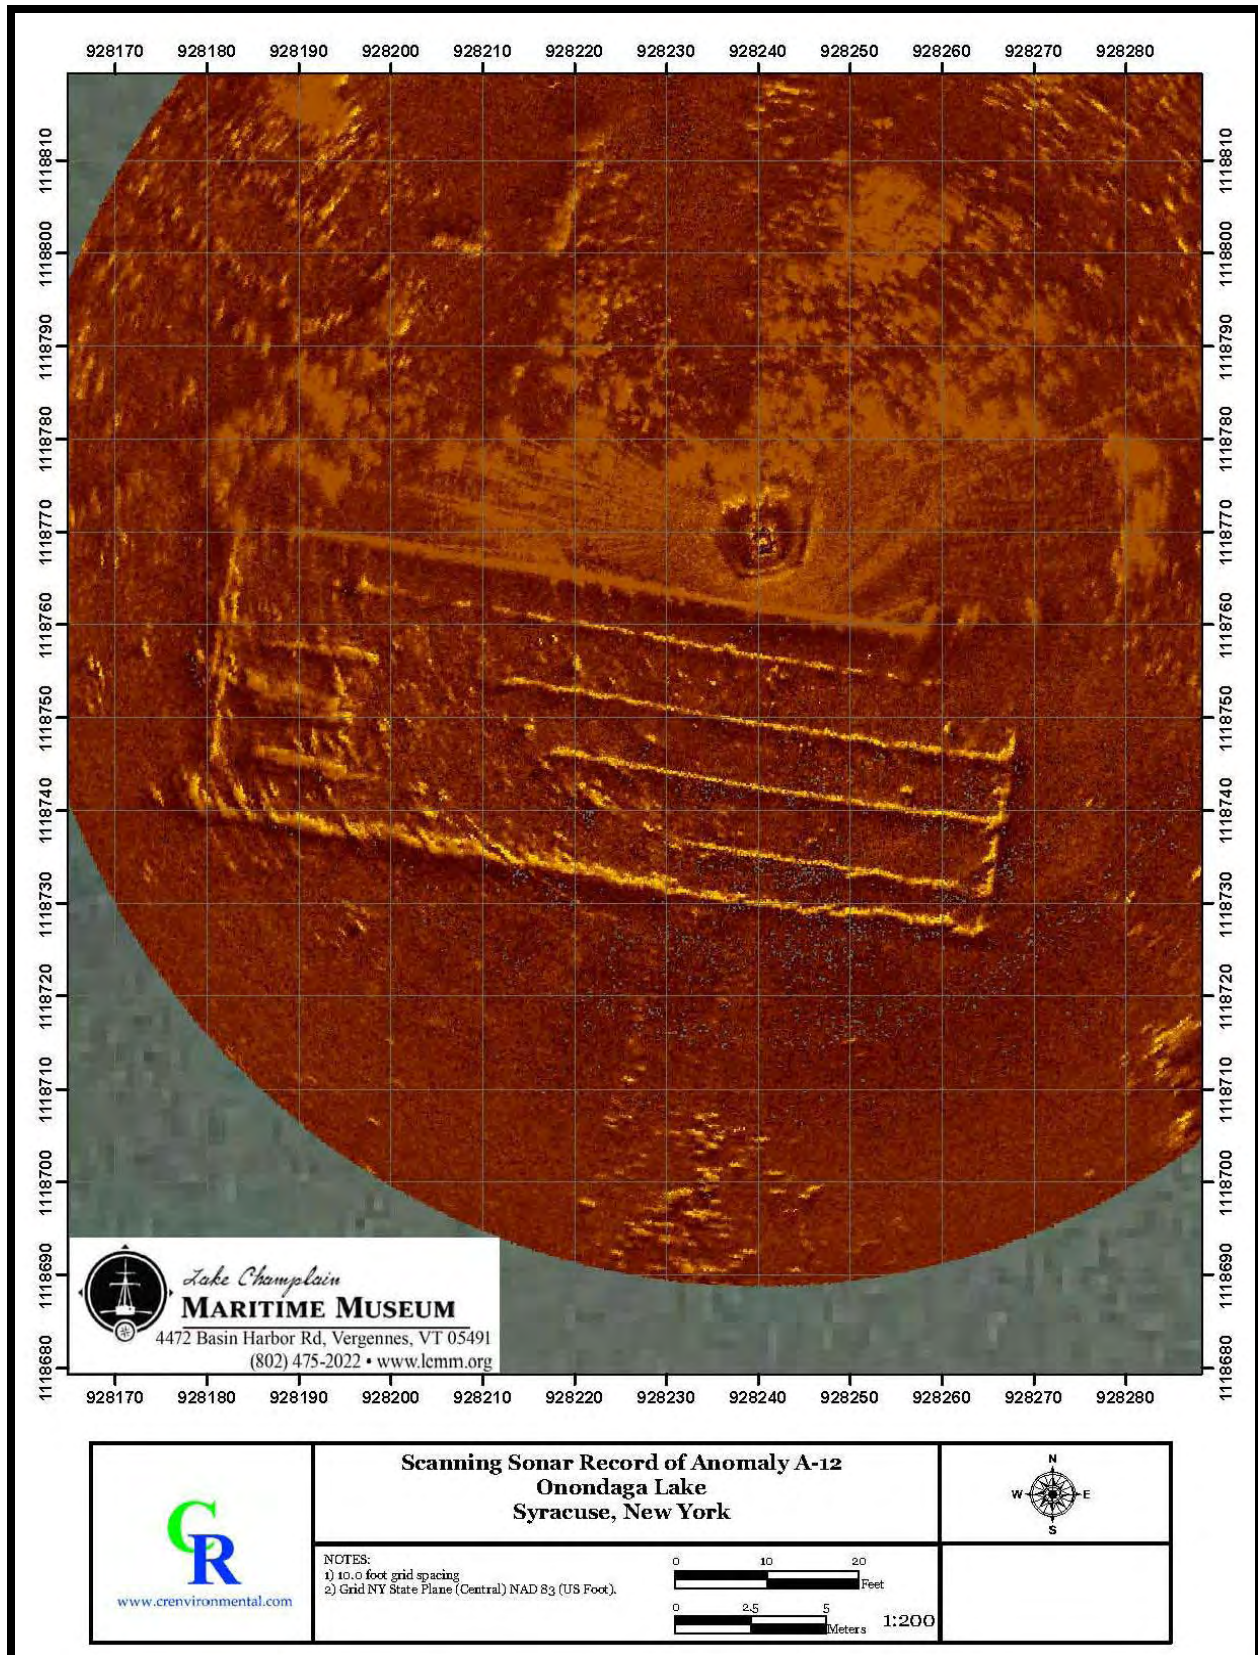
equipped with derricks were known as derrick lighters, and were commonplace during the nineteenth and twentieth centuries (Figure 56). The vertical end of the barge closest to the spud holders and step is covered in sheet iron, suggesting a use which created wear on that end of the barge. The lack of other distinguishing features on the vertical end is not consistent with the features expected of pile drivers and dredges, leaving derrick lighter as the most logical identification for A12.

Figure 52. Scanning sonar image of A12.

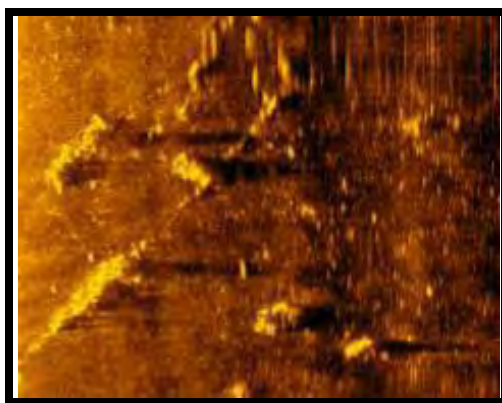
Figure 69. A5 sonar images showing linear acoustic anomalies which were identified as piping associated with water monitoring (courtesy CRE).

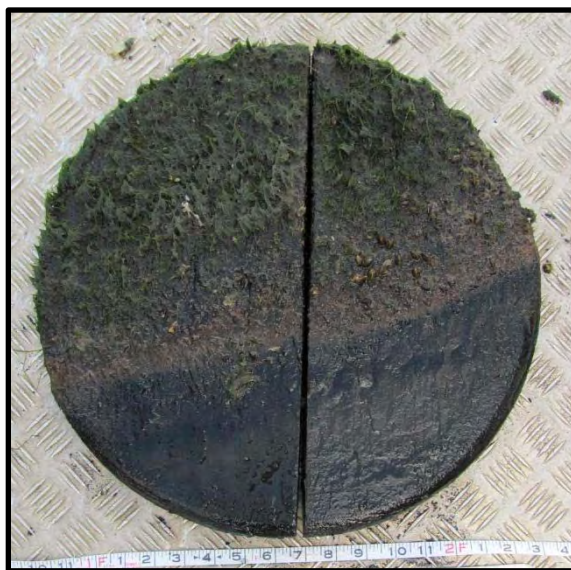
Figure 94. Anomaly 57, wooden barrel lid (LCMM Collection).

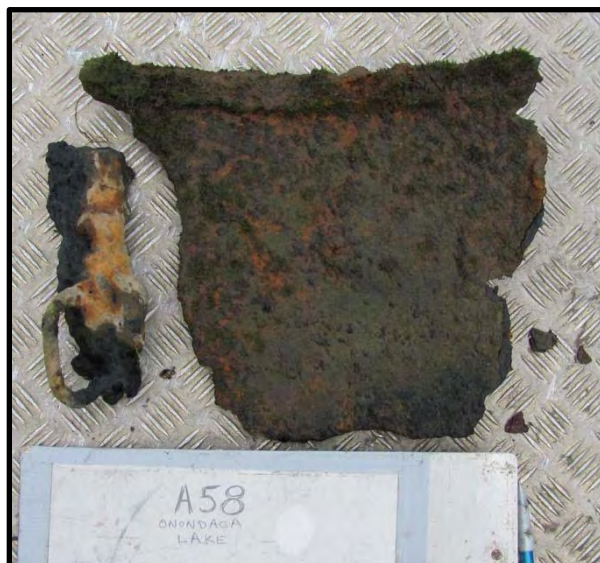
Figure 95. Anomaly 58, a fragmentary 55-gallon drum (LCMM Collection).

<p>After A57, PAL swam over to A58 which was determined to be a disintegrating 55 gallon drum. The sheet iron was falling to pieces. Two parts were brought to the surface and photographed.</p>
A59	1630	PAL back into the water at A59, verified to be a long coil of wire rope.
	1640	PAL out of the water. End of dive operations for the day.
	1700	Depart dive site.
	1710	Arrive Marina
	1730	Depart Marina. PAL departs for Vermont.
	1945	Chris Sabick arrives in Liverpool.
June 24, 2011		
	0600	Meet for Breakfast. AK, ST, and CS.
	0645	Depart hotel.
	0700	Arrive marina. CW & SD from CRE are here already as well as KM from Parsons. CS gets safety overview from KM. Gear up for the day. The plan is to dive verify magnetic anomalies in the SMHD. The weather looks marginal with scattered T-storms all day.
	0815	Safety briefing. AK, ST, CS, CW SD & KM. T-storms approaching.
	0900	Still waiting for T-storms to pass.

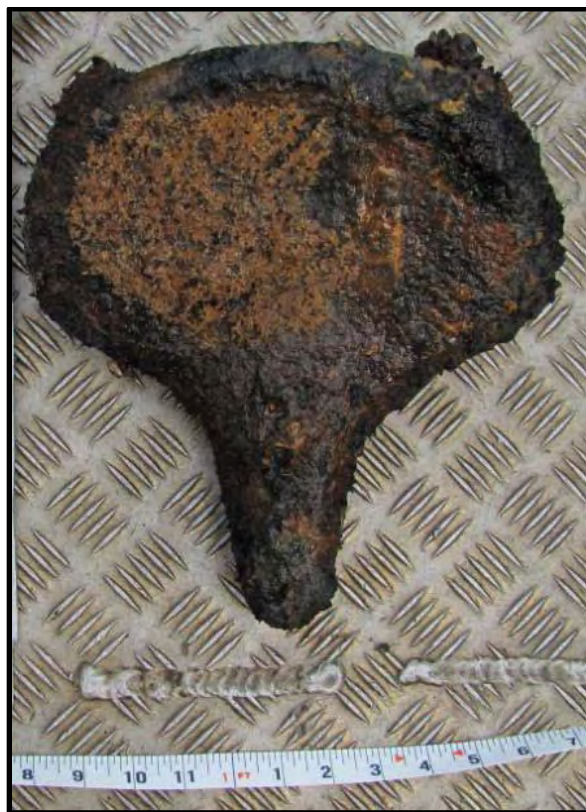
Figure 99. Seat from a motorcycle - Anomaly 81 (LCMM Collection).

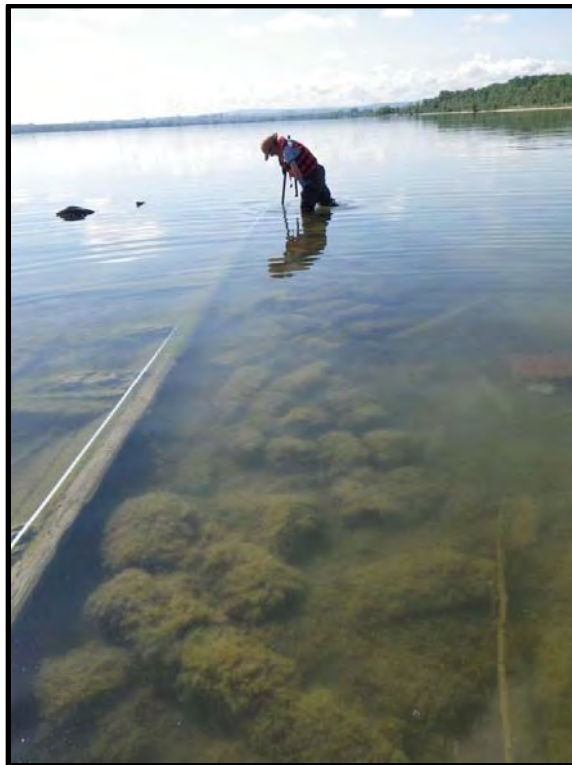
Figure 106. LCMM archaeologist wears waders to document the shallow site A17. Note the pile of concrete blocks outside A17-2 (LCMM Collection).

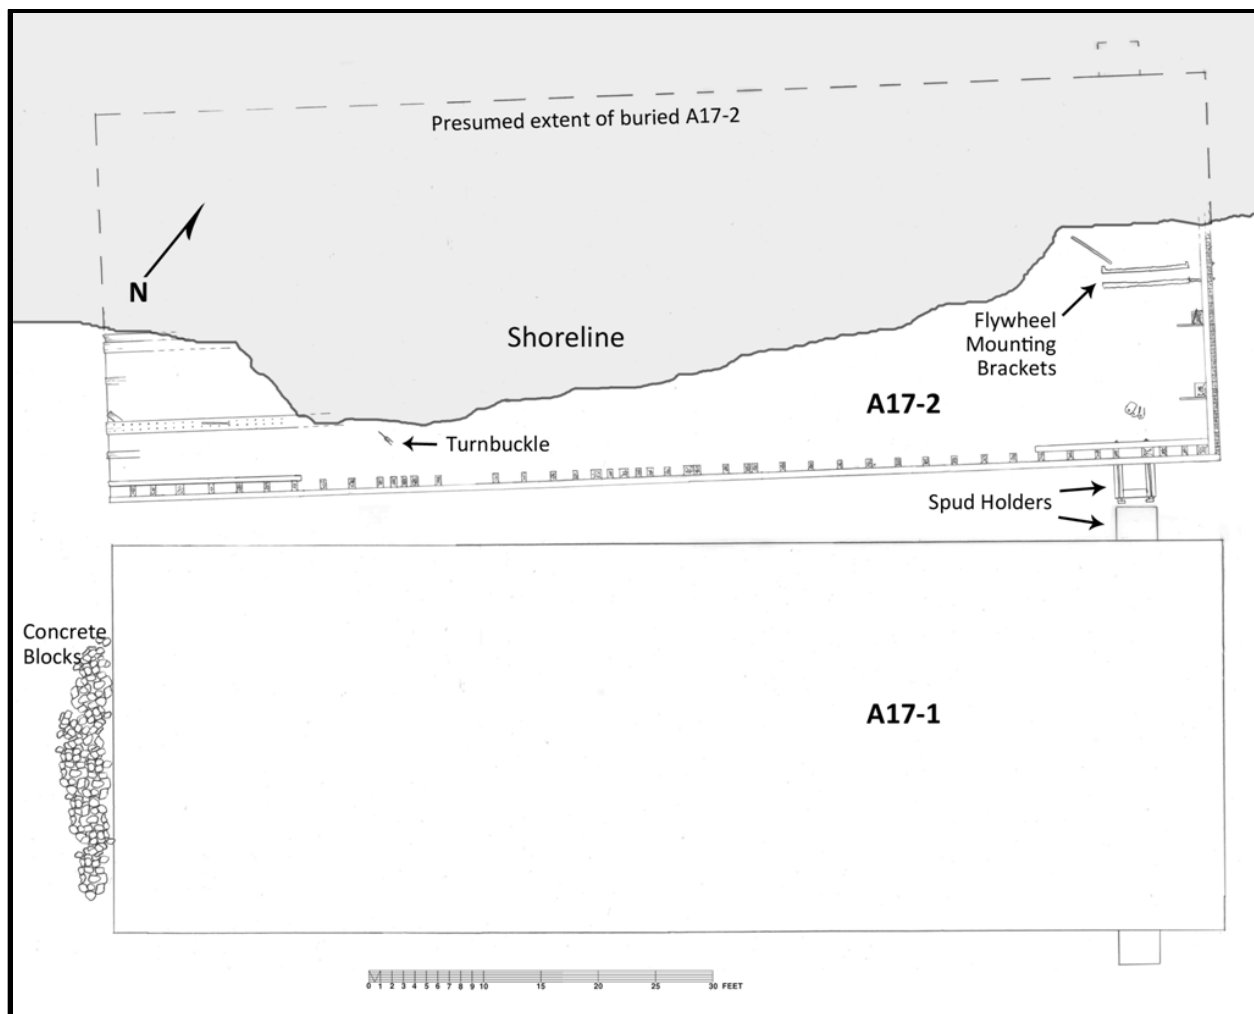
Figure 107. Scale drawing of spud barges A17-1 and A17-2 (Sarah L. Tichonuk, LCMM Collection).
