Re: Letter of Transmittal – Onondaga Lake Repository Addition

2015-2016 Source Control Summary for the Onondaga Lake Bottom Subsite May 2017

Re: 2015-2016 Source Control Summary for the Onondaga Lake Bottom Subsite, dated May 2017

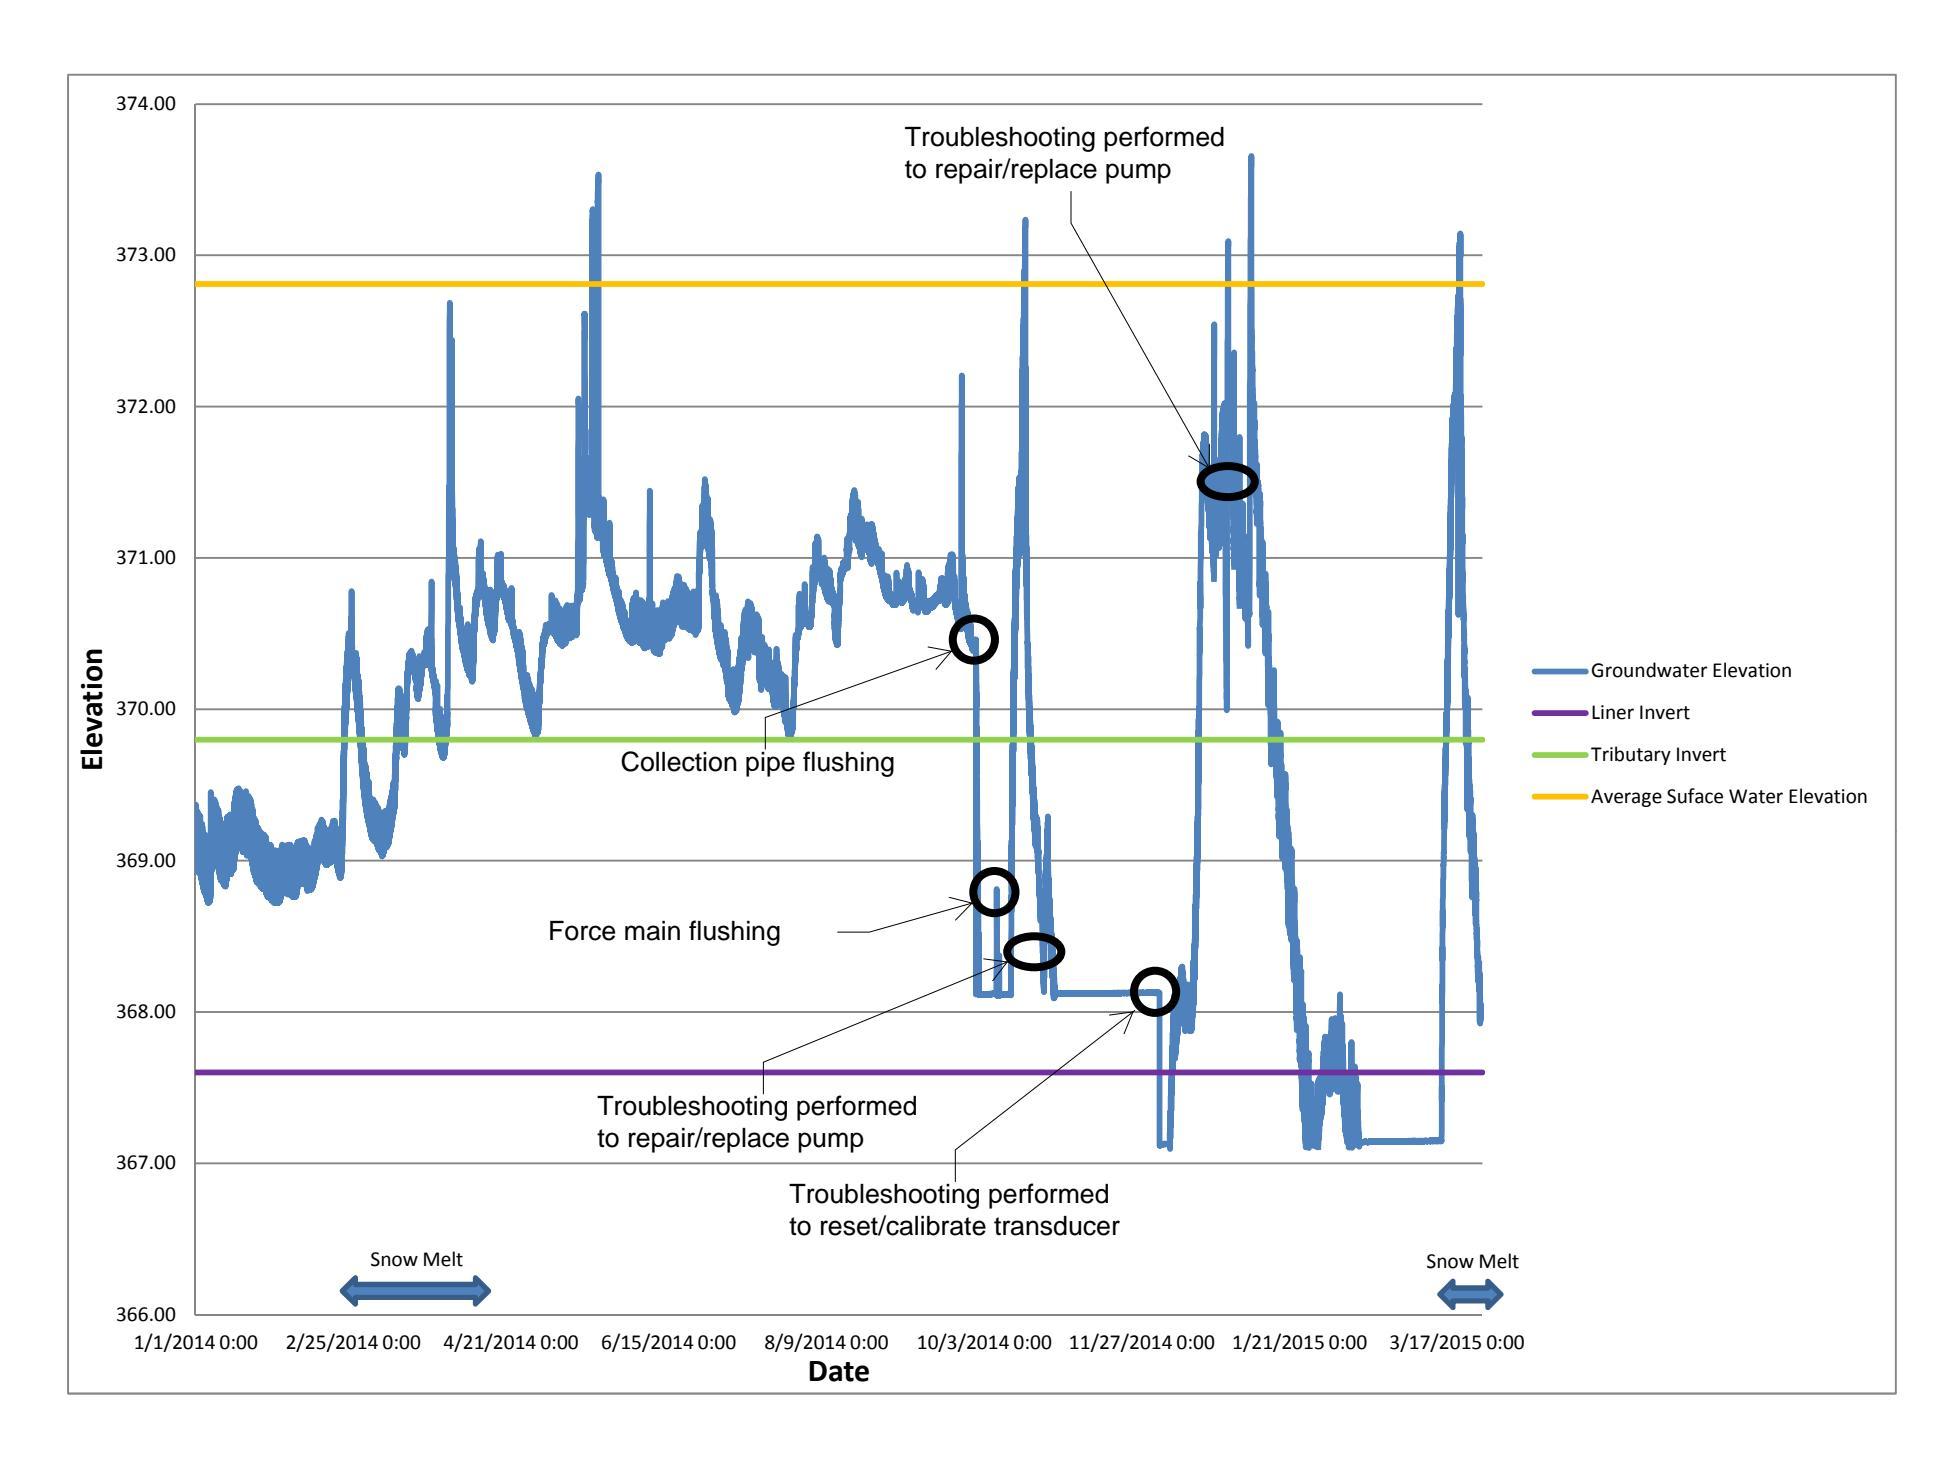
Figure B-3 Tributary 5A R1CO-1 2014 Groundwater Elevations

At the R1CO-1 and R10M-5 monitoring locations, groundwater elevations were consistently noted above the liner elevation prior to the September 2014 maintenance. While the groundwater elevations at R1CO-1 were consistently above the liner elevation, they remained below the tributary surface water elevation with the exception of the data spikes shown on **Figure B-3**. Groundwater elevations at R1OM-5 were consistently above the liner and surface water elevations (**Figure B-4**); however, visual inspection consisting of activities described above, proximate to R1OM-5 did not indicate that the liner was impacted or floating. Groundwater elevations at the R1CO-11 monitoring location were consistently below the adjacent tributary and surface water elevations with the exception of the spikes noted on **Figure B-5**. These data and visual inspection information demonstrates movement of groundwater to the collection system.

The elevated groundwater conditions in mid-2014 were attributable to blockages (*e.g.*, sedimentation, slots clogged or fouled) within the collection pipe. Maintenance was performed to flush the Reach 1 groundwater collection pipe in September 2014 and an immediate response in the form of increased pump speed and pump runtime were noted. Following maintenance, groundwater elevations trended downward and returned to conditions below the tributary invert elevation, as shown on **Figures B-3**, **B-4**, **and B-5**. During the spring months, there was rainfall and ongoing snow melt, which may have contributed to the data spikes and general increase in groundwater elevations during these periods.

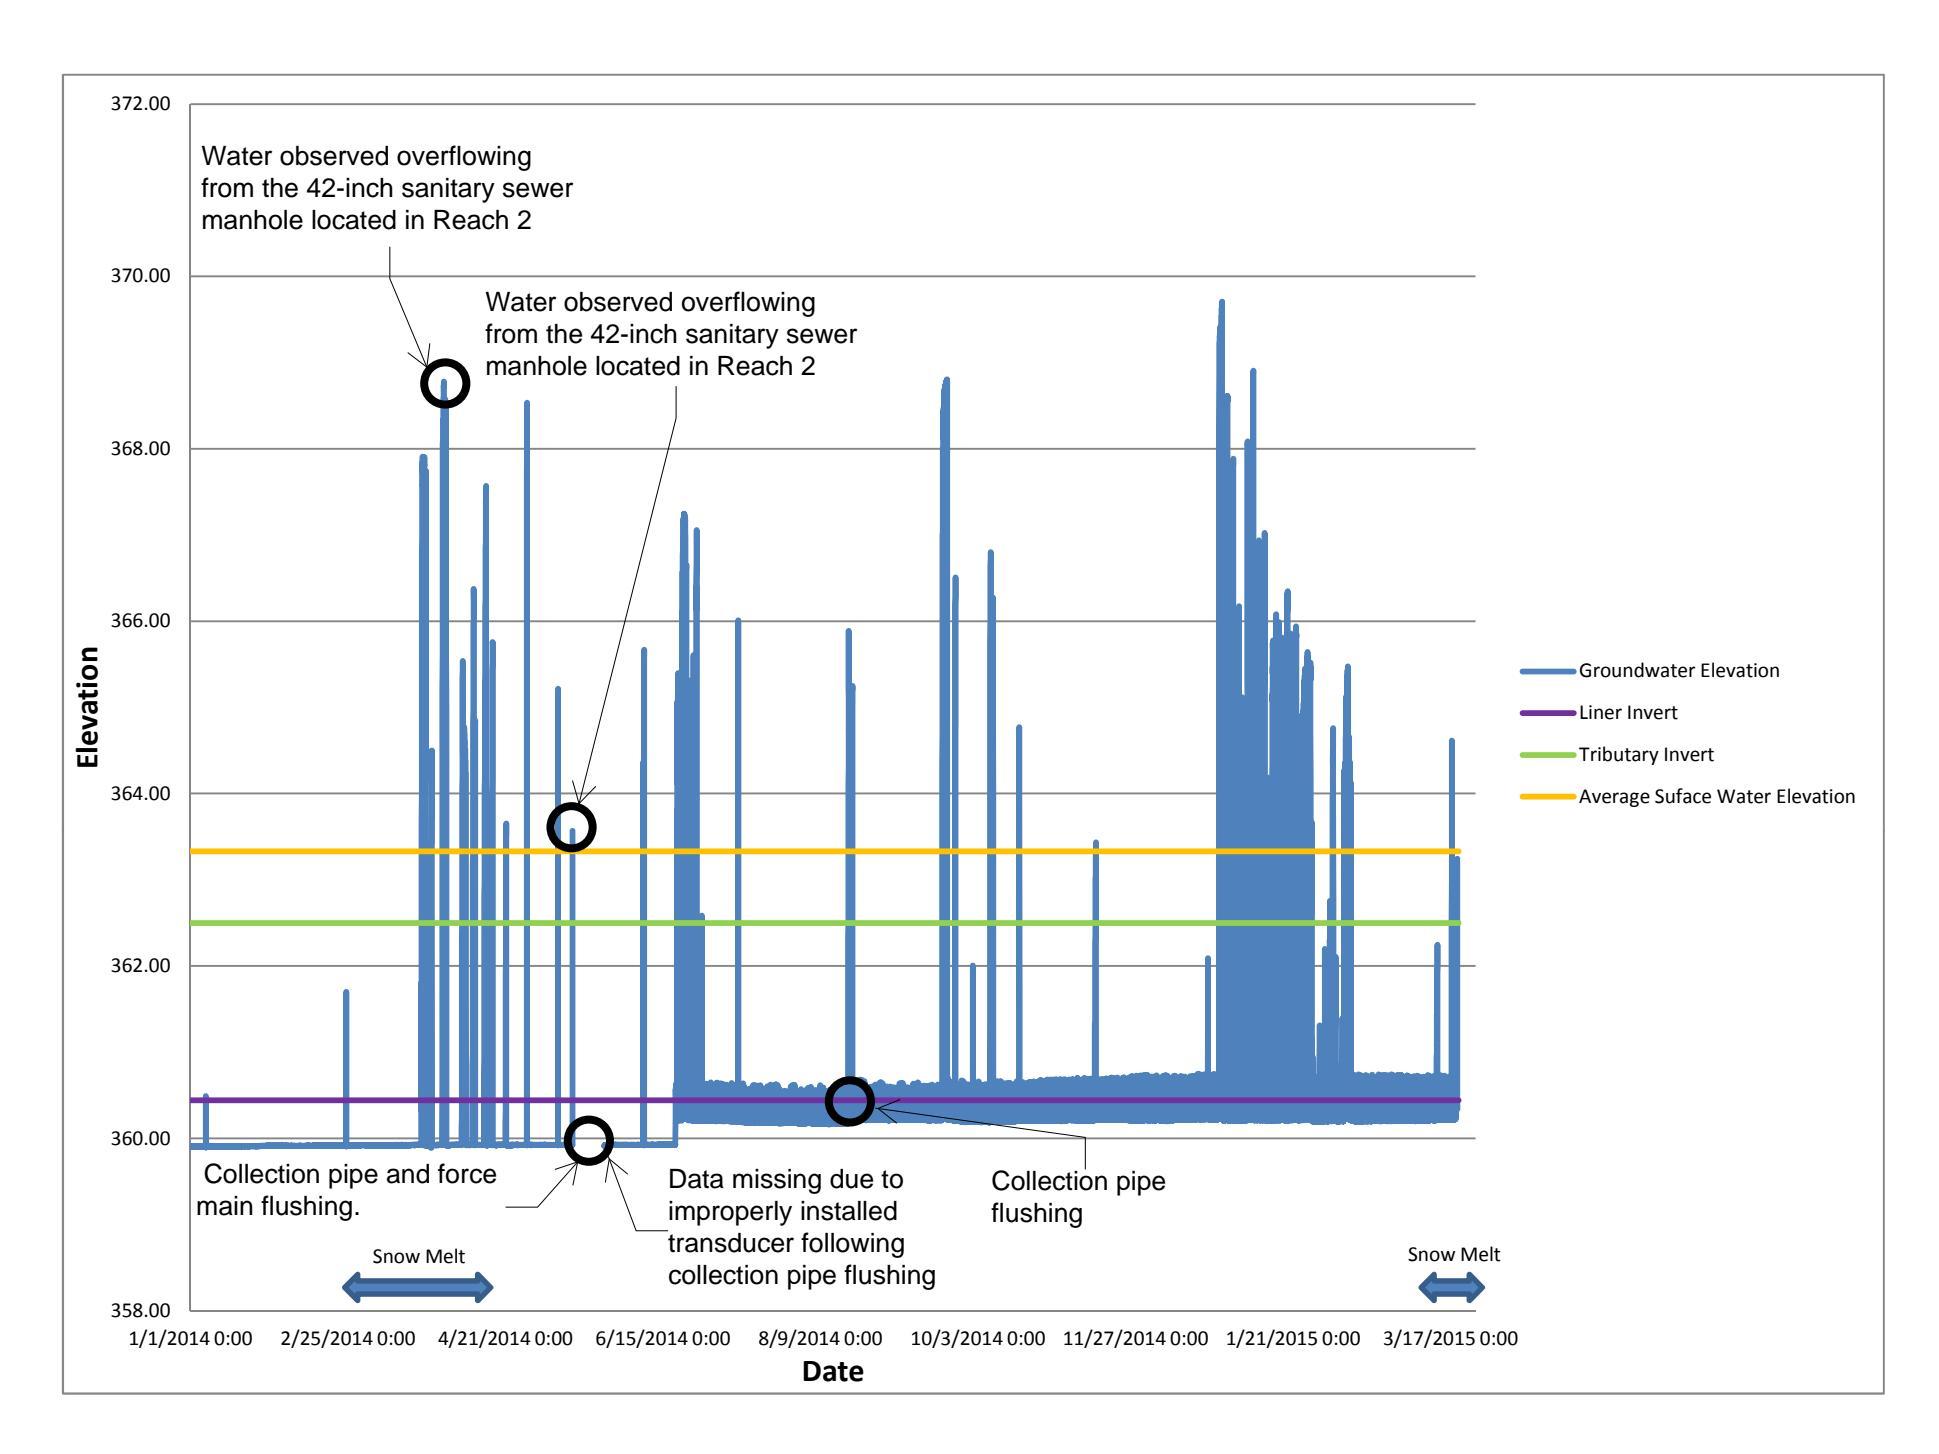
Figure B-6 Tributary 5A R2CO-1 2014 Groundwater Elevations

At the R2CO-1 monitoring location, groundwater elevations were consistently below the liner elevation; however, beginning in March 2014, data spikes exceeding the tributary invert and surface water elevations were noted (see **Figure B-6**), but elevations returned to relatively static conditions below the liner invert, tributary invert, and surface water elevations. Groundwater elevations at R2OM-1 were consistently above the liner elevation, but below the tributary invert elevation, with the exception of the data spikes noted on **Figure B-7**. As part of 2014 corrective actions, monitoring location R2OM-1 was relocated to the next downstream cleanout (R2CO-3) in October 2014. Groundwater elevations at R2CO-3 (**Figure B-8**) were noted above and below the liner invert elevation, but remained consistently below the tributary invert elevation. At the R2CO-8 monitoring location, groundwater elevations were consistently below the liner elevation, with the exception of the data spikes noted on **Figure B-9**. This data demonstrates movement of the groundwater to the collection system.

The cause of these data spikes was likely attributable to blockages (*e.g.*, sedimentation, slots clogged or fouled) within the collection pipe and scale buildup causing the pump to shut down. Maintenance was performed to flush the Reach 2 groundwater collection pipe in May 2014 and August 2014 and an immediate response in the form of increased pump speed and pump runtime were noted. Following maintenance, groundwater elevations appeared to spike less frequently. Ongoing acid addition to the pump station has continued being performed as a preventative maintenance measure to minimize potential impacts due to scaling.
