**2012 AND 2013 SOURCE CONTROL SUMMARY FOR THE  
ONONDAGA LAKE BOTTOM SUBSITE  
Syracuse, New York**

**Honeywell**

**PARSONS**

**DECEMBER 2013**

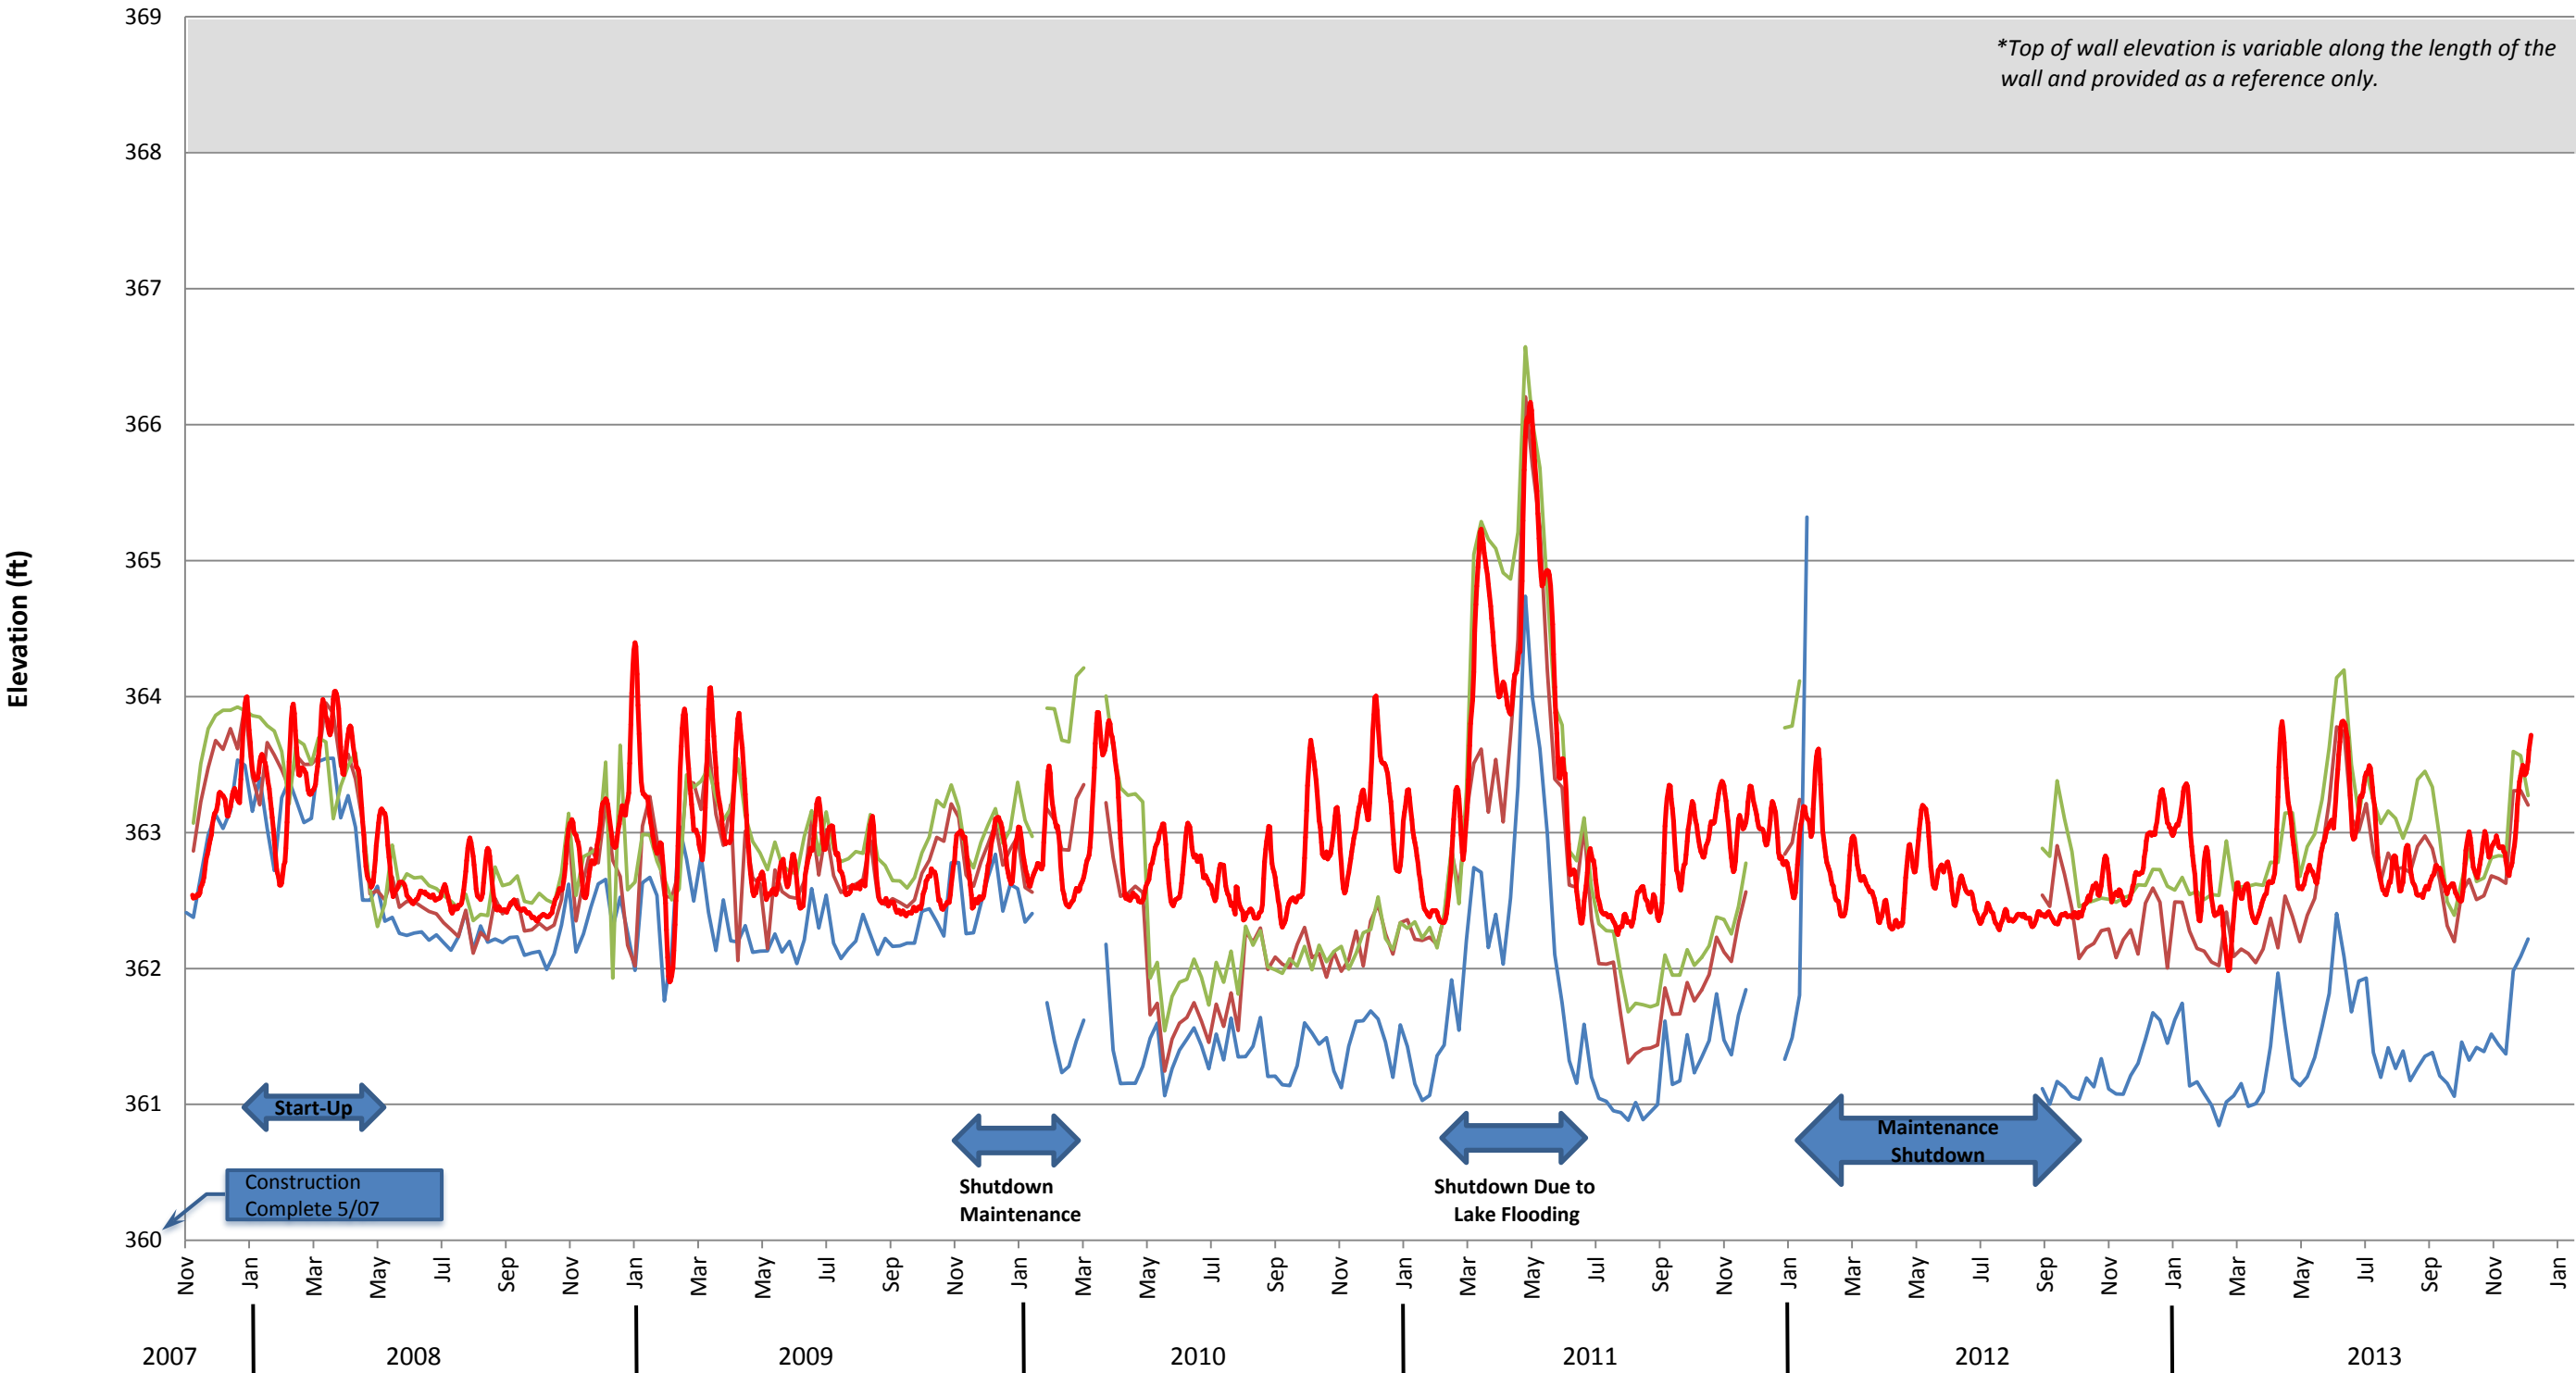
Figure 3

- Piezometer #3, located in the Phase 1 wall section, occasionally exceeds lake levels due to additional contributions from the I-690 storm underdrain and the west section of the temporary collection trench (a French drain) during storm events. Both of these drain into Transition Sump #2 (located in the vicinity of Piezometer #3) and flows from storm events can temporarily raise water levels in the nearby sections of the trench where Piezometer #3 is located.

- Groundwater levels along Phase 2 trench were affected by leaks in the Wastebeds 1-8 force main caused by ground settlement during the fall of 2013. A bypass pipe was installed to divert flows around the affected area in the event of future Wastebeds 1-8 force main leaks.

- Piezometers # 4 and #5 were damaged during construction of the tie-back wall and were repaired in July, 2013. Both piezometers have been functional since then, however only Piezometer 4 has been providing consistently usable data. In November 2013 both wells were examined and it was determined that sand from the nearby roadway was being washed into the wells when dust control water trucks passed. Both wells were flushed the week of November 11, 2013. The pull box on Piezometer 5 was

Phase 2 (Willis) - Weekly Average Groundwater Elevations

raised 6-inches and Piezometer 4 raised 3-inches to prevent sediment from reaching the well. In addition an extension has been added to the Piezometer 5 riser and the wire piezometer was set to match the previous depth. Both piezometers are now functioning and providing data.

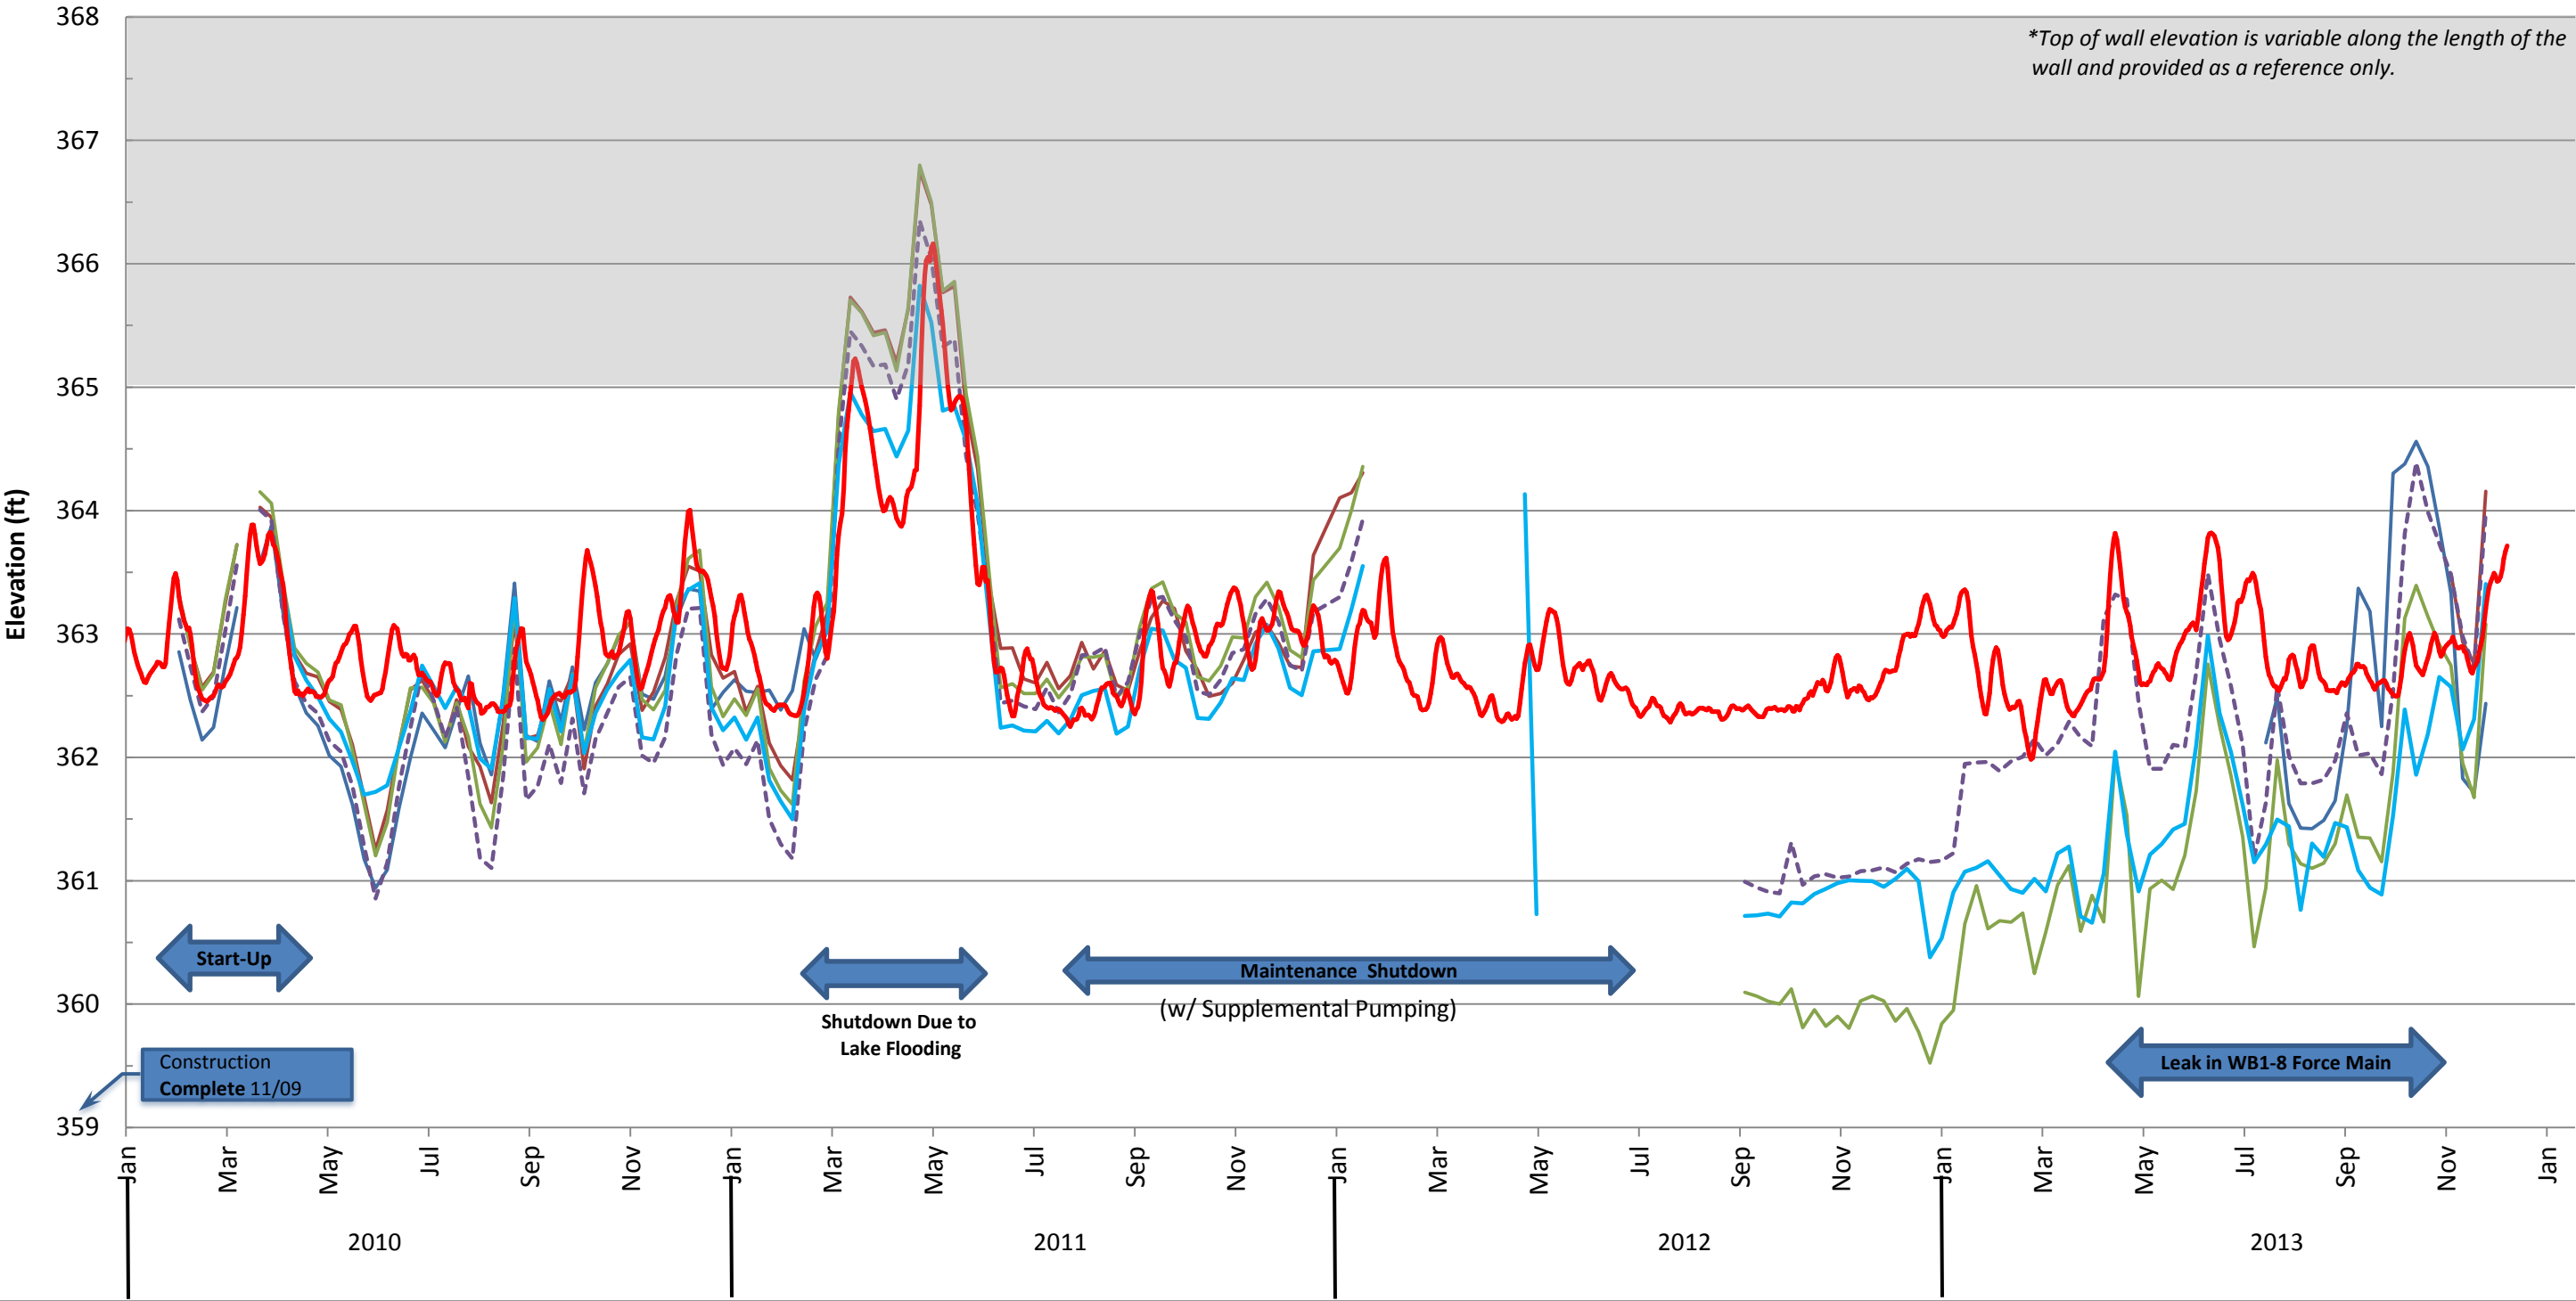
**Figure 4**  
**Phase 3(West) - Weekly Average Groundwater Elevations**

- During start-up of Phase 3 in April 2012, obstructions were located in portions of the Phase 3 collection system and corrective actions taken. Immediately following implementation of the corrective actions and completion of startup in July 2012, inward hydraulic gradients consistent with those demonstrated for the Phase 1 and Phase 2 portions were documented. Power was lost to the Phase 3 data loggers in mid-October 2012 and restored in mid-December 2012; procedures have been implemented, including weekly data downloads, to verify piezometer function on a regular and frequent basis so that periods of data loss do not occur in the future.

Beginning in early 2013, to facilitate Harbor Brook remedial construction activities that will be completed this season, water from Harbor Brook construction activities was diverted into the Phase 3 collection system, which conveys the collected water to the treatment plant. During short periods in April and June this additional water resulted in an increase in groundwater levels behind some sections of the barrier wall that were higher than elevations along the sections of wall with lowest top of wall elevations. Observations at the time verified that the pumping systems were sufficient and prevented groundwater from reaching the surface and overtopping the barrier wall. As detailed above, the containment of groundwater provided by the barrier wall and the groundwater collection system addresses concerns related to potential recontamination of the cap. The ability to contain groundwater and maintain an inward gradient, even during periods where external contributions influence groundwater levels, has been demonstrated for all three Phases of the IRM and is expected to continue indefinitely.
