Phase 3 Underwater Archaeological Report for the Onondaga Lake Bottom, Subsite of the Onondaga Lake Superfund Site, Onondaga County, New York

September 2014

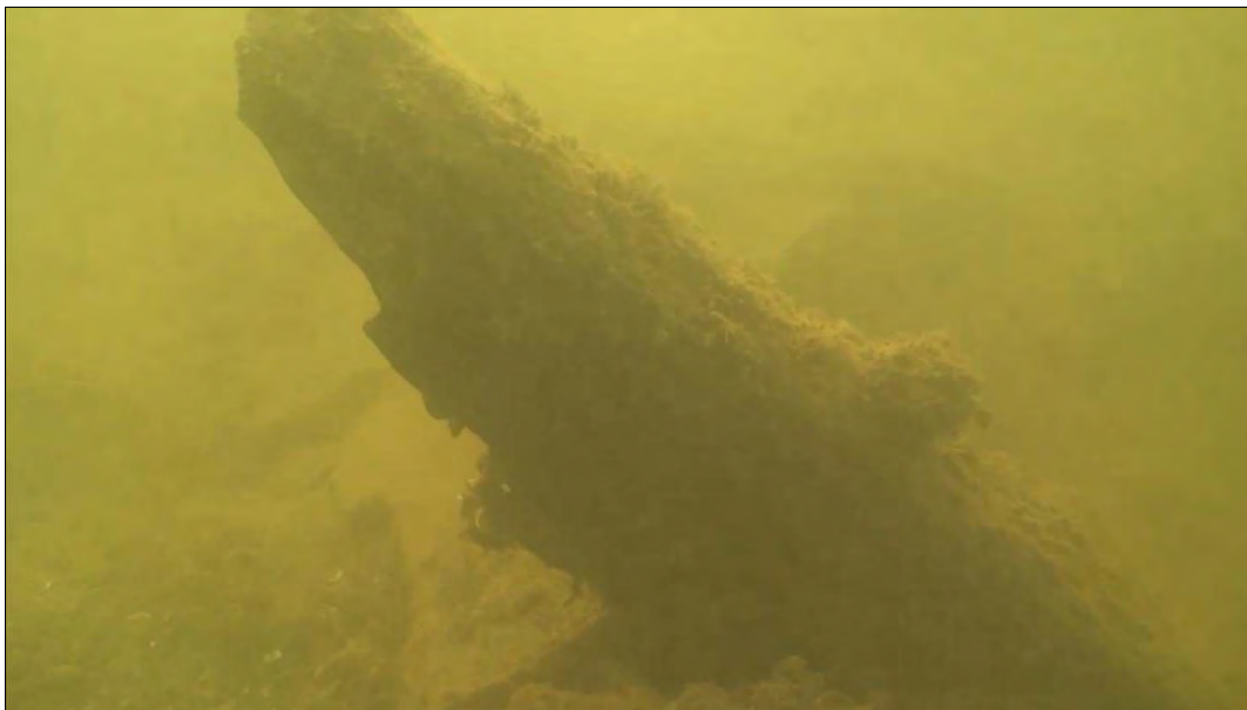
Figure 45: One of three angled braces in A2-2 which provide structural support, similar to the function of a standing knee (LCMM Collection)

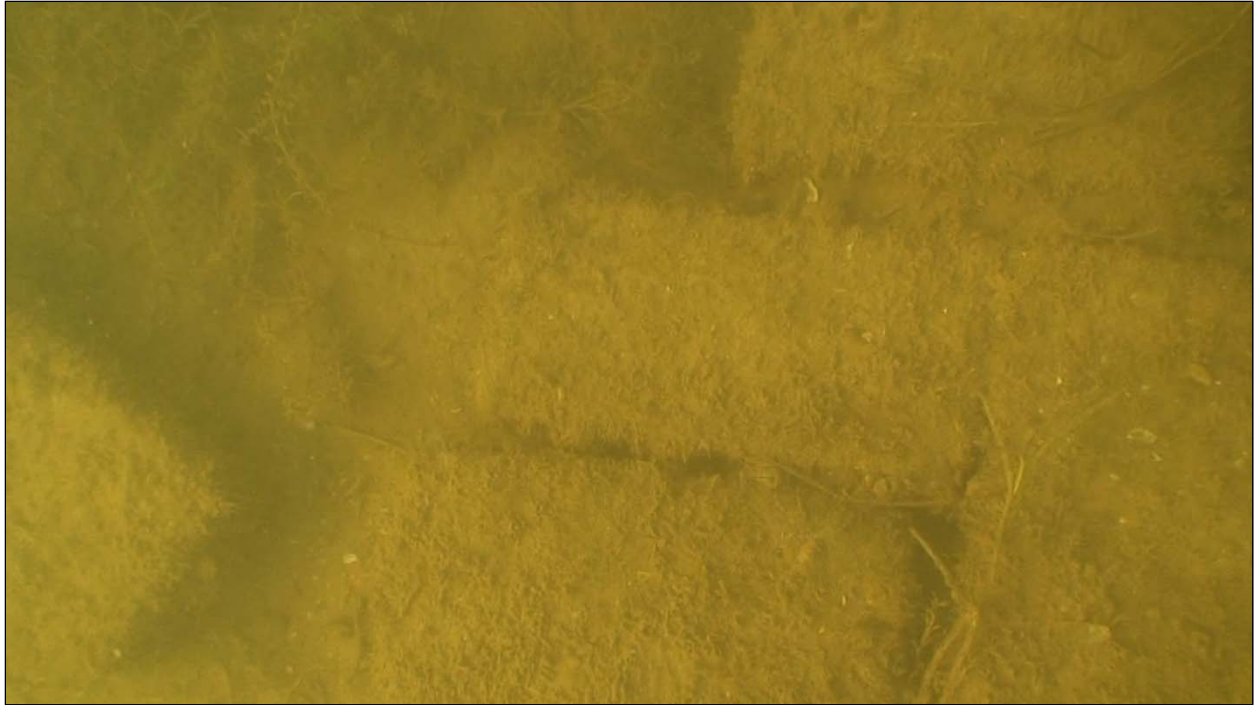
Figure 48: Approximately 35 feet forward of the stern appears a layer of neatly arranged fire bricks (LCMM Collection).

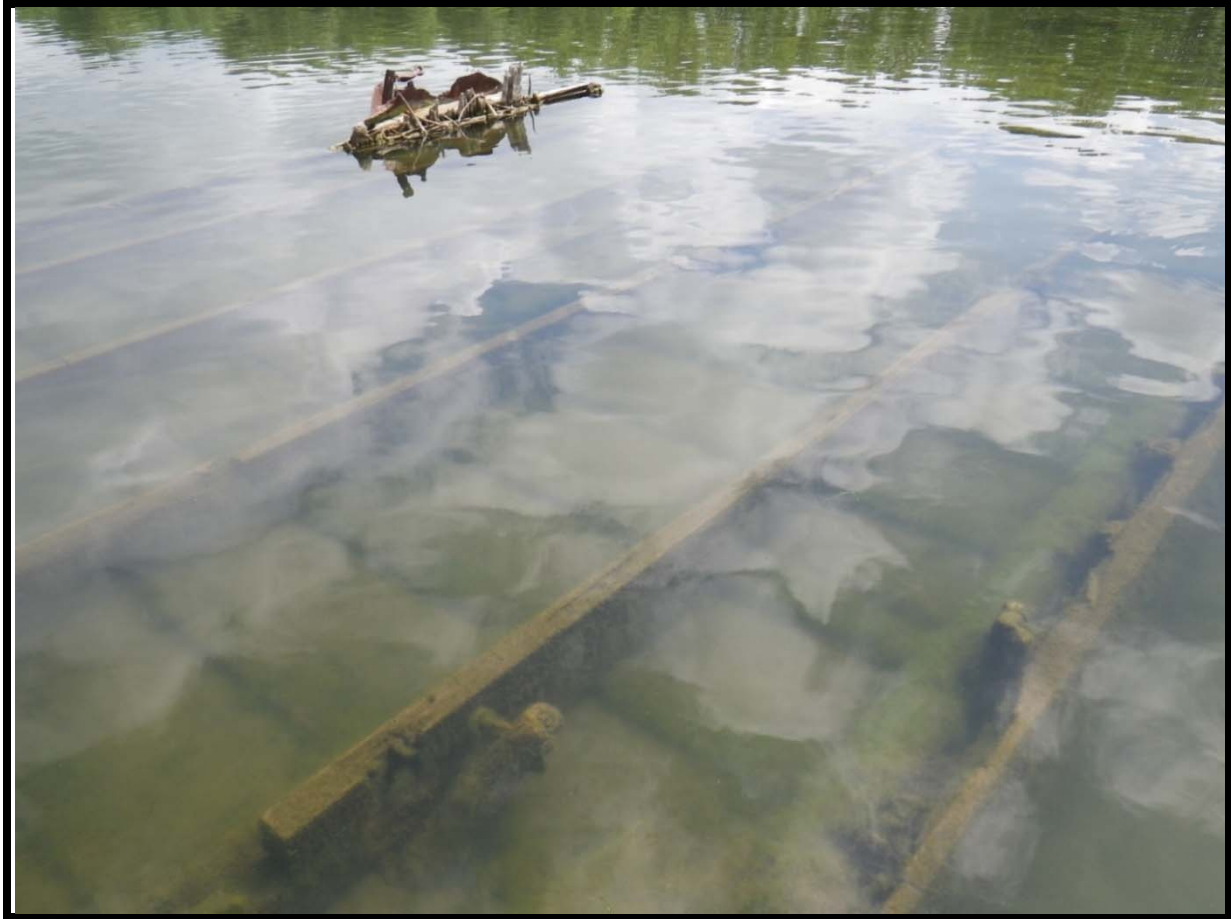
Figure 81: Photograph showing Anomaly A12's longitudinal bulkheads with the spud box in the background (LCMM Collection).

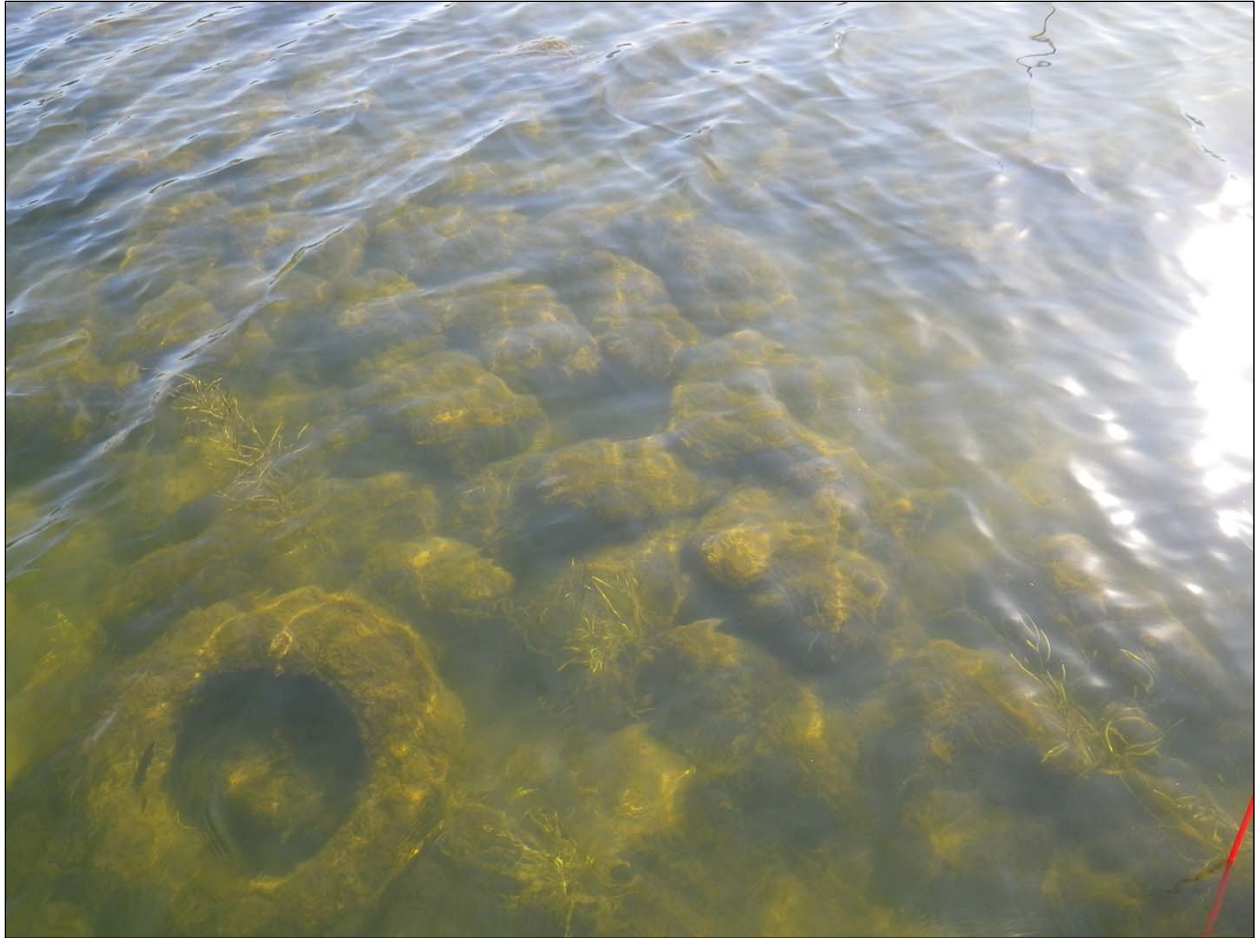
Figure 88: A view of A45 from above the water's surface. Note the modern debris amidst the concrete pillows (LCMM Collection).

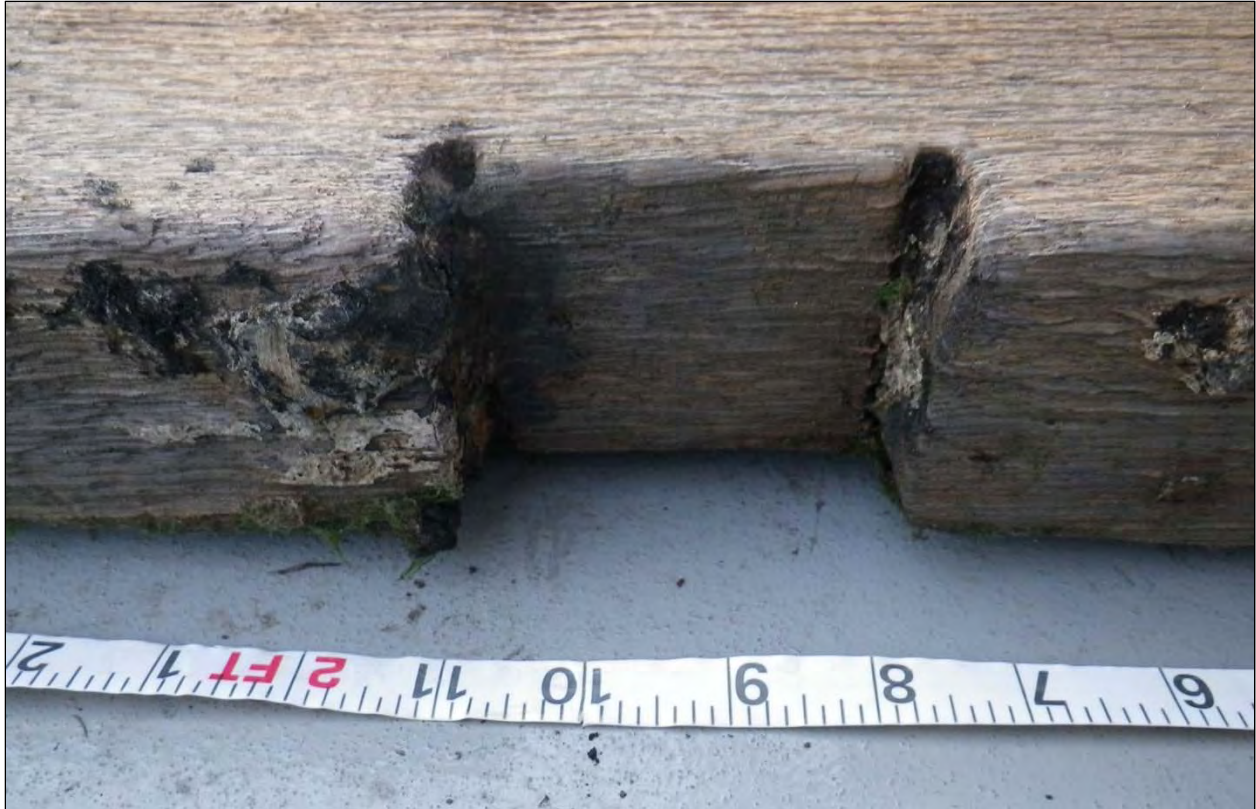
Figure 95: Limber hole of Timber 8 of A53. Note drilled holes in the corners, allowing for the rectangle to be sawn out (LCMM Collection).

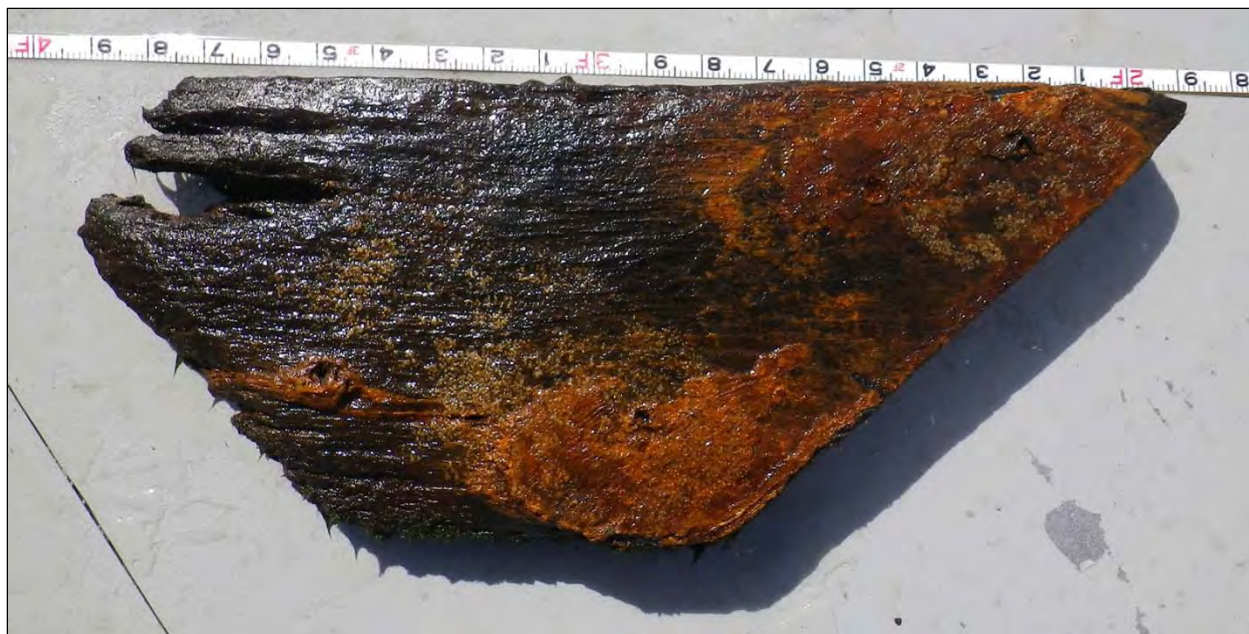
Figure 96: This cocked hat was found dislodged from its frame on A53 and was documented at the surface (LCMM Collection).
