ONONDAGA LAKE PHASE 1 PRE-DESIGN INVESTIGATION GEOPHYSICAL SURVEY REPORT

Bathymetric Contour Map of Onondaga Lake Showing Sediment Management Units

Prepared for:
Parsons
290 Elwood Davis Road, Suite 312
Syracuse, New York 13088

Prepared by:
CR Environmental Inc.
639 Boxberry Hill Road
East Falmouth, MA 02356

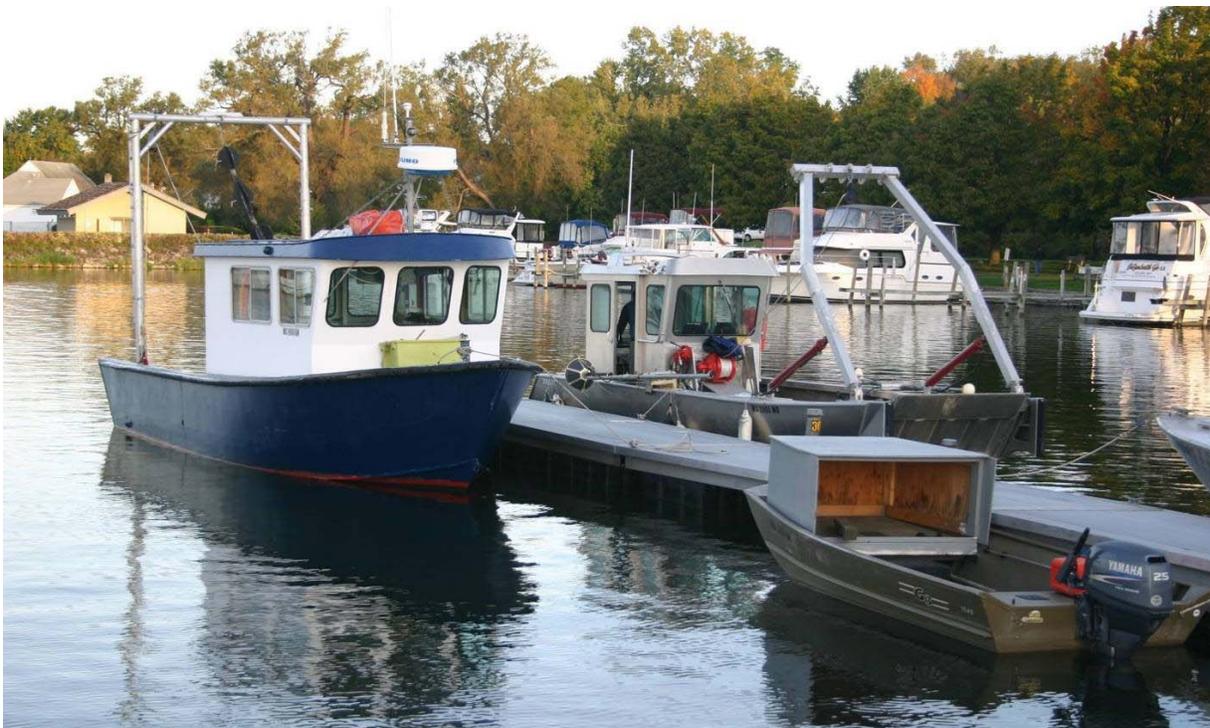
Photograph 1. CR Environmental's aluminum survey vessels R/V *Cyprinodon*, R/V *Lophius* and a jonboat at Onondaga Park Marina

On November 4, 2005, survey gear was transferred from R/V *Lophius* to CR's 22 ft fiberglass survey vessel, R/V *Seahawk*. Additional bathymetric and magnetometer data were collected for nearshore portions of the SMUs, and data along Quality Control (QC) bathymetric cross-tie transects oriented perpendicular to the primary survey transects were collected. During this same time period, *Lophius* collected box-core sediment samples.

Survey gear was transferred from *SeaHawk* to the 15 ft shallow draft aluminum jonboat R/V *Salvelinus* on November 5, 2005. The jonboat was used to survey other shallow portions of the littoral SMUs that could not be safely navigated using the larger vessels. Bathymetric data were collected from the jonboat on November 5 and 6, 2005.

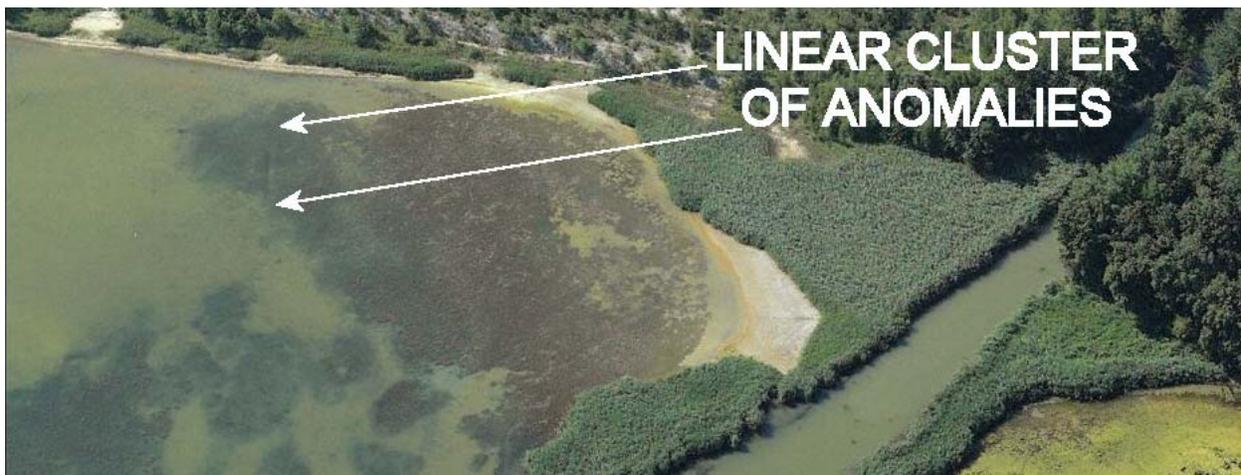
Photograph 3. Aerial photograph (looking south) at SMU 4 identifies a linear bottom feature approximately co-located with a linear arrangement of magnetic anomalies.

An approximately linear cluster of large anomalies is located approximately 100 yards to the east of the Nine Mile Creek inlet, and extends approximately 370 ft into SMU 4 from the shoreline (Figure 39). This cluster is located at an elevation of 360 to 361 ft in waters 1 to 2 ft deep. Side-scan sonar coverage and resolution of this area was limited by the shallow depths. However, some indication of the nature of this cluster can be gained from inspection of high resolution aerial photography (Microsoft, Inc. (www.local.live.com), Photographs 3 and 4, below).

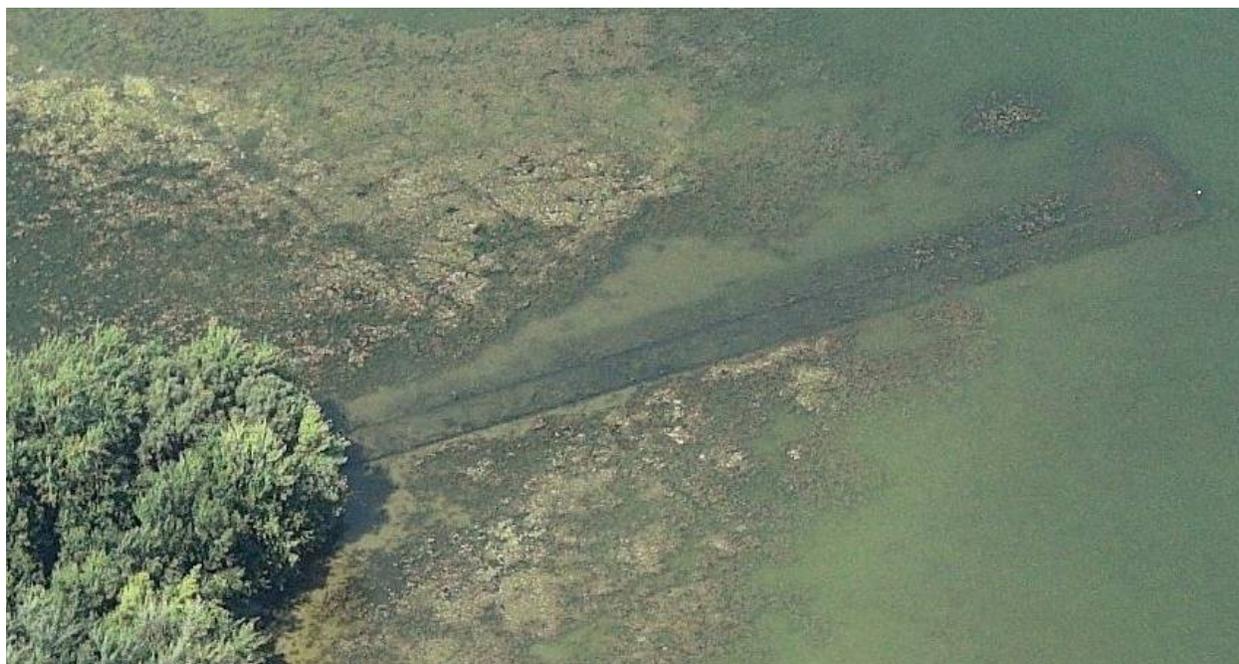
Photograph 6. – *View to the north of a feature in southern SMU 5B.*

This feature was not identified in the historical database. The parallel linear structure and evenly spaced cross members are clearly shown in Photograph 7, below (from www.local.live.com). This image also suggests the presence of surrounding debris. Both the side-scan sonar data and magnetic data identified the feature (Figures 23 and 41). All three remote sensing methods

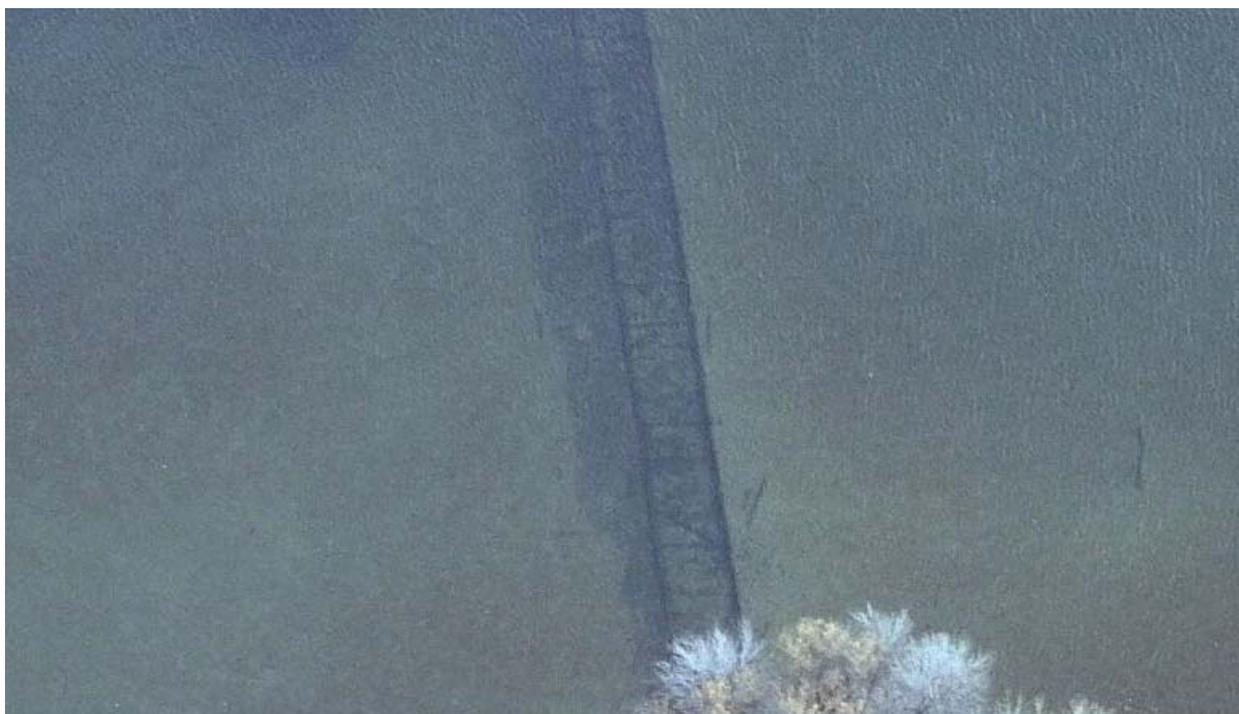
Photograph 7. – *View to the east of the feature in southern SMU 5B, showing its linear nature, cross members and surrounding debris.*

suggest a broad, well-defined terminal structure with nearby pilings. Side-scan sonar data suggests vertical sheet piling, at least at the terminus (Figure 47). Nine magnetic anomalies were associated with the structure (Figure 41). The magnitude of these magnetic anomalies ranged from 9g to 595g (average 237g).

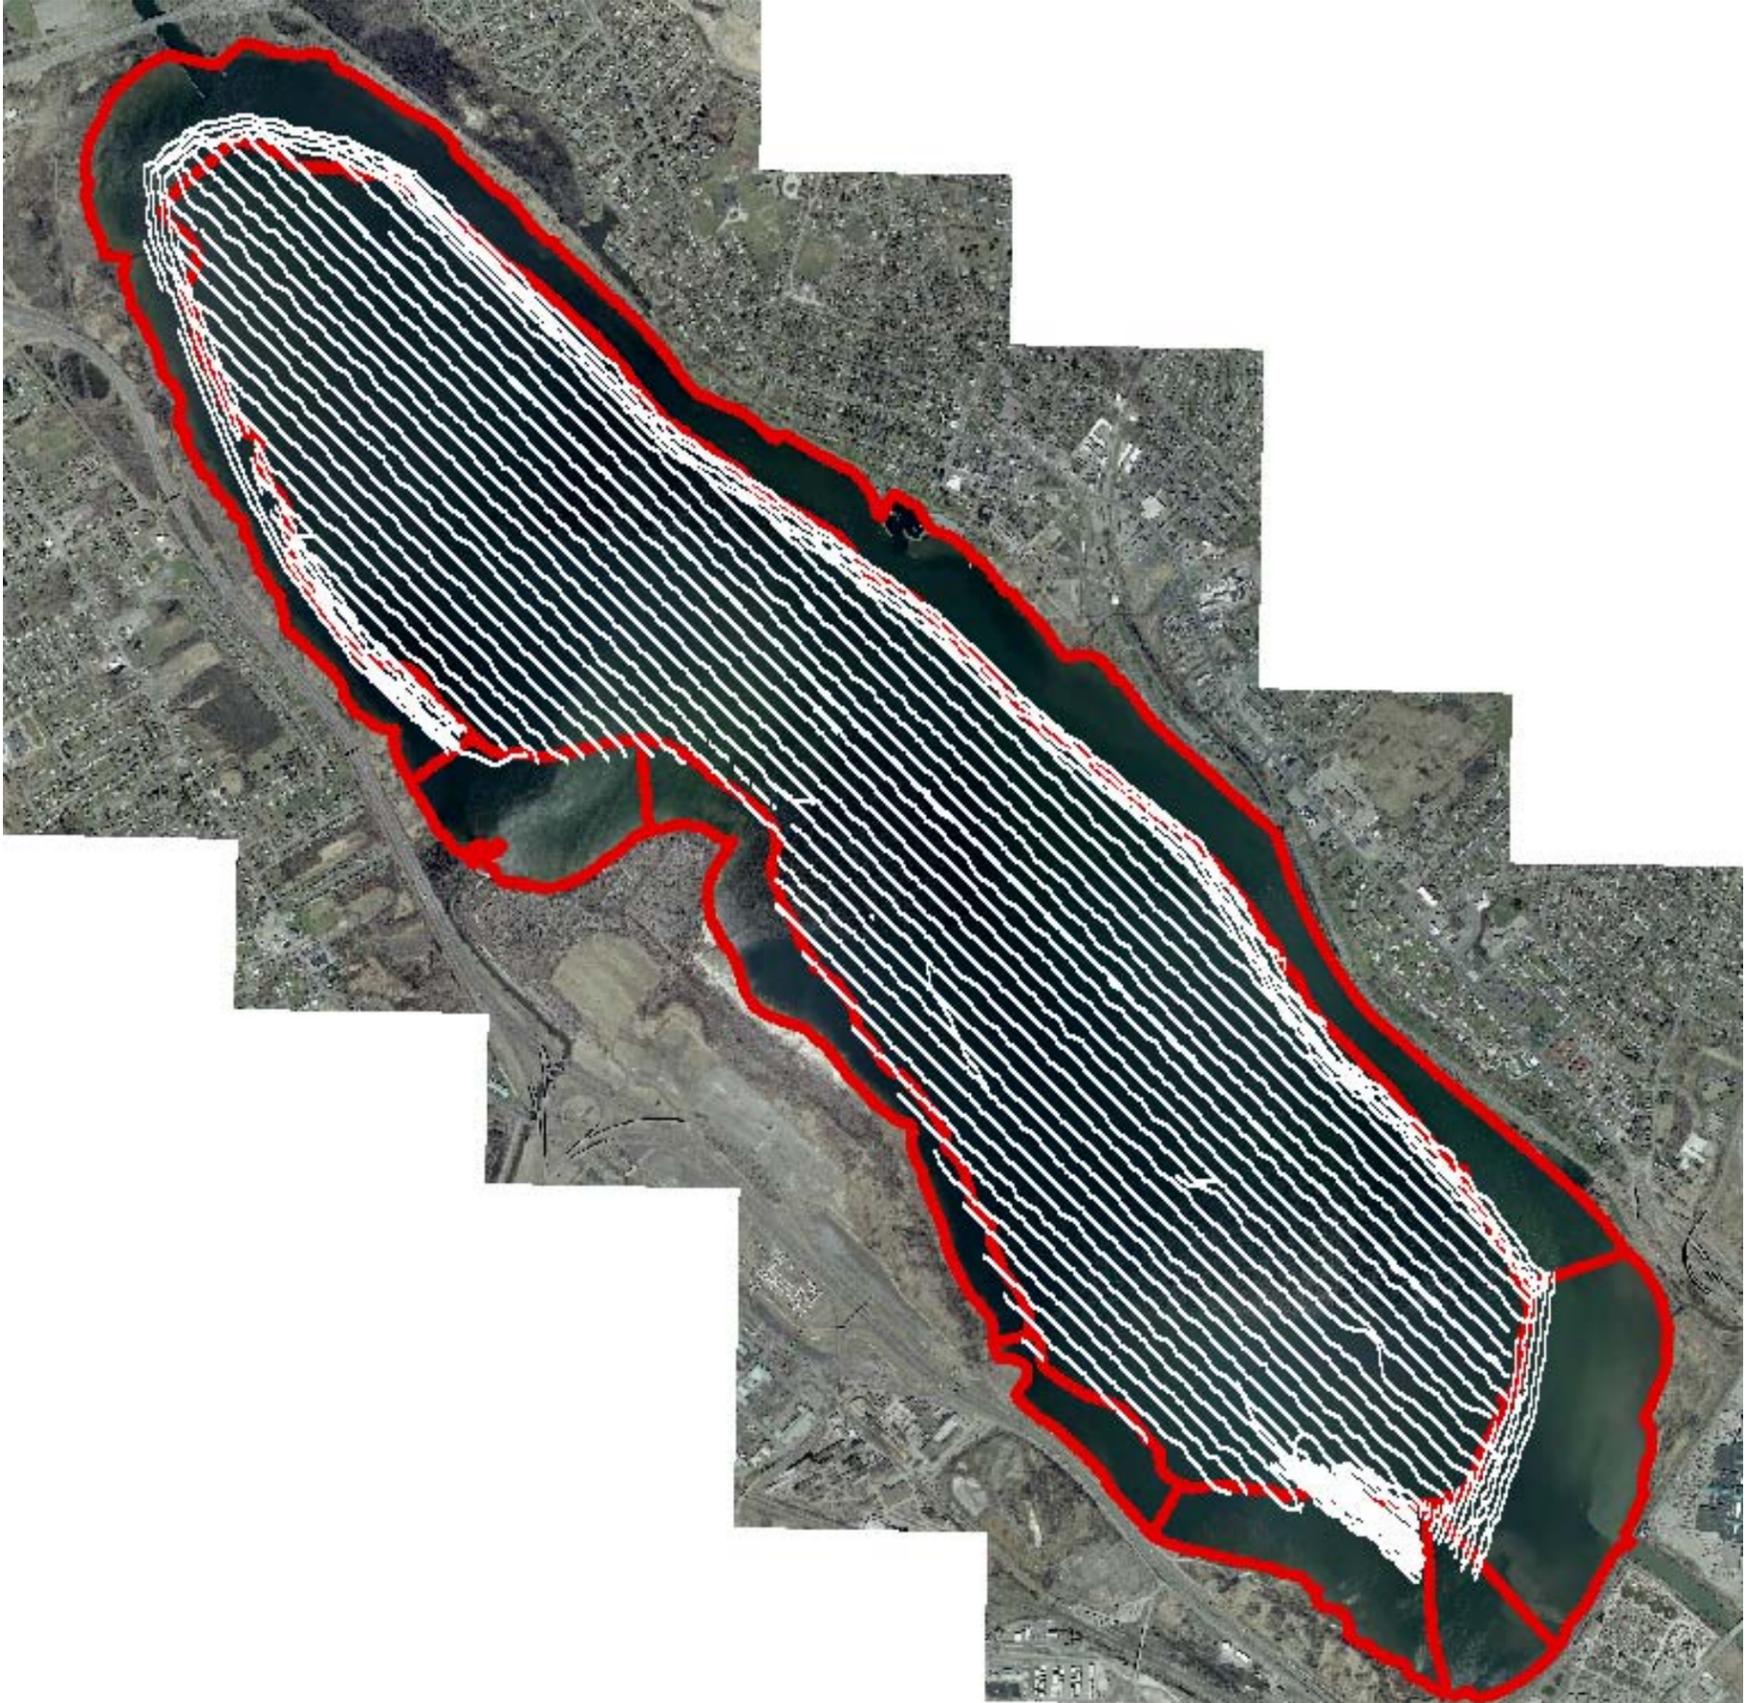
FIGURE 2

**SURVEY TRACKLINES OCCUPIED BETWEEN
OCTOBER 12 AND 19, 2005 FROM R/V CYPRINODON**

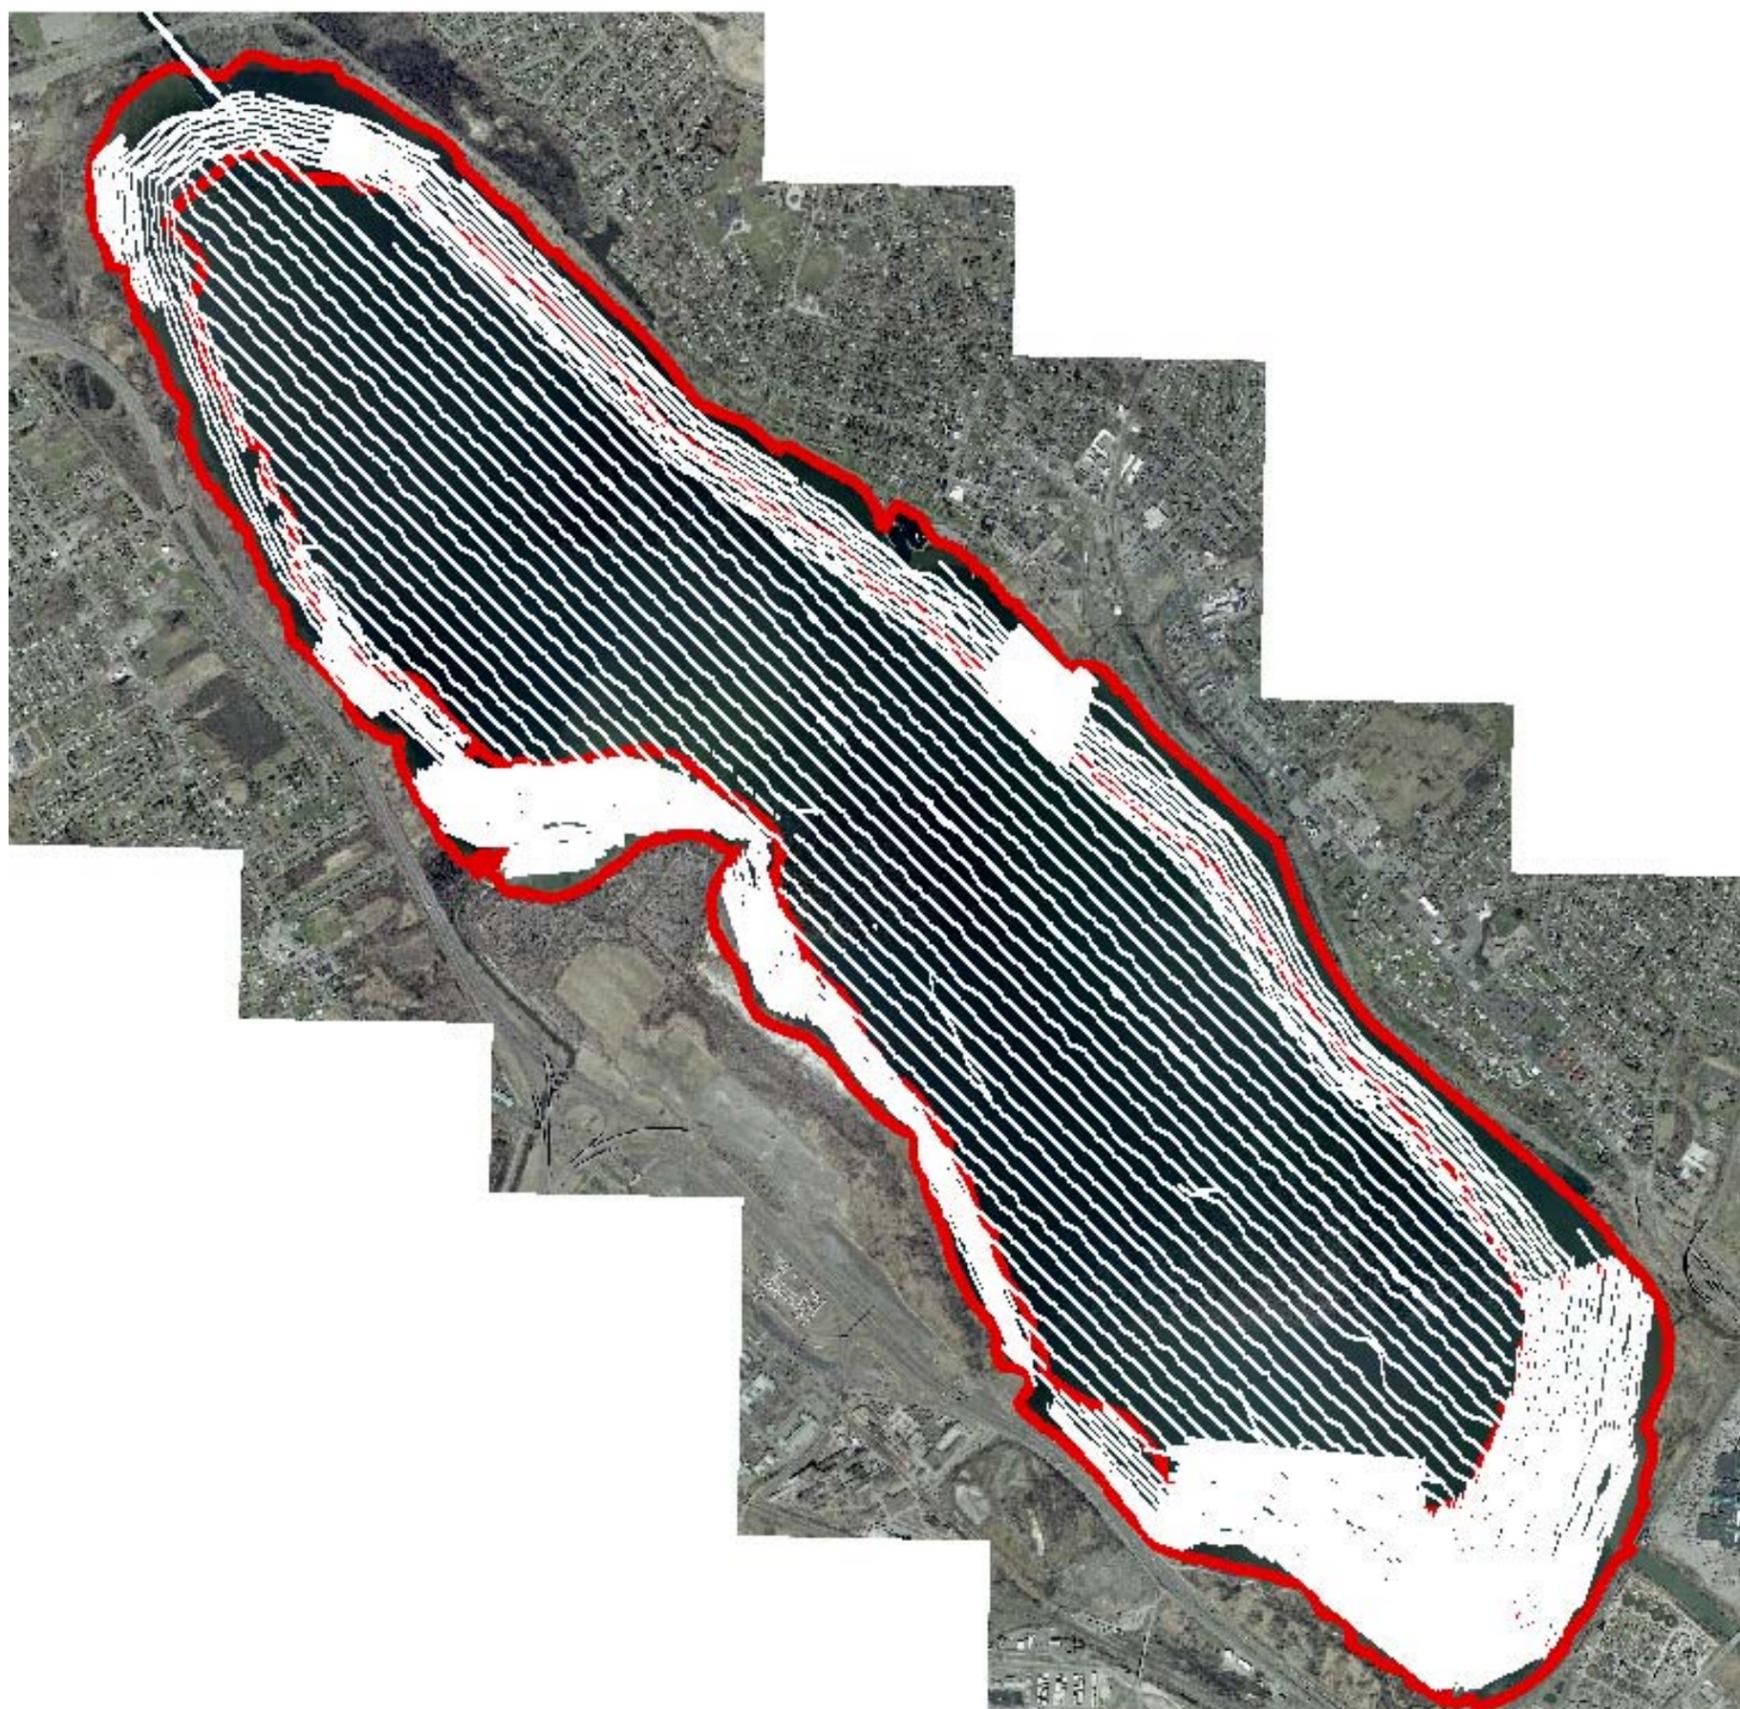
FIGURE 3

**SURVEY TRACKLINES OCCUPIED BETWEEN
OCTOBER 12 AND NOVEMBER 3, 2005
FROM R/V CYPRINODON AND R/V LOPHIUS**

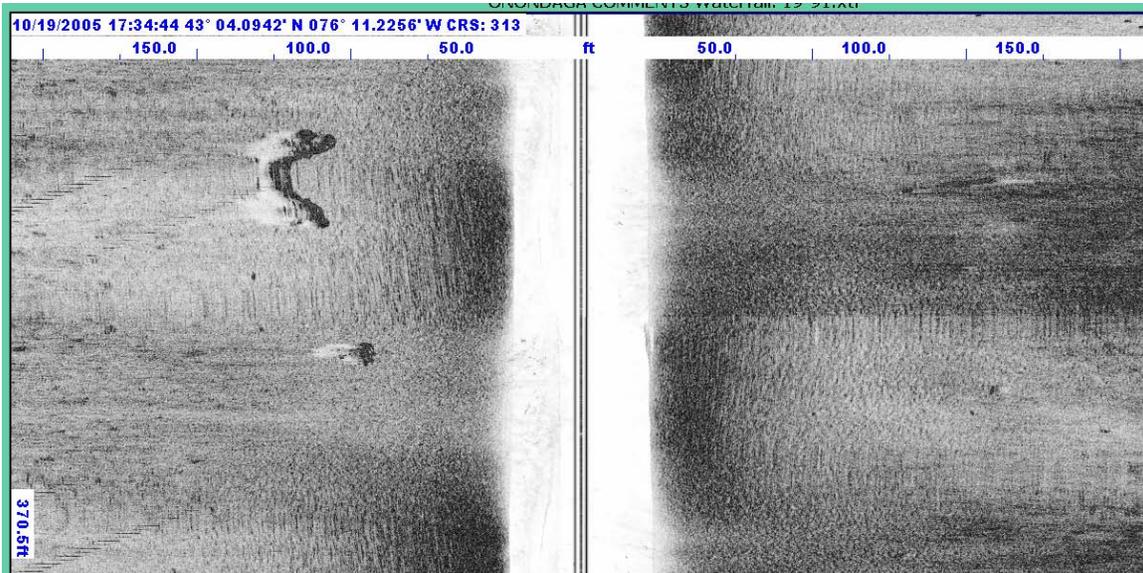
“RAW” WATERFALL DATA FROM SIDE SCAN SONAR LINE 19-91

Raw data from sonar file 19-91.xtf depicts large objects (Contacts or Targets “A” and “B”) on port (left) channel, smaller targets on starboard channel. The vessel’s heading was roughly northwest and the beginning of the recording is the upper portion off the record. Note that Contact “A” is observed almost immediately after beginning the recording (~120 pings or 8 seconds).
