Client: Honeywell Project: Onondaga Lake SCA Final Cover Design Project/Proposal #: GD5497

SETTLEMENT ANALYSES REEVALUATION (SPRING 2016) FOR SCA FINAL COVER DESIGN

ADDENDUM 2

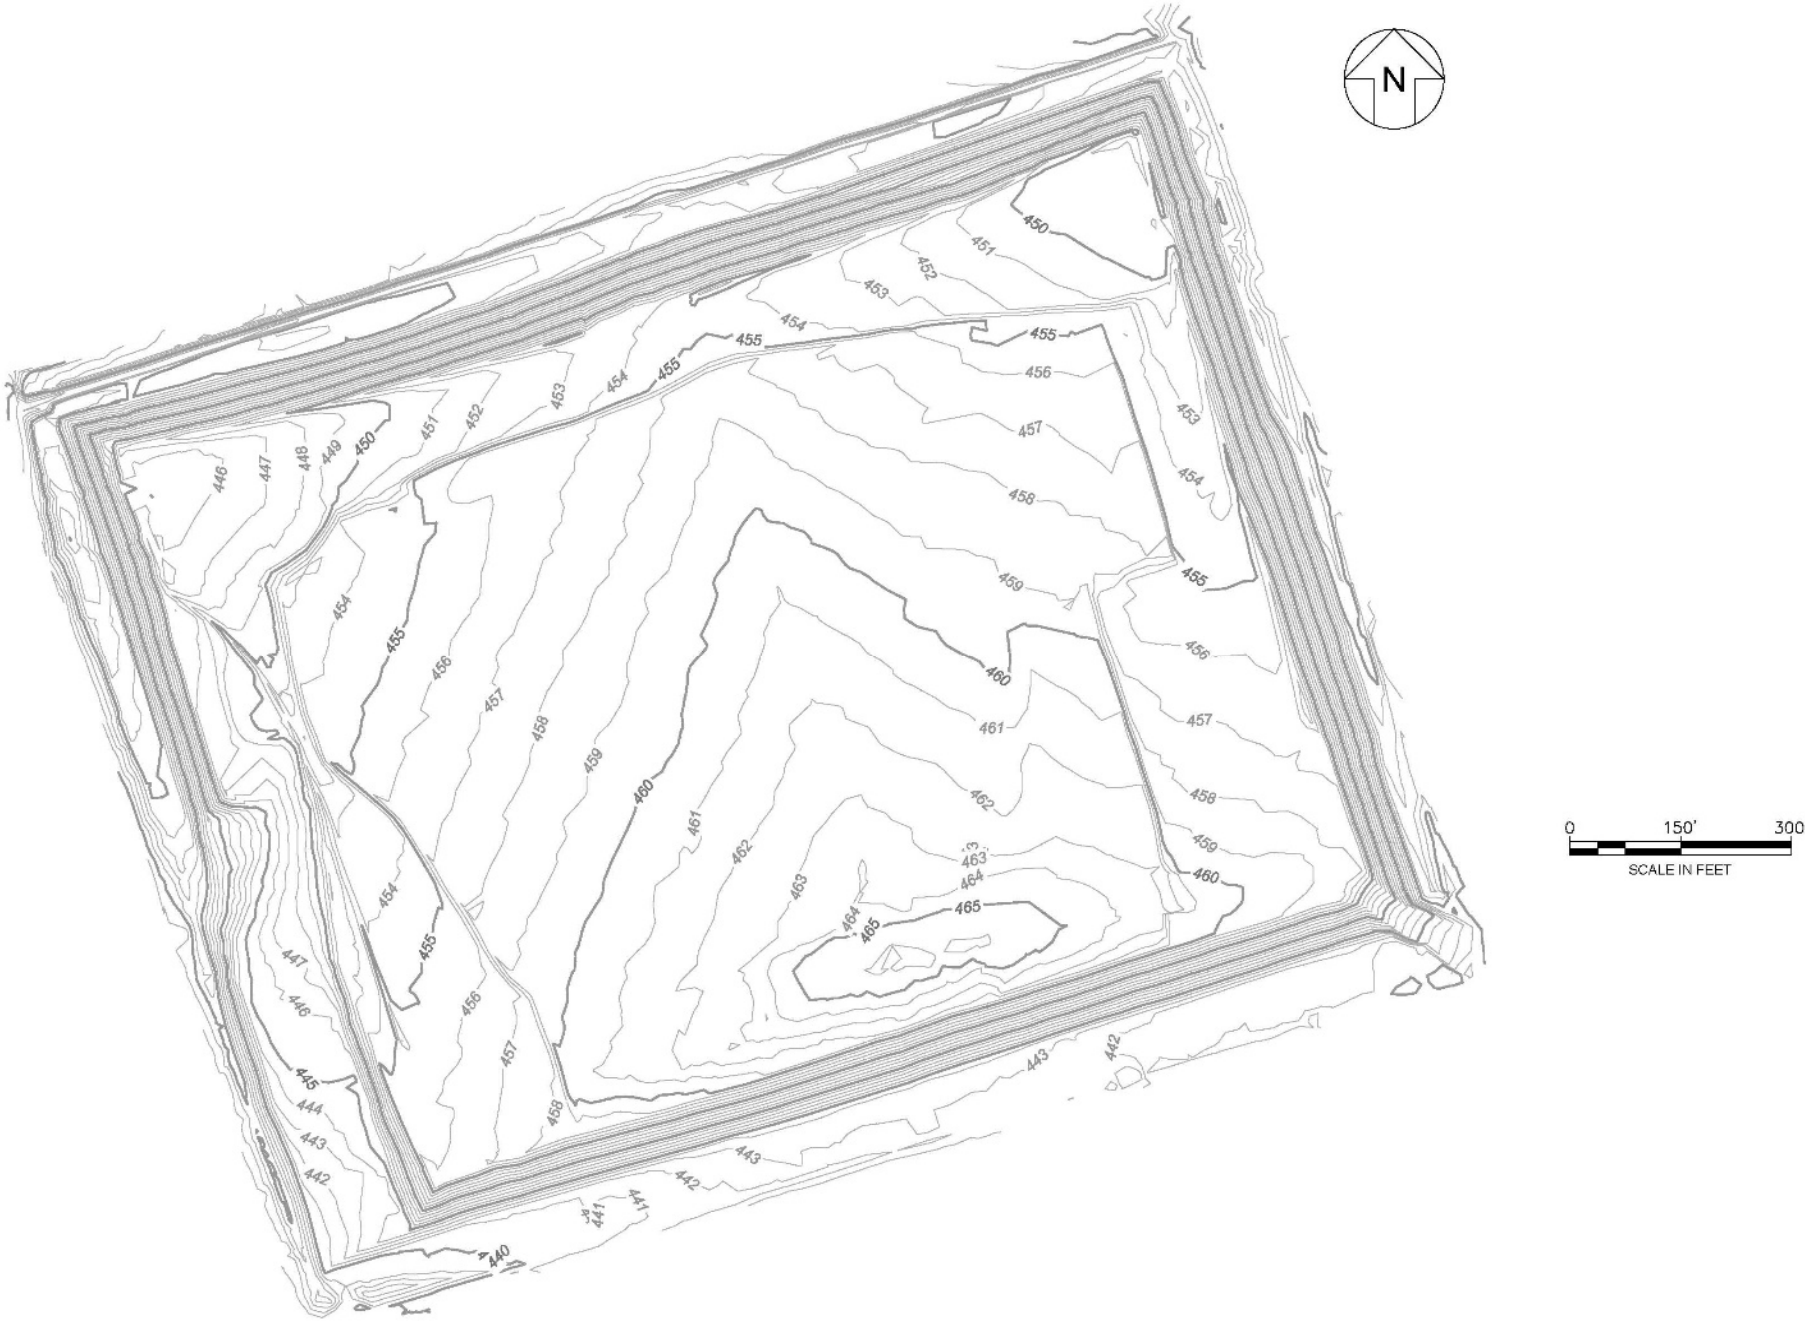
Figure 1. SCA survey performed 1 December 2015 (survey data provided by Parsons)

The December 2015 and March 2016 SCA surveys are shown in Figures 1 and 2, respectively. The December 2015 survey was performed approximately one month after the 2015 leveling layer construction was completed at the SCA (i.e., beginning of SCA winter shutdown conditions) and the March 2016 survey was performed before the start of the 2016 construction season. Therefore, the December 2015 and March 2016 surveys bracket an approximately four month period when no additional construction loading occurred in the SCA. As shown in Figure 3, an isopach (negative values are indicative of settlement) between the two surveys indicates that approximately:

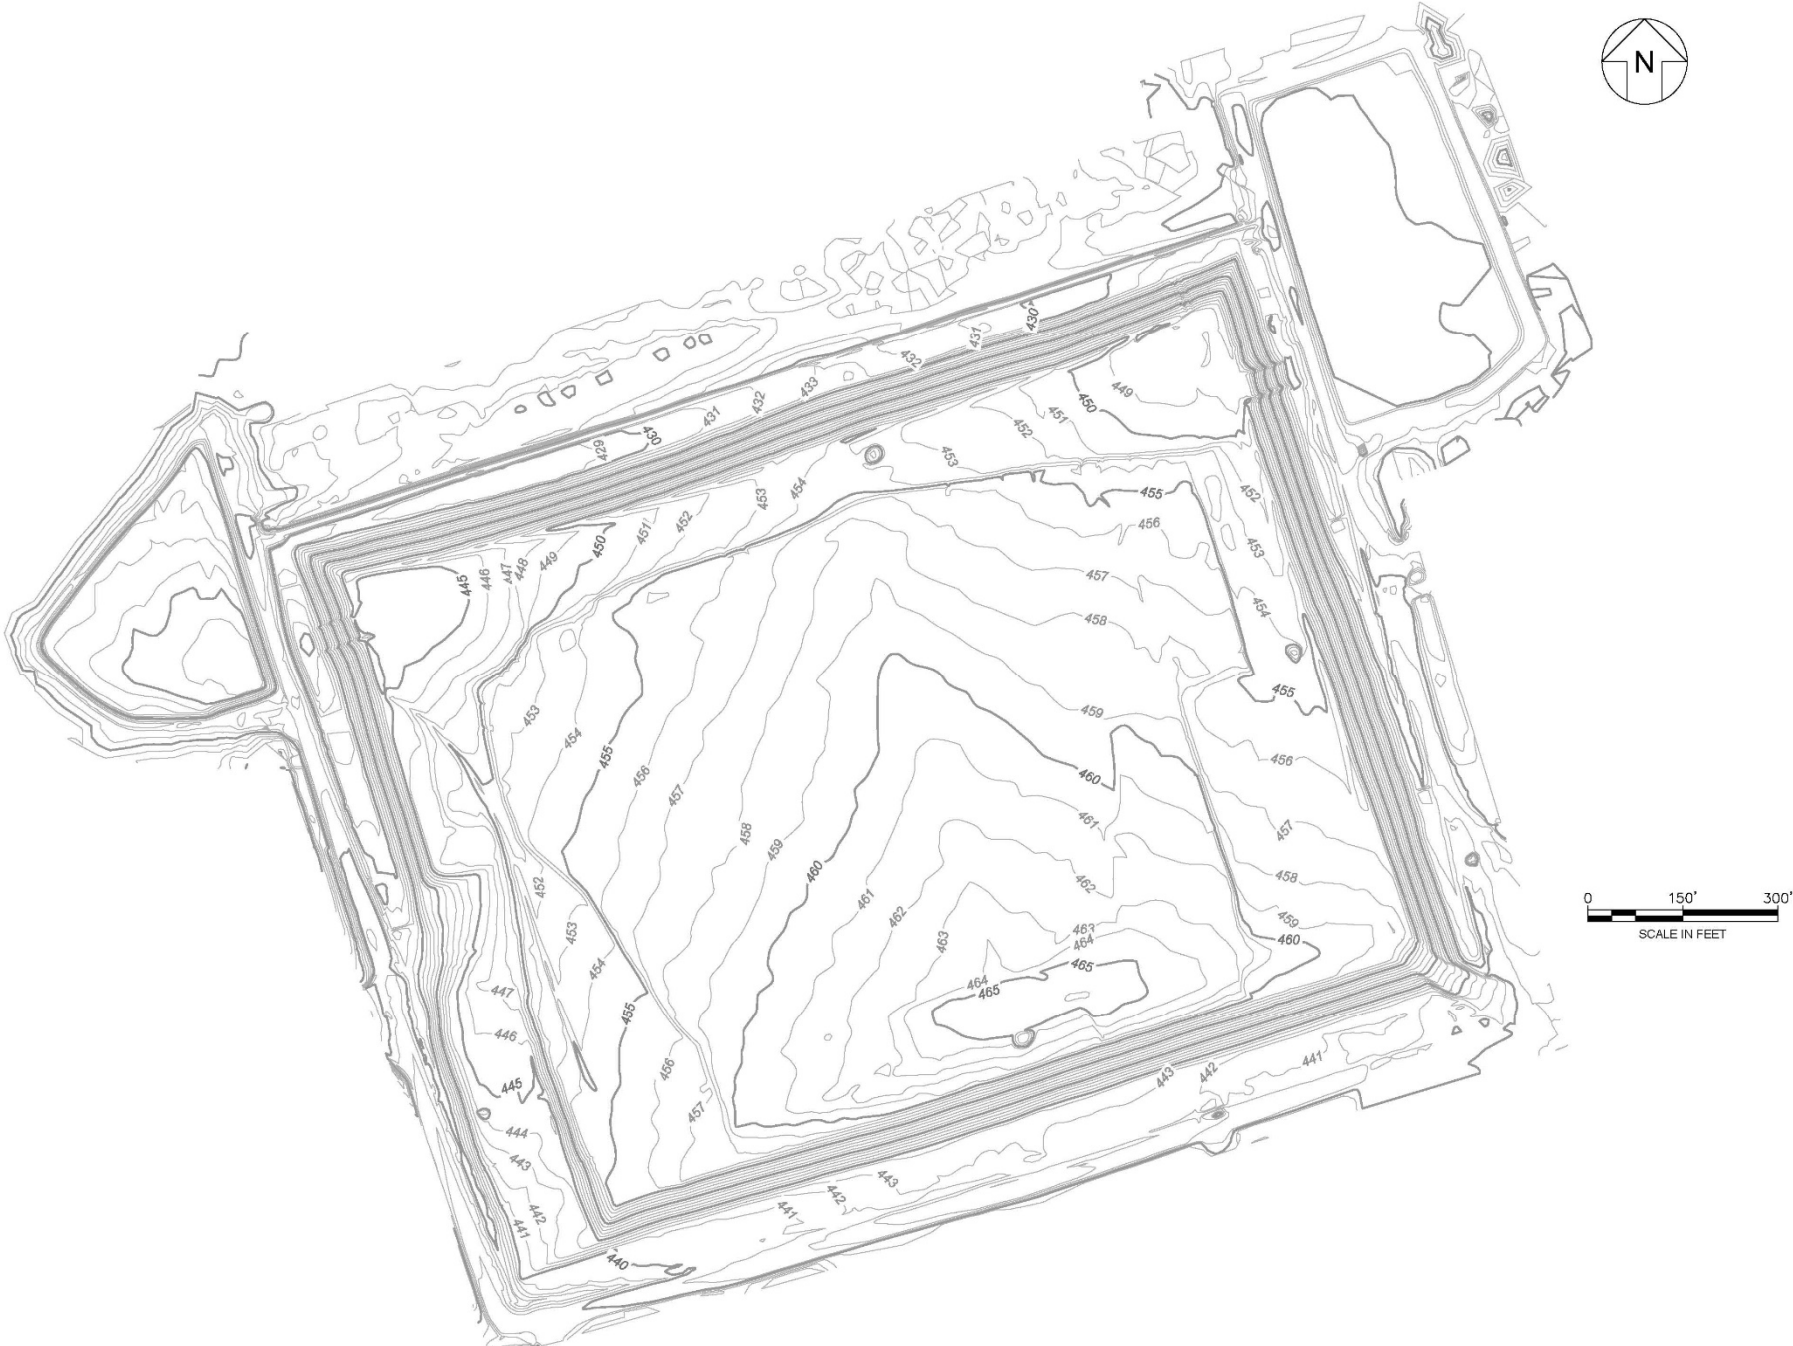
Figure 2. SCA survey performed 17 March 2016 (survey data provided by Parsons)

The accuracy of the March 2016 aerial survey was reported to be ± 0.5 to 1 ft.¹ Therefore, approximately 91% of the areas showing a change in elevation are within the accuracy of the survey.

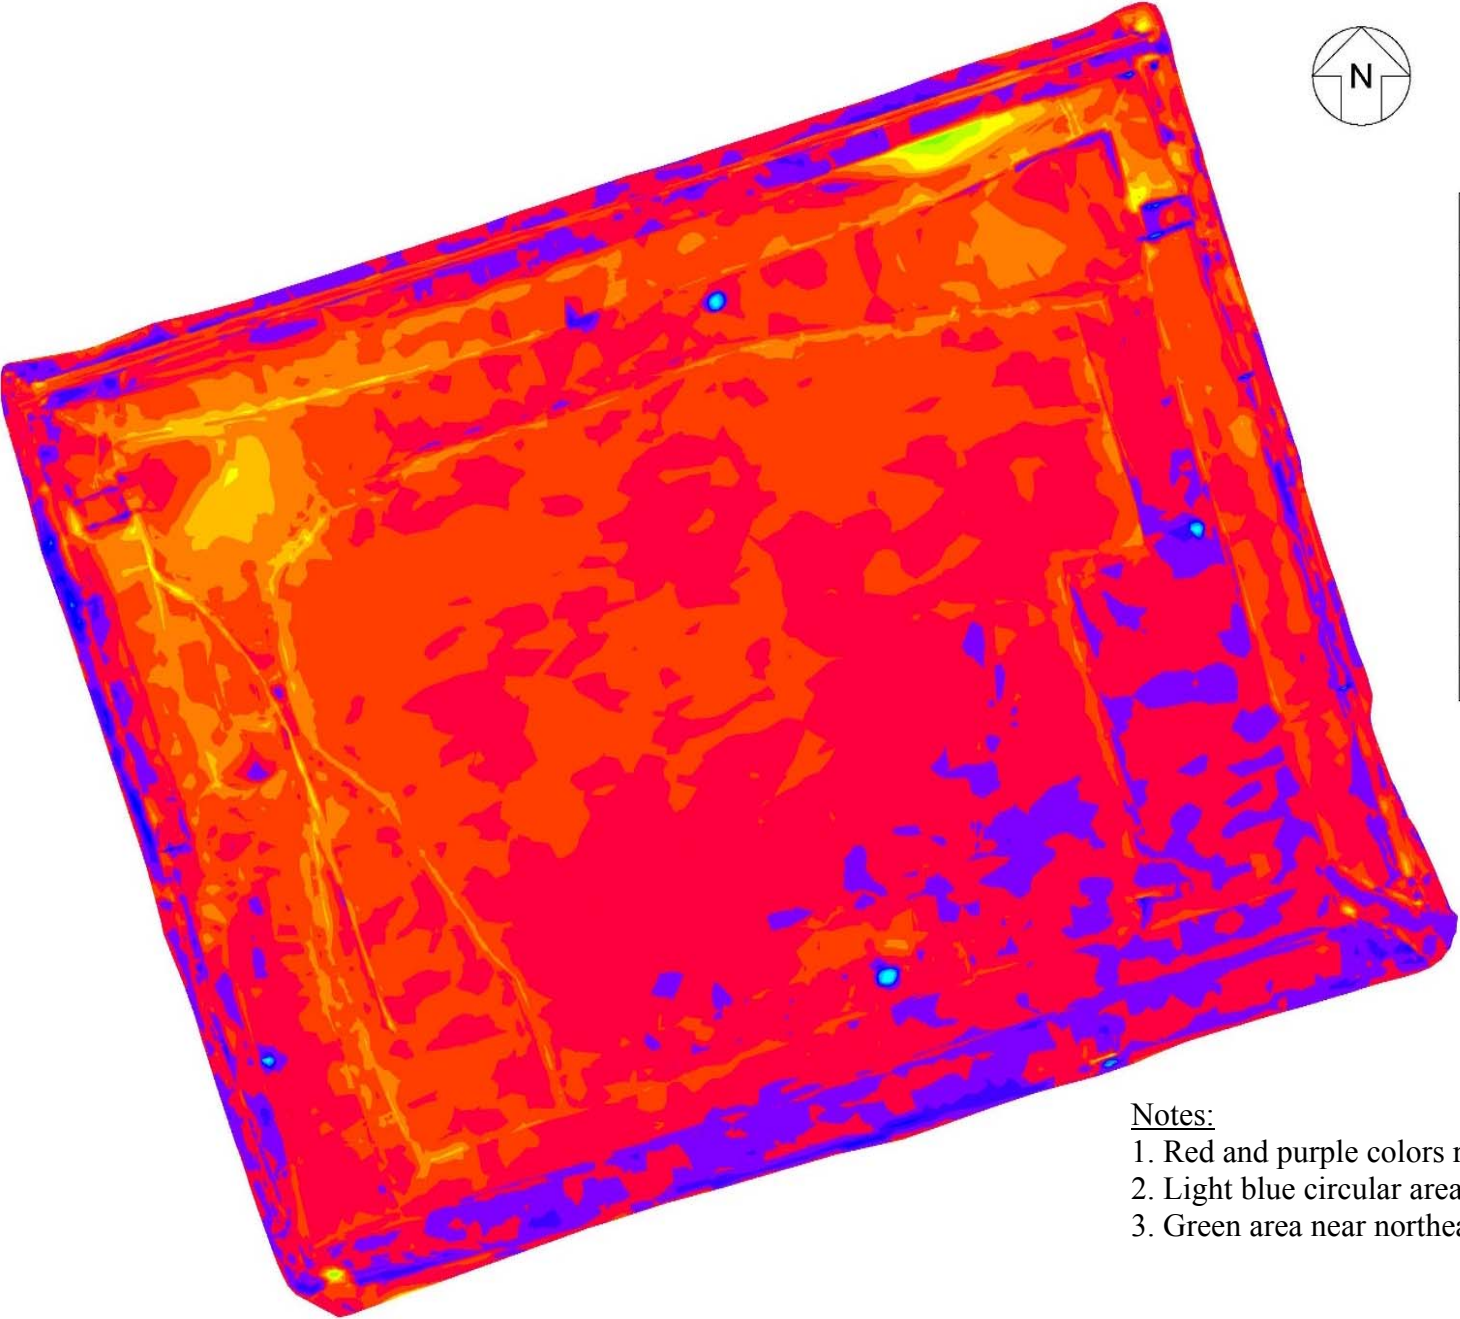
- Notes:
- 1. Red and purple colors represent change in elevation between ± 0.5 ft.
 - 2. Light blue circular areas represent rock piles placed after the December 2015 ground survey.
 - 3. Green area near northeast corner represents large erosion rill.

Figure 3. Isopach between SCA surveys performed 1 December 2015 and 17 March 2016 (survey data provided by Parsons)

- 57% of the SCA area had a change in elevation between -0.5 and 0.5 ft;
- 34% of the SCA area had a change in elevation between -0.5 and -1 ft;
- 8% of the SCA area had a change in elevation between -1 and -2 ft; and
- 1% of the SCA area had a change in elevation less than -2 or greater than 0.5 ft.

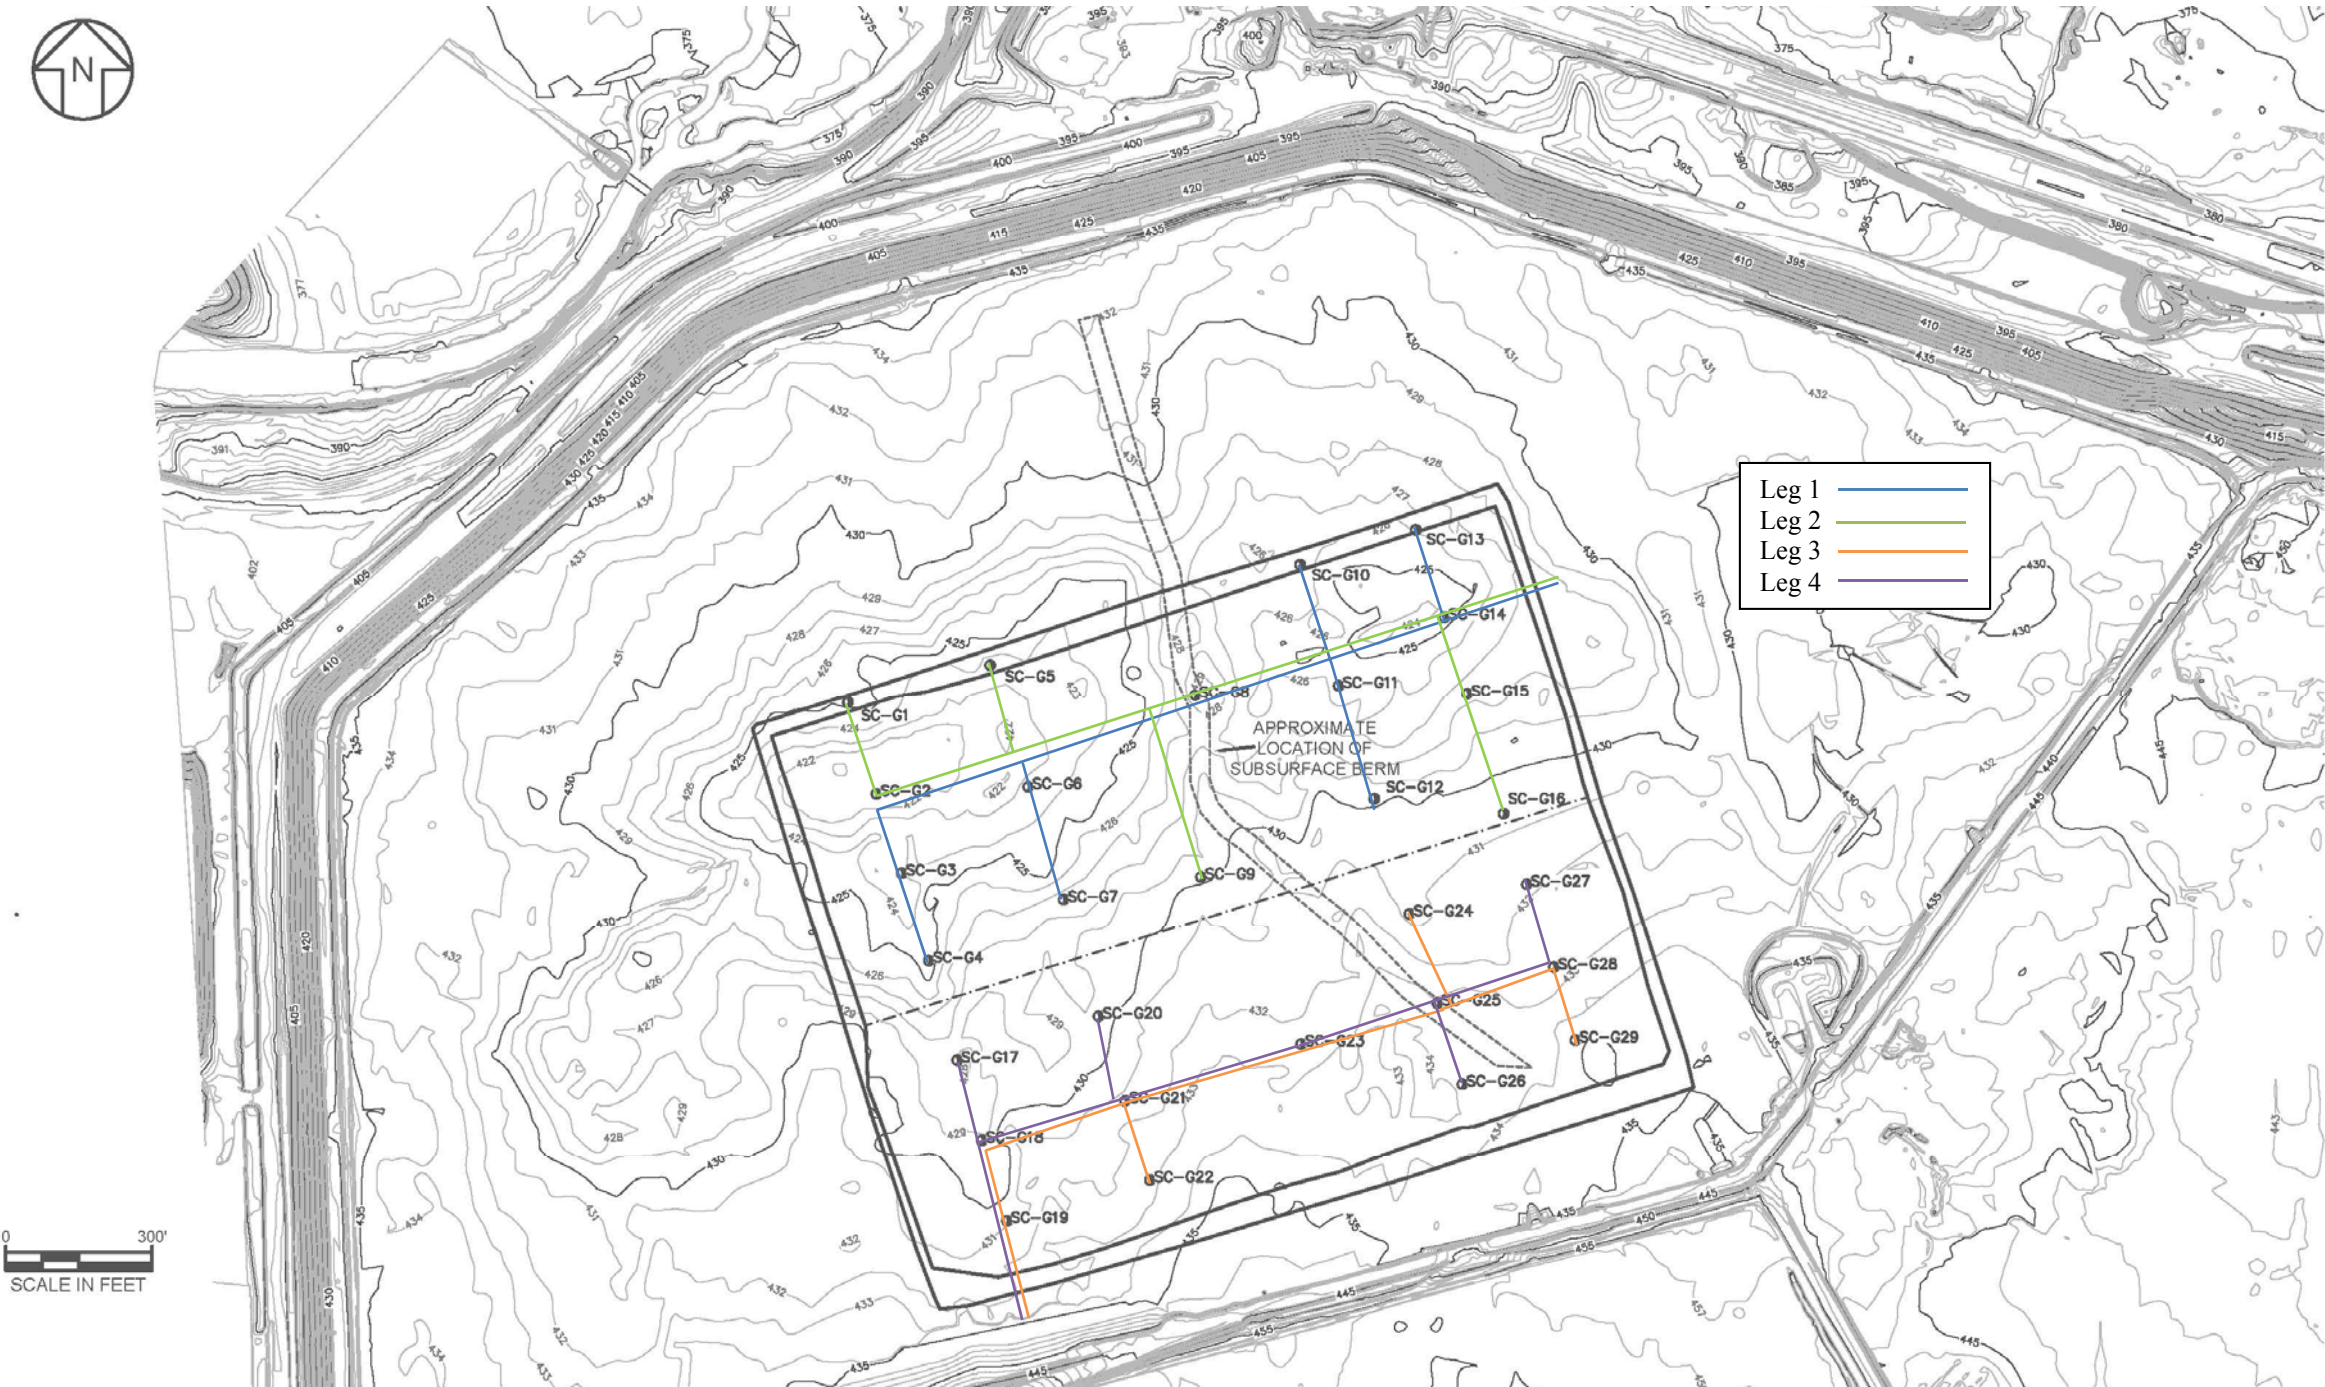
Figure 4. Location of Settlement Cells (SCs) in SCA

During the four months between the December 2015 and March 2016 surveys, the functioning settlement cells (i.e., SCs connected to Legs 2 and 3 installed underneath the compacted clay liner, Figure 4) measured minimal settlement on the order of 0.5 to 1 ft, except near the east and west sumps where the measured settlement was on the order of 1.5 to 2 ft, as shown in Figures 5A through 5D. It is noted that the general range of 0.5 to 1 ft of settlement was also generally seen in previous winter shutdown condition periods. Since the settlement measured by the SCs is within the elevation differences between the December 2015 and March 2016 surveys, the following observations are made:

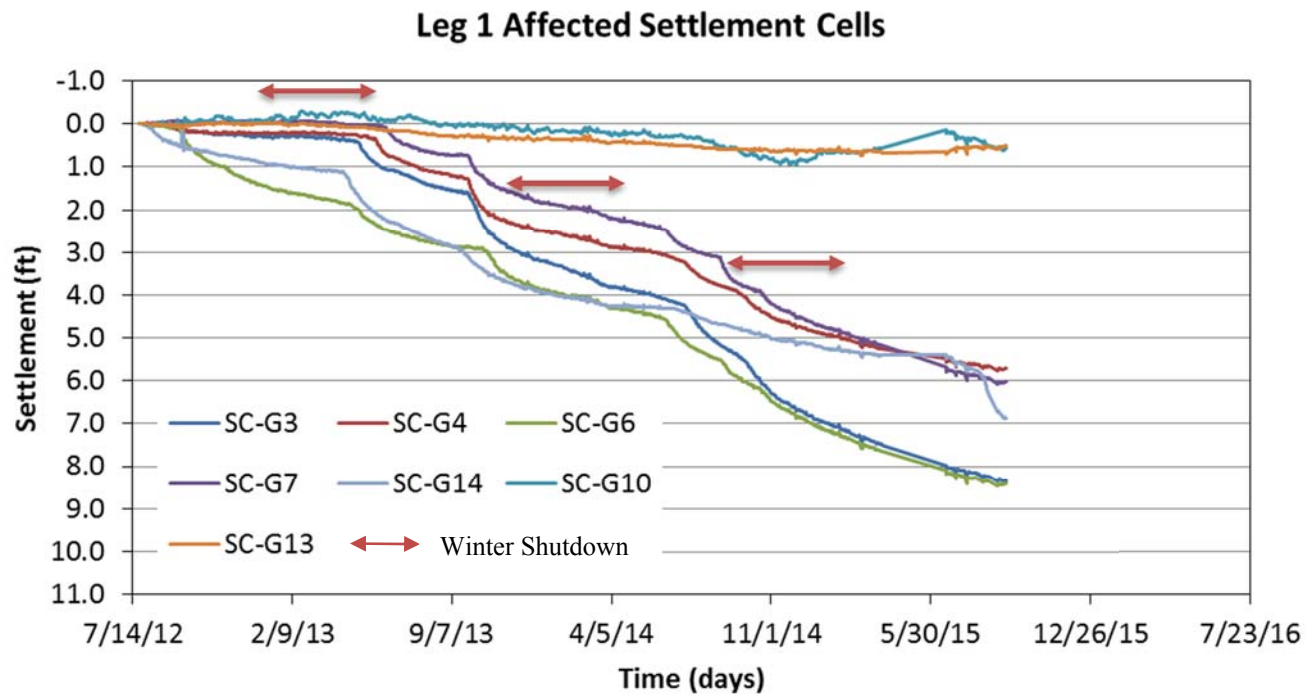
Figure 5A. Leg 1 Settlement Cell Data between 31 January 2012 and 6 April 2016
Note: Leg 1 was abandoned on 17 September 2015 due to an unrepairable leak within the SCA.
[Red arrows indicate approximate winter shutdown conditions]

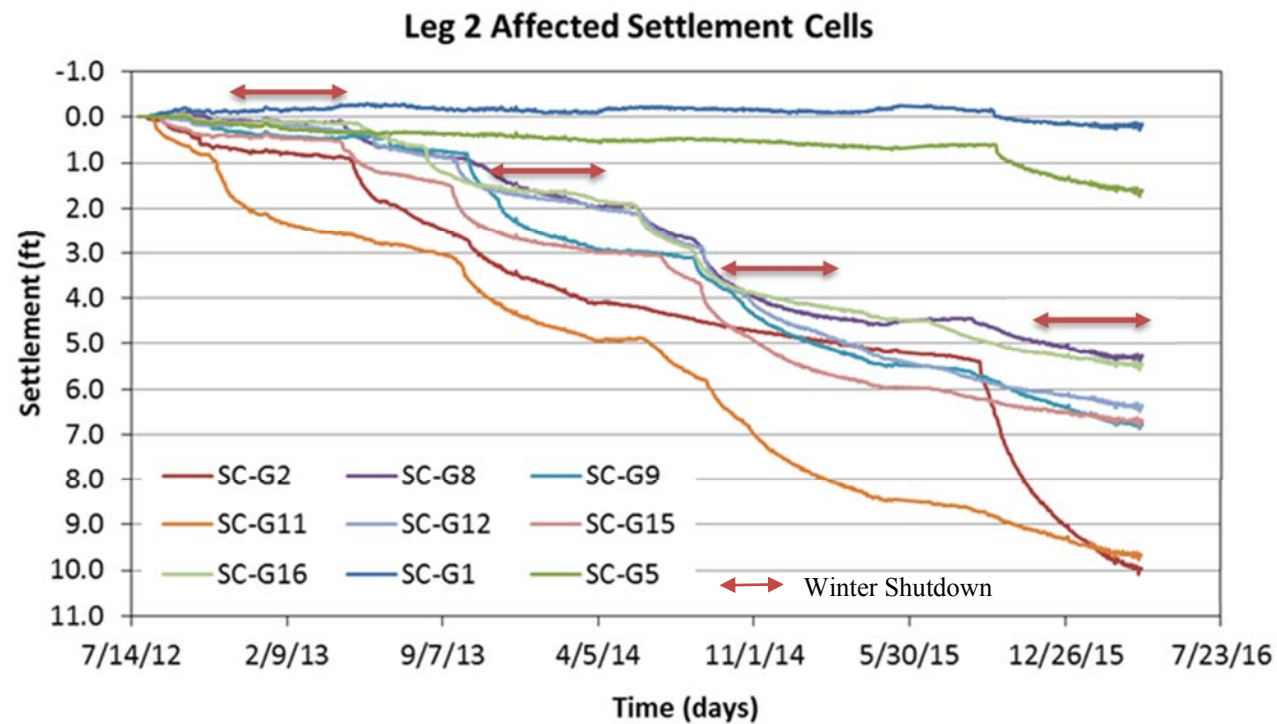
Figure 5B. Leg 2 Settlement Cell Data between 31 January 2012 and 6 April 2016
[Red arrows indicate approximate winter shutdown conditions]

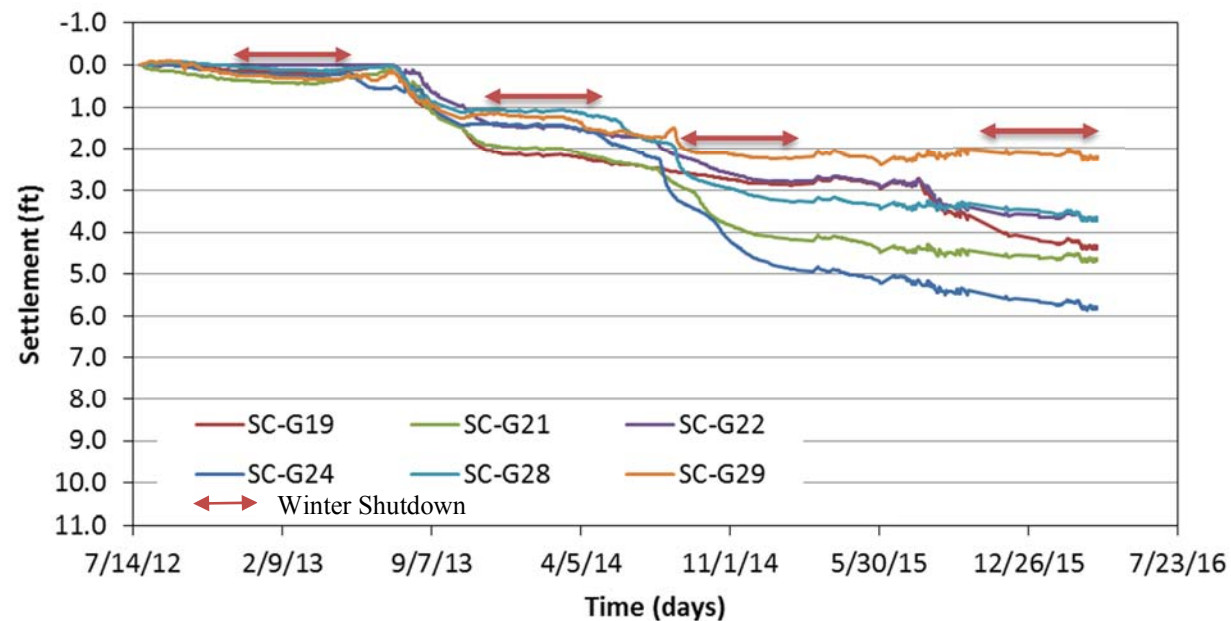
Figure 5C. Leg 3 Settlement Cell Data between 31 January 2012 and 6 April 2016
[Red arrows indicate approximate winter shutdown conditions]

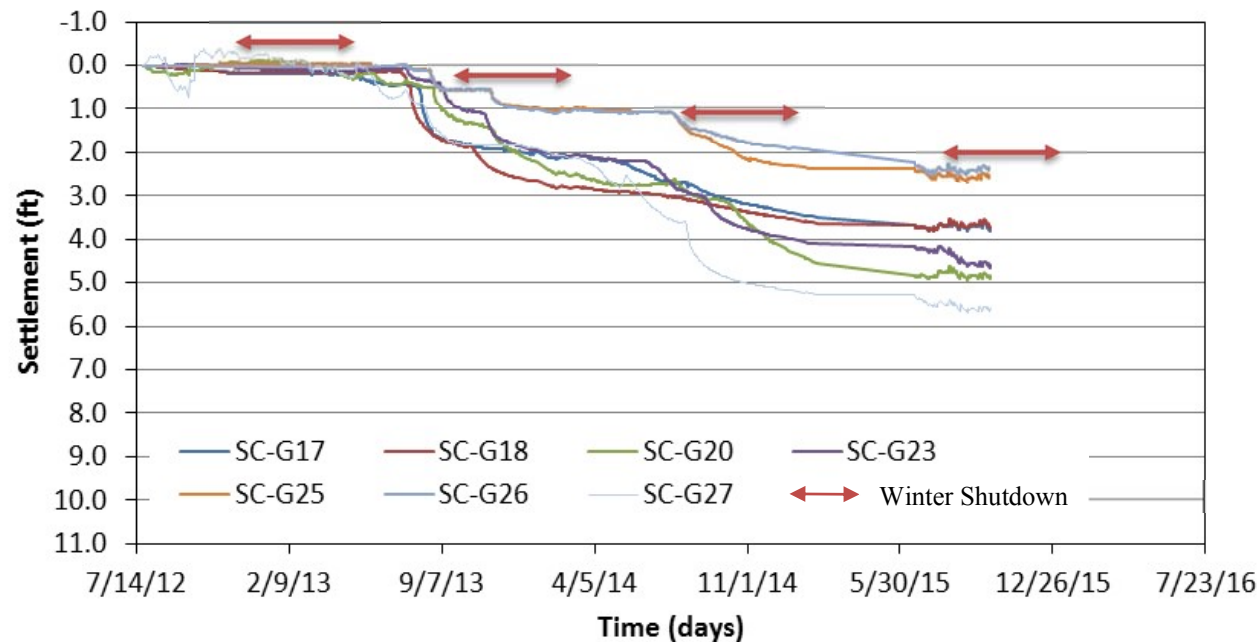
Figure 5D. Leg 4 Settlement Cell Data between 31 January 2012 and 6 April 2016

Note: Leg 4 data collection was interrupted as of 7 December 2015 due to a suspected leak in the hydraulic line.
