APPENDIX D

DIRECT SHEAR INTERFACE TEST RESULTS

**ONONDAGA LAKE
PRE DESIGN INVESTIGATION
SEDIMENT CONSOLIDATION AREA (SCA)
INTERFACE DIRECT SHEAR TESTING
SUMMARY REPORT**

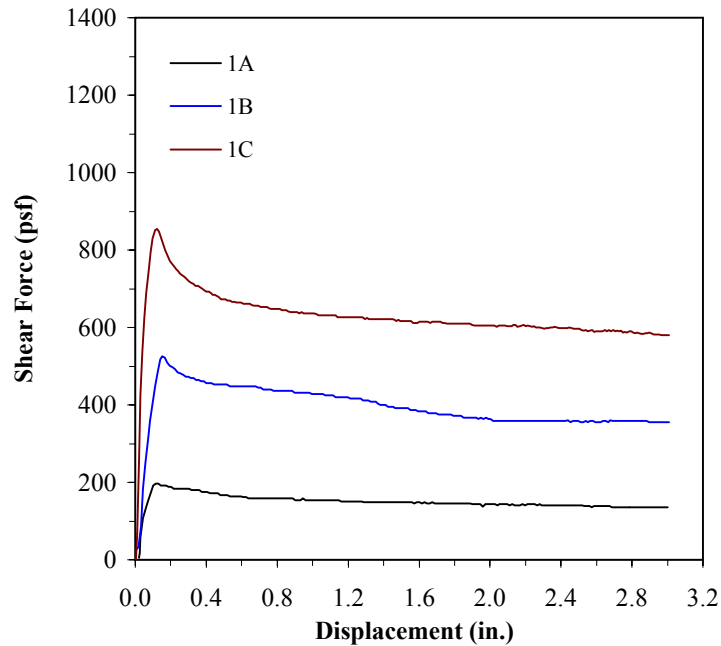
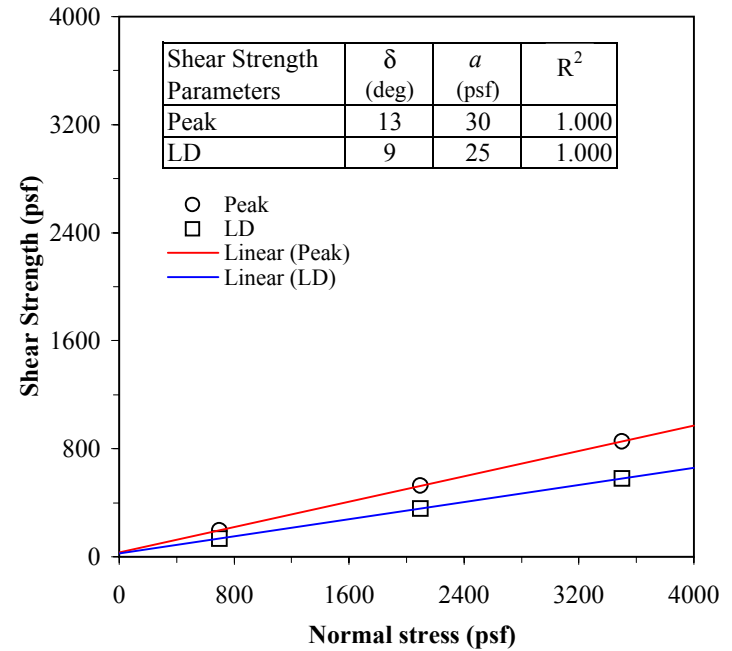
FIGURE NO.	C-1
PROJECT NO.	SGI9002
DOCUMENT NO.	
FILE NO.

Upper Shear Box: Concrete sand

TenCate S1600 (16 oz) nonwoven geotextile #000167745 with non heat-treated side down/

GSE 40-mil double smooth HDPE geomembrane # 101130132/

Lower Shear Box: Clay soil compacted to approximately 95% of max modified Proctor density at 3% wet of optimum moisture content

- (1) Sliding (i.e., shear failure) occurred at the interface between the non heat-treated side of 16 oz nonwoven geotextile and geomembrane.
- (2) Each geosynthetic specimen was tested in the machine direction (i.e., direction of shearing parallel to MD)

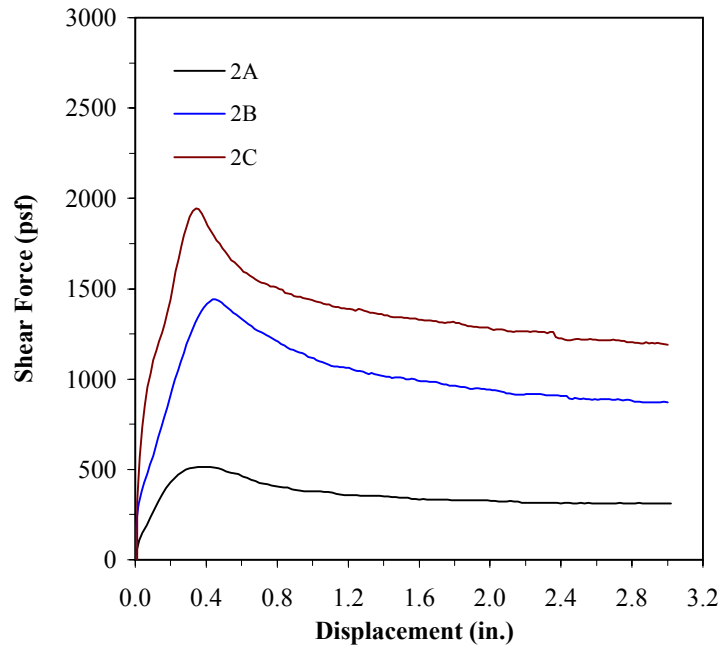
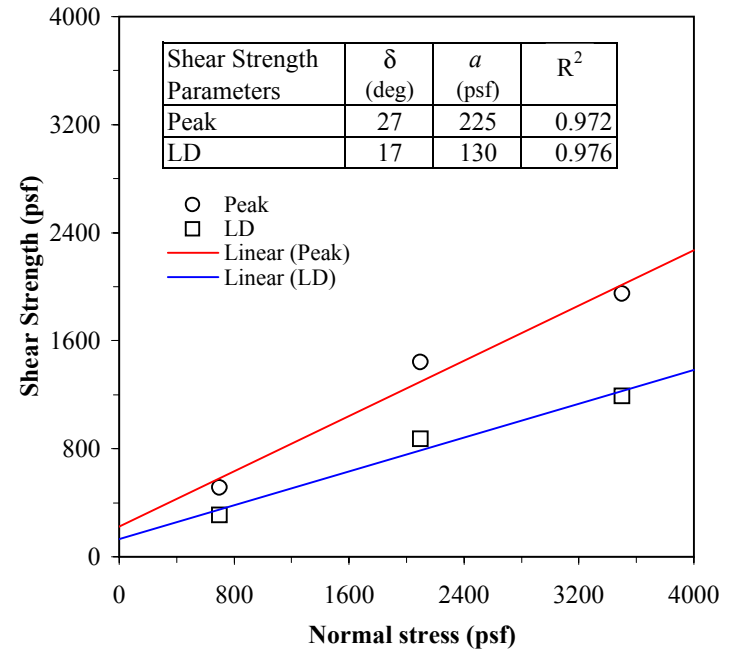
FIGURE NO.	C-2
PROJECT NO.	SGI9002
DOCUMENT NO.	
FILE NO.

Upper Shear Box: Concrete sand

TenCate S1600 (16 oz) nonwoven geotextile #000167745 with non heat-treated side down/

GSE 40-mil double textured HDPE geomembrane # 105140273/

Lower Shear Box: Clay soil compacted to approximately 95% of max modified Proctor density at 3% wet of optimum moisture content

- (1) Sliding (i.e., shear failure) occurred at the interface between the non heat-treated side of 16 oz nonwoven geotextile and geomembrane.
- (2) Each geosynthetic specimen was tested in the machine direction (i.e., direction of shearing parallel to MD)

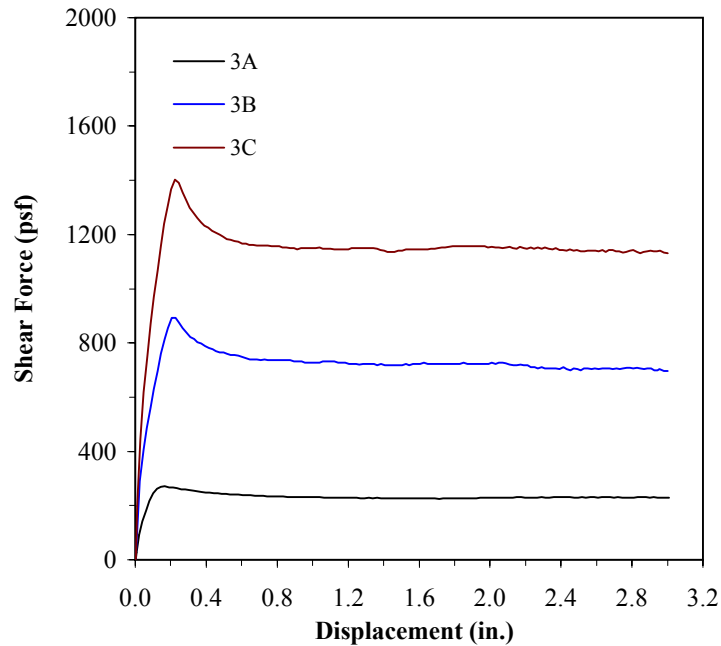
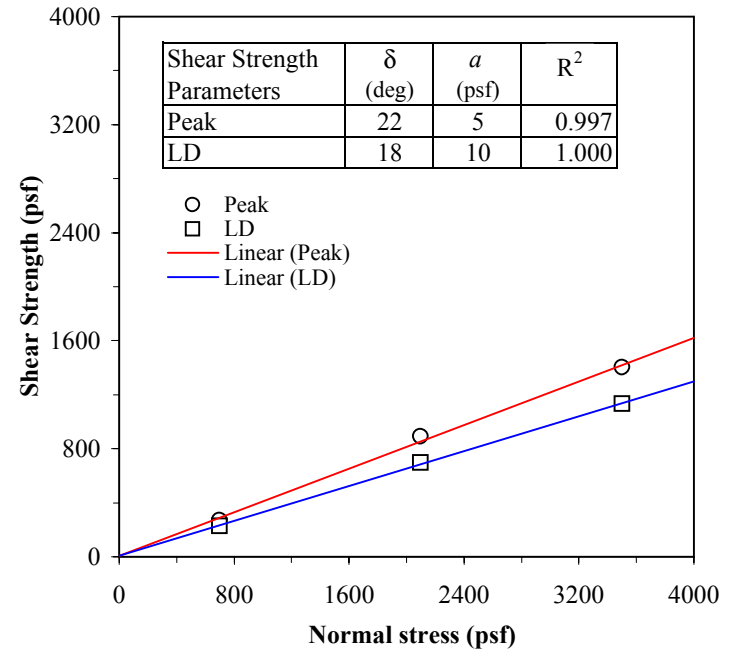
FIGURE NO. C-3
 PROJECT NO. SG19002
 DOCUMENT NO.
 FILE NO.

Upper Shear Box: Concrete sand

TenCate S1600 (16 oz) nonwoven geotextile #000167745 with non heat-treated side down/

40-mil EPDM geomembrane # AZ 12343/

Lower Shear Box: Clay soil compacted to approximately 95% of max modified Proctor density at 3% wet of optimum moisture content

- (1) Sliding (i.e., shear failure) occurred at the interface between the non heat-treated side of 16 oz nonwoven geotextile and geomembrane.
- (2) Each geosynthetic specimen was tested in the machine direction (i.e., direction of shearing parallel to MD)

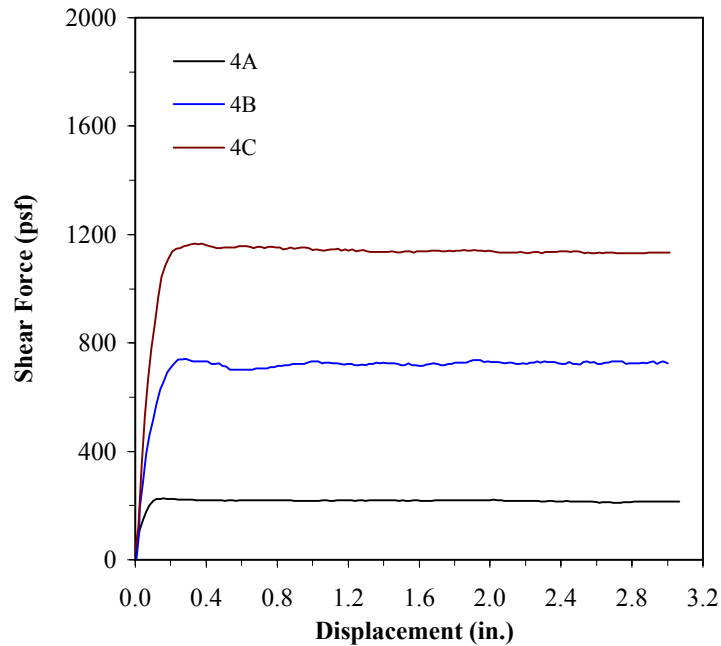
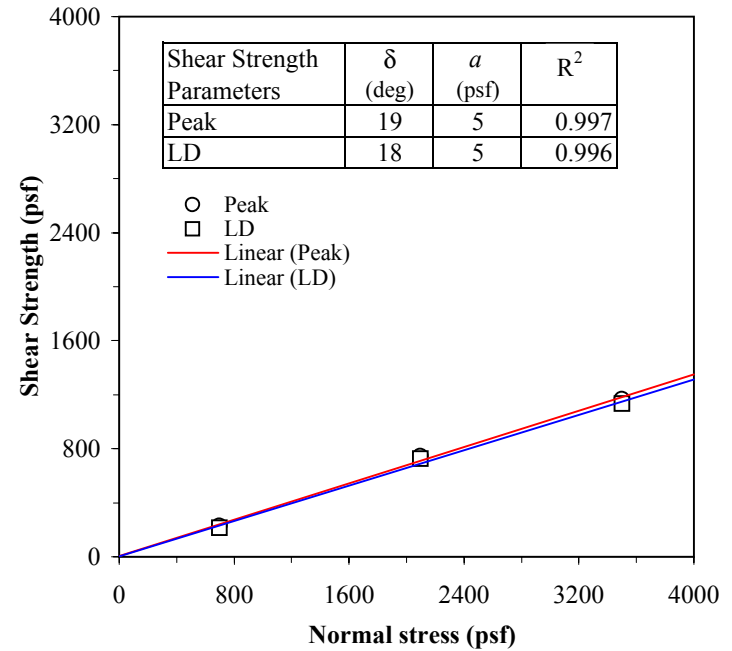
FIGURE NO.	C-4
PROJECT NO.	SGI9002
DOCUMENT NO.	
FILE NO.

Upper Shear Box: Concrete sand

TenCate S1600 (16 oz) nonwoven geotextile #000167745 with non heat-treated side down/
40-mil PP geomembrane with rough side up to geotextile and smooth side down to clay soil/

Lower Shear Box: Clay soil compacted to approximately 95% of max modified Proctor density at 3% wet of optimum moisture content

- (1) Sliding (i.e., shear failure) occurred at the interface between the non heat-treated side of 16 oz nonwoven geotextile and rough side of geomembrane.
- (2) Each geosynthetic specimen was tested in the machine direction (i.e., direction of shearing parallel to MD)

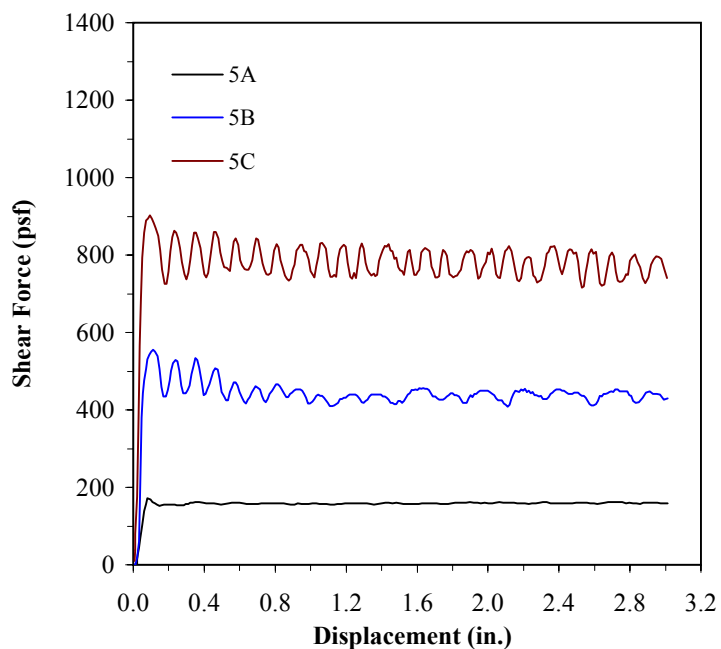
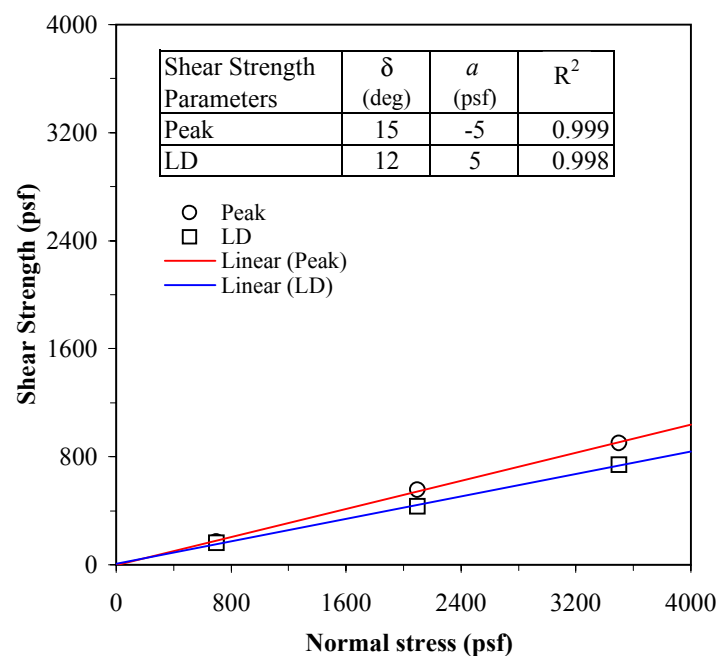
FIGURE NO.	C-5
PROJECT NO.	SGI9002
DOCUMENT NO.	
FILE NO.

Upper Shear Box: Rigid substrate

TenCate GT500 geotextile #021812318 in the machine direction/

TenCate GT500 geotextile #021812318 in the machine direction

Lower Shear Box: Concrete sand

- (1) Sliding (i.e., shear failure) occurred at the interface between the GT500 geotextile and GT500 geotextile.
- (2) Each geosynthetic specimen was tested in the machine direction (i.e., direction of shearing parallel to MD)

The peak and residual (i.e., large displacement) effective stress friction angles of the geotextile-tube to geotextile-tube interface were measured to be 15 degrees and 12 degrees, respectively. The peak effective stress friction angle of the composite liner system varied depending on the type of geomembrane tested. Based on these results, smooth HDPE geomembrane is not being considered for use on this project. Among the remaining geomembrane options tested, the peak effective stress friction angle varied from 19 degrees to 27 degrees, and the residual effective stress friction angle varied from 17 degrees to 18 degrees. The laboratory test report is provided in Attachment 1, and additional discussion of the results is provided in Appendix G, “Slope Stability Analyses for SCA Design” of the SCA Final Design.
