**Honeywell International Inc.**

**ONONDAGA LAKE BOTTOM  
PHASE I – SEDIMENT CONSOLIDATION  
AREA CONSTRUCTION  
CONSTRUCTION QUALITY ASSURANCE (COA)  
FINAL REPORT – Volume I  
ONONDAGA COUNTY  
TOWN OF CAMILLUS, NEW YORK**

Project Number GJ4706B

May 2012 (Revision 0)  
August 2012 (Revision 3)

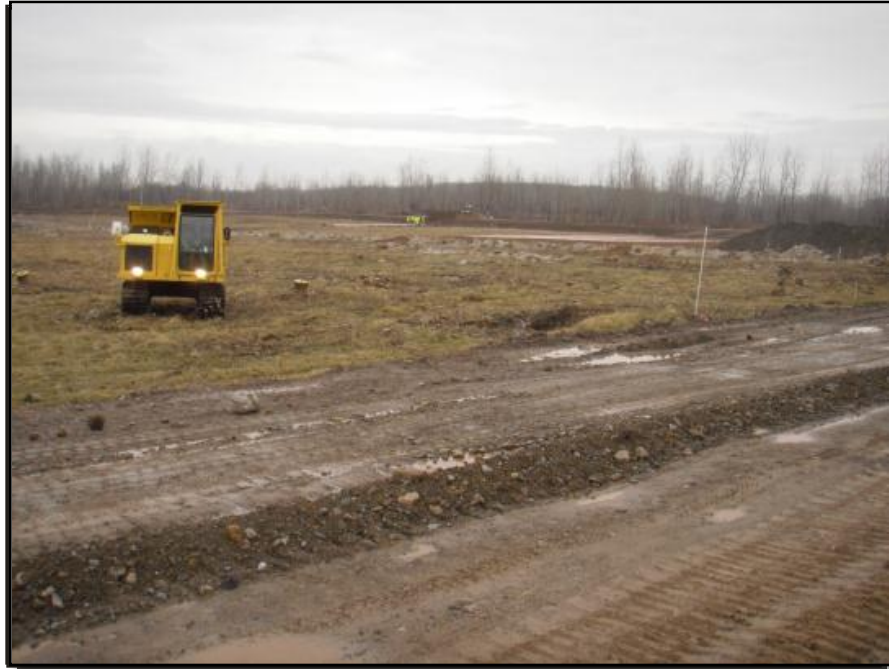
**Photograph 1:** The Sediment Consolidation Area (SCA) was cleared and partially grubbed prior to placement of engineered fill and low-permeability (LP) soil layer. In 2010, a LP soil test pad, shown in the background, was constructed.

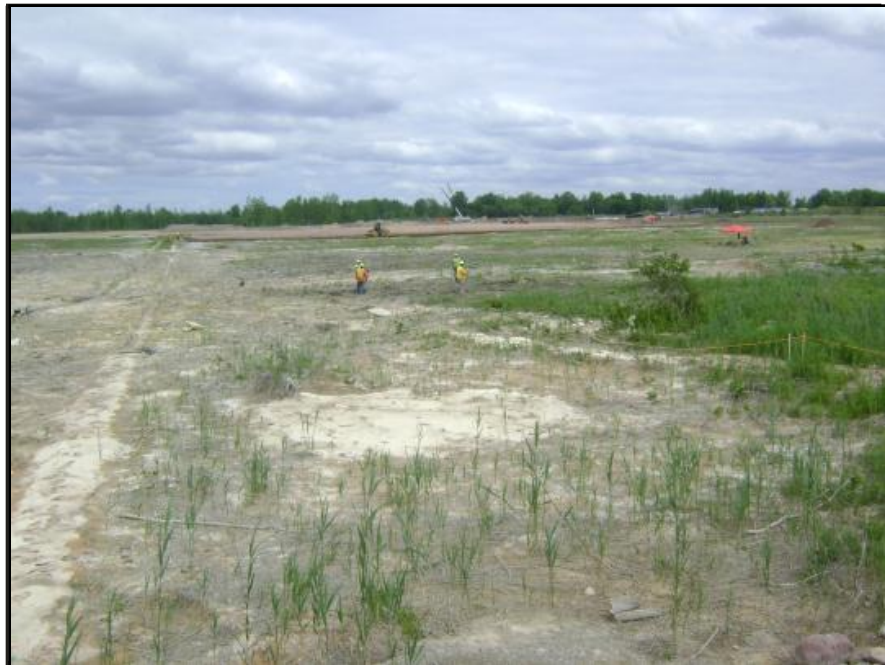
**Photograph 2:** Initially, surface debris was removed using a combination of manual labor and light equipment.

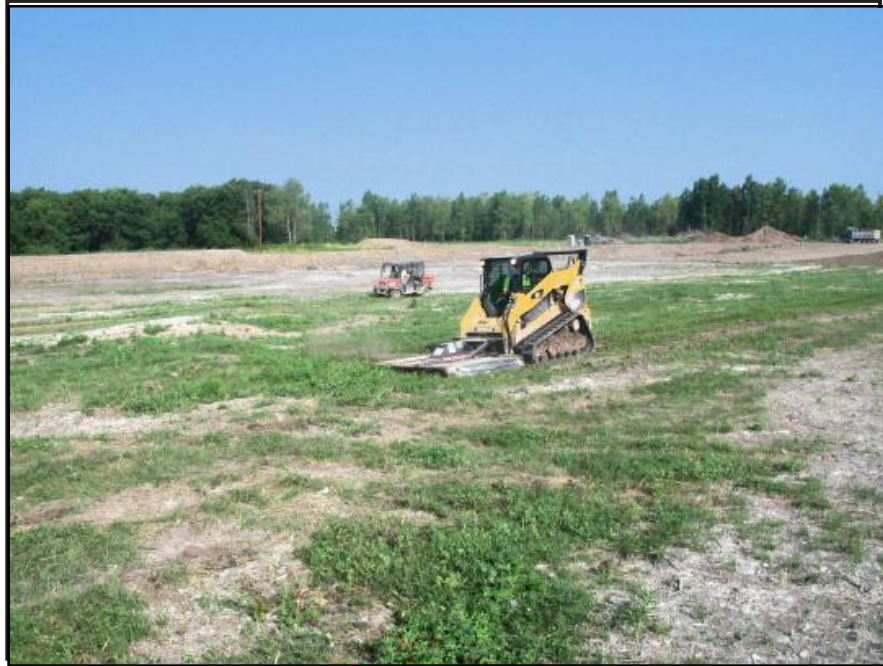
**Photograph 3:** Request for Information (RFI) No. 10 allowed the use of low-ground pressure bulldozers to strip the vegetation and debris. A skid loader with a brushcutter was used as well a bulldozer.

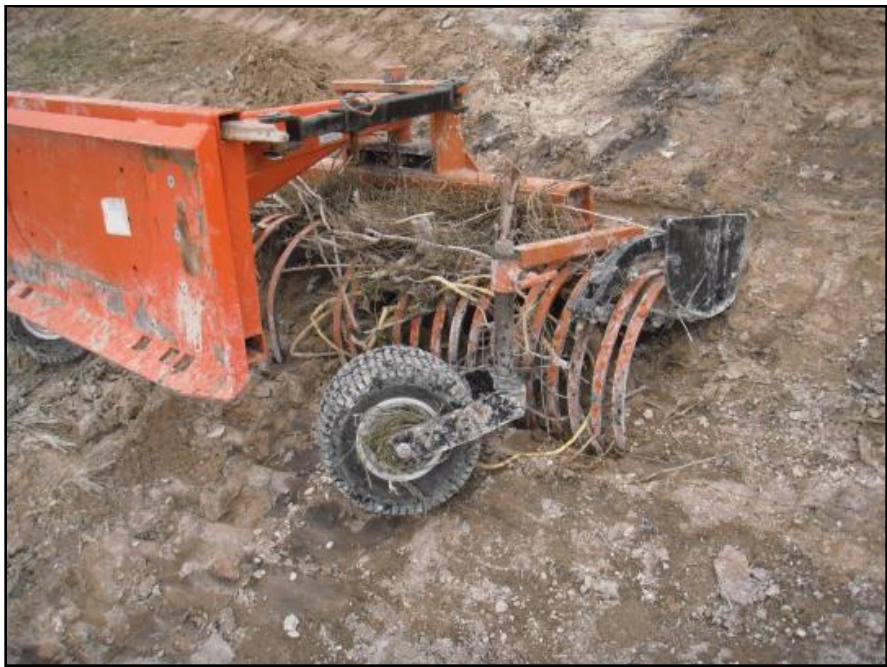
**Photograph 4:** A landscape rake was also used to remove roots and debris from the subgrade surface.

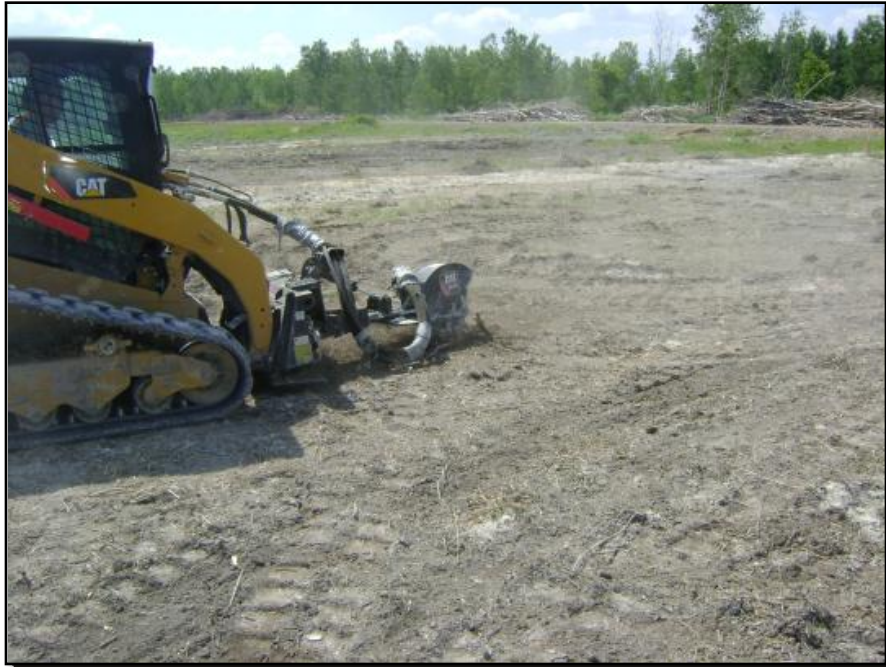
**Photograph 5:** Stumps were ground below the subgrade surface using a grinder. The prepared subgrade was observed and approved by NYSDEC and CQA personnel before placement low permeability layer.

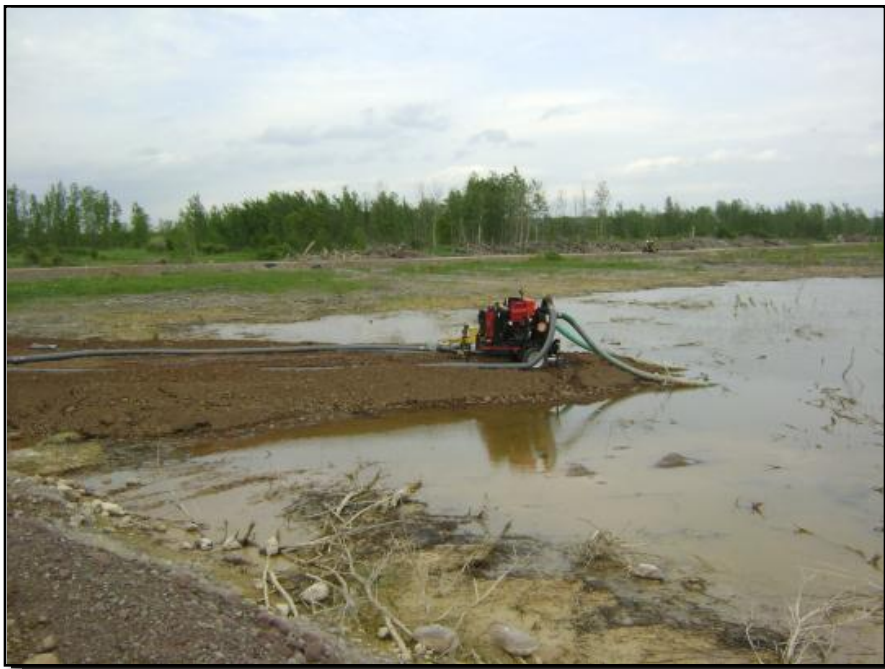
**Photograph 6:** Pumps were used during construction to remove stormwater from the work area.

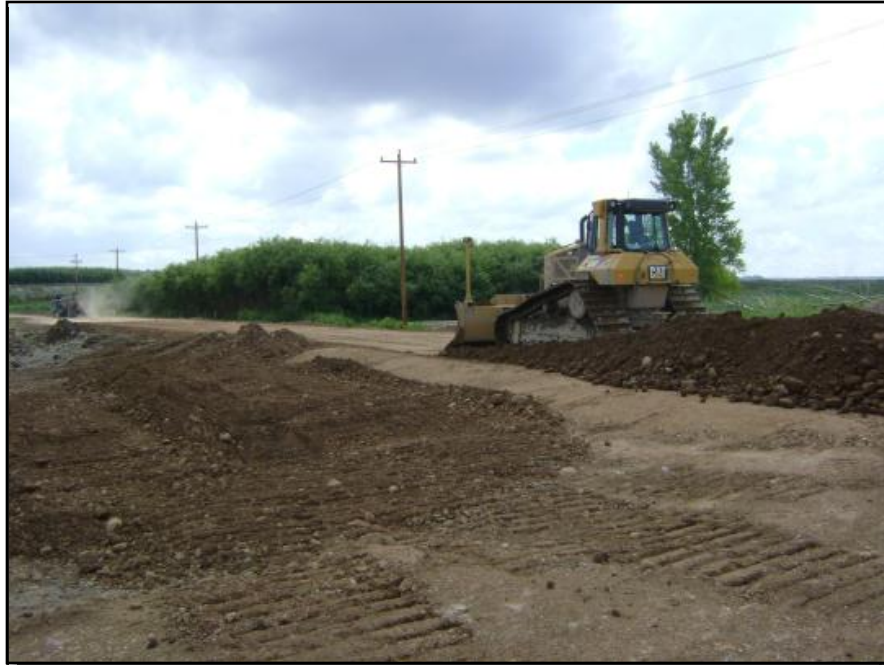
**Photograph 7:** Off-site engineered fill was used to construct perimeter berms. A bulldozer was used to spread the soil in lifts that were densified with a compactor. In-place compaction tests were performed by the contractor's laboratory or by CQA personnel after mobilization.

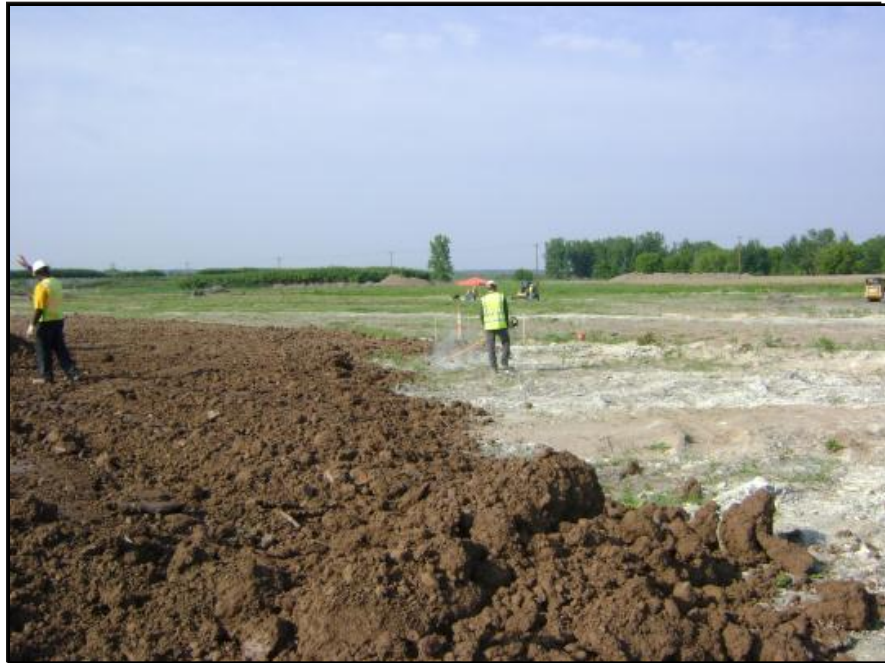
**Photograph 8:** The initial 12-in thick lift of low permeability soil was placed over the approved cleared area. This lift was considered a bridge lift.

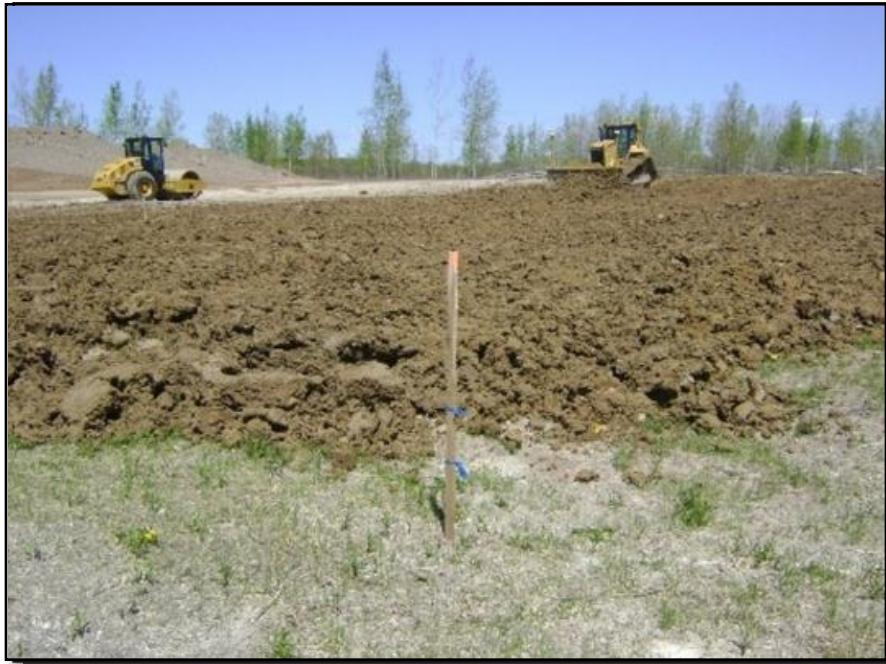
**Photograph 9:** Low permeability soil was delivered from two off-site sources, placed, and compacted to the grades defined in RFI No. 3 and Field Change Form (FCF) No. 3.

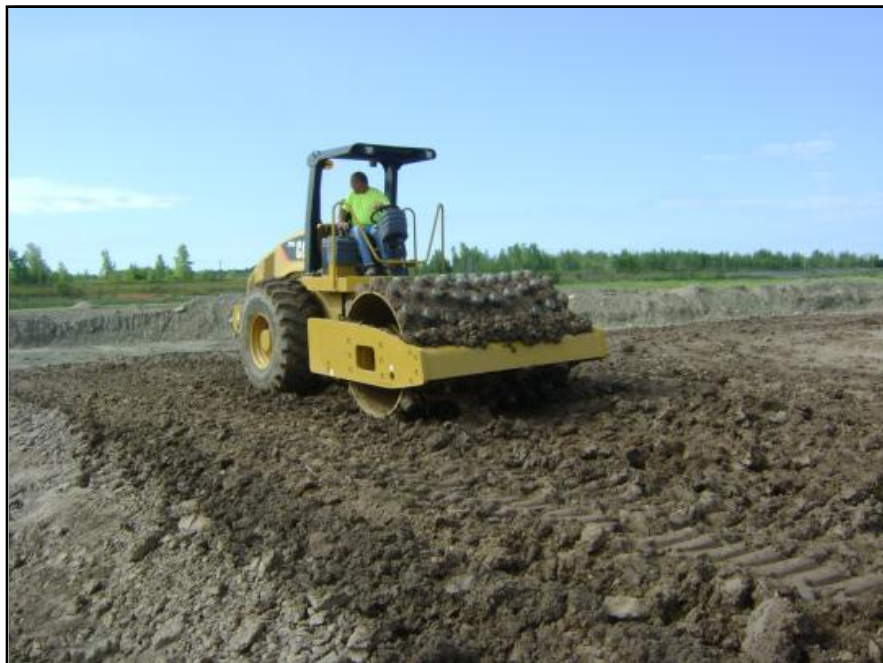
**Photograph 10:** Lifts of low permeability soil were compacted by a smooth drum or, as shown above, a pad-foot roller.

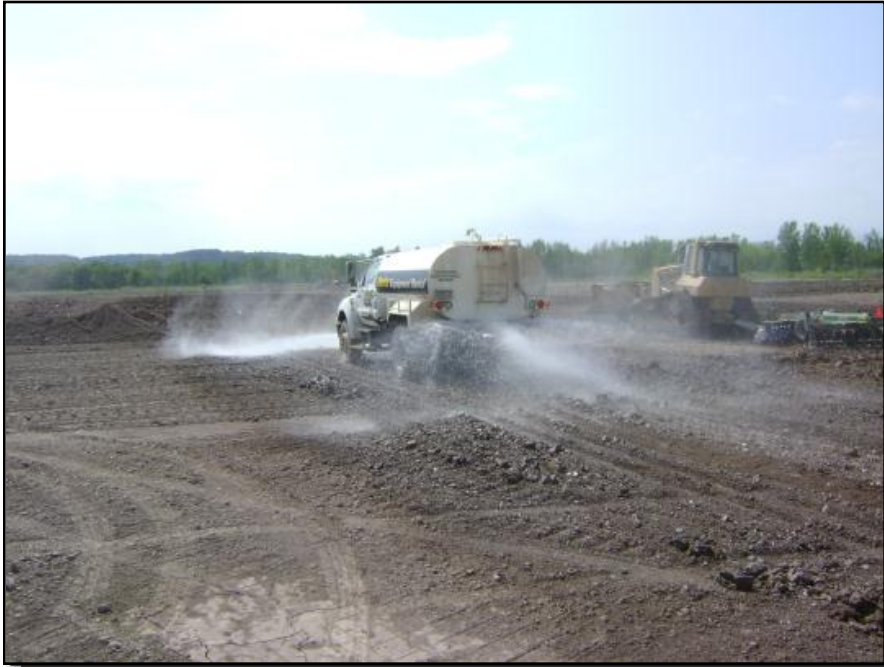
**Photograph 11:** Water was added to the low permeability soil, as needed. Occasionally, a tractor or bulldozer with a draw type harrow was used to condition the low permeability soil.

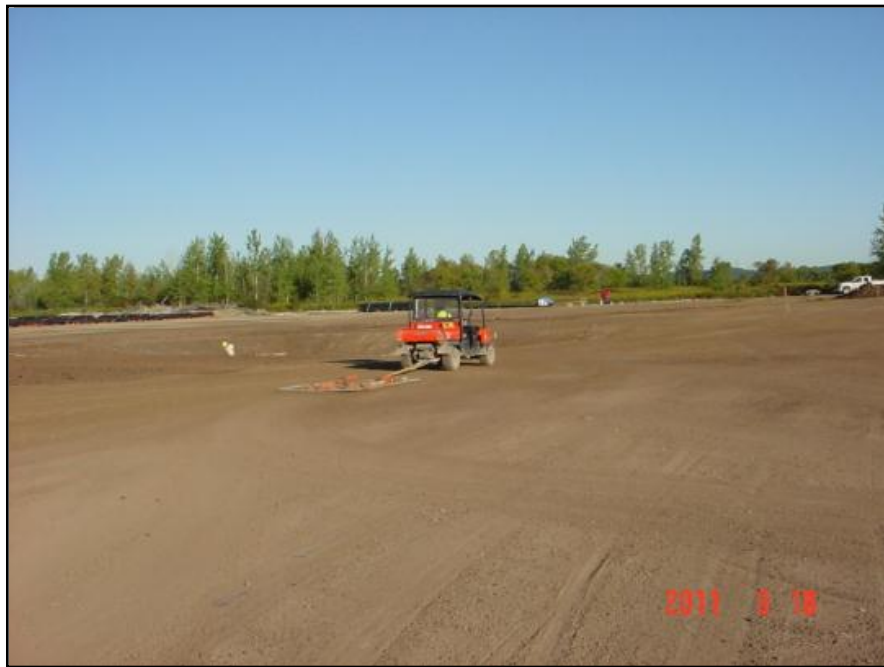
**Photograph 12:** Prior to geosynthetics installation, the surface of the low permeability layer was fine graded. Occasionally, an all-terrain vehicle pulling a weighted chain link fence was used to drag the surface, filling minor surface irregularities.

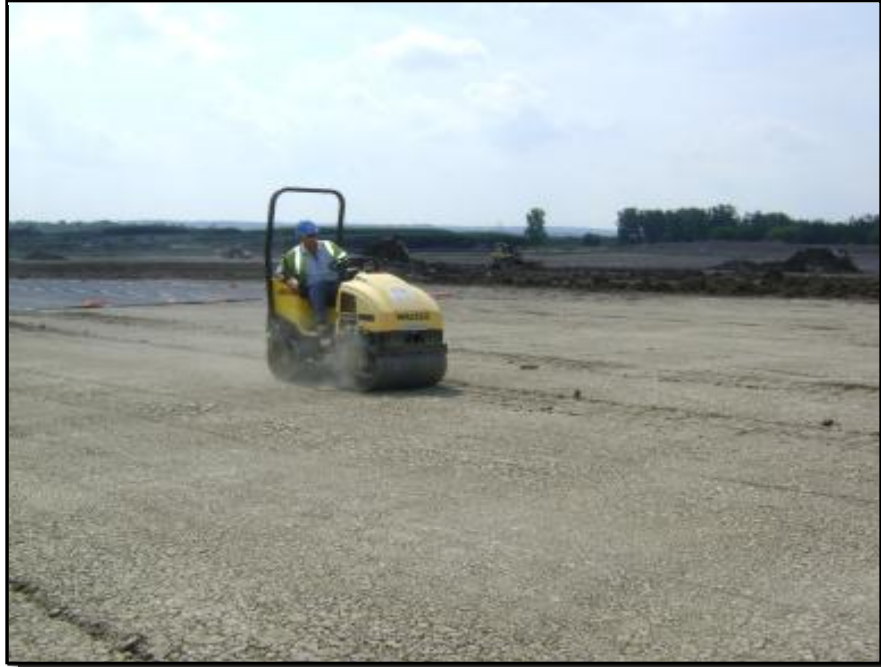
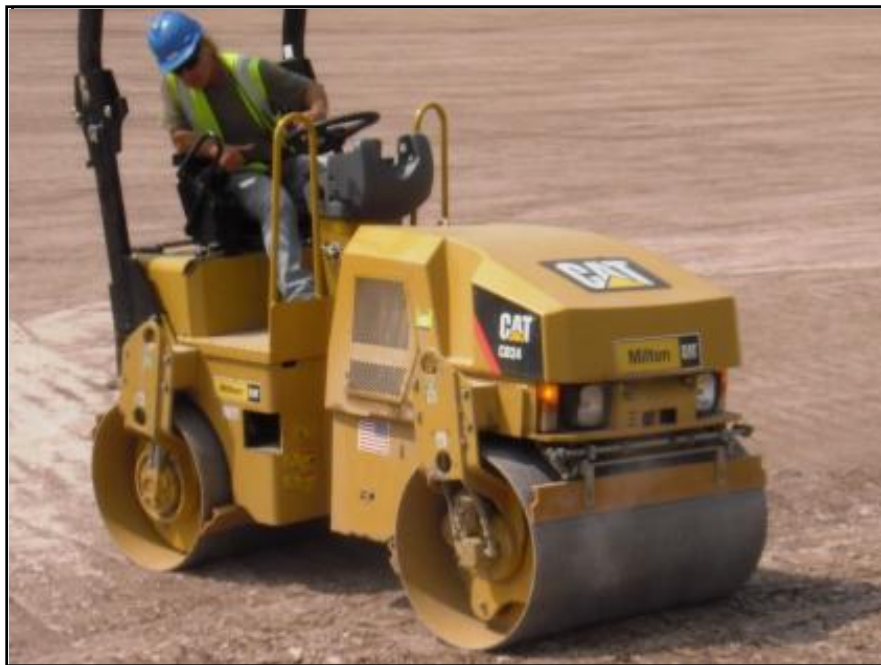
**Photographs 13 and 14:** In small areas, various compaction and surface preparations were performed. A Wacker 4614 or a Caterpillar CB24 rollers were used.

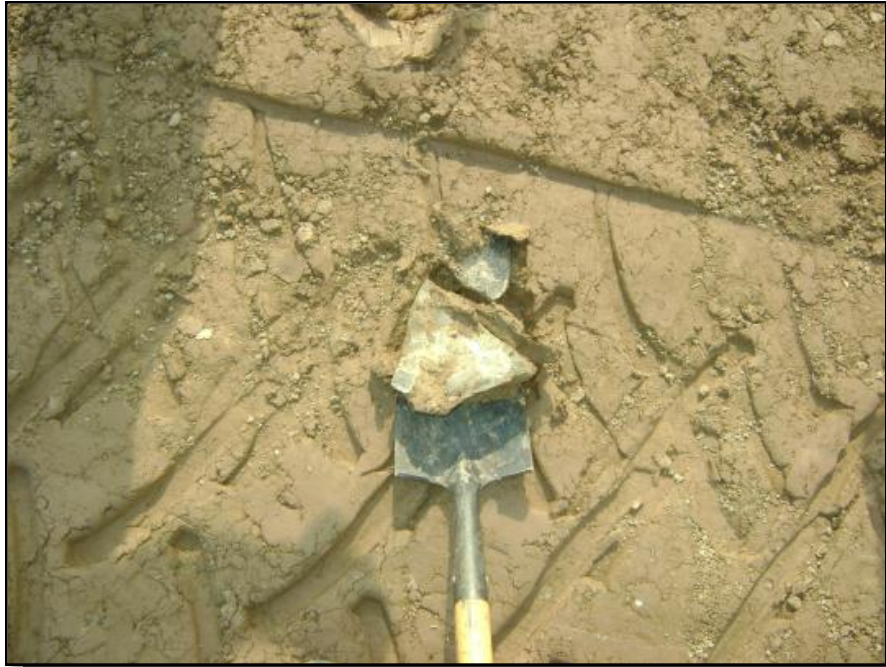
**Photograph 15:** Visible rocks were removed manually from the low permeability soil layer prior to geomembrane deployment.

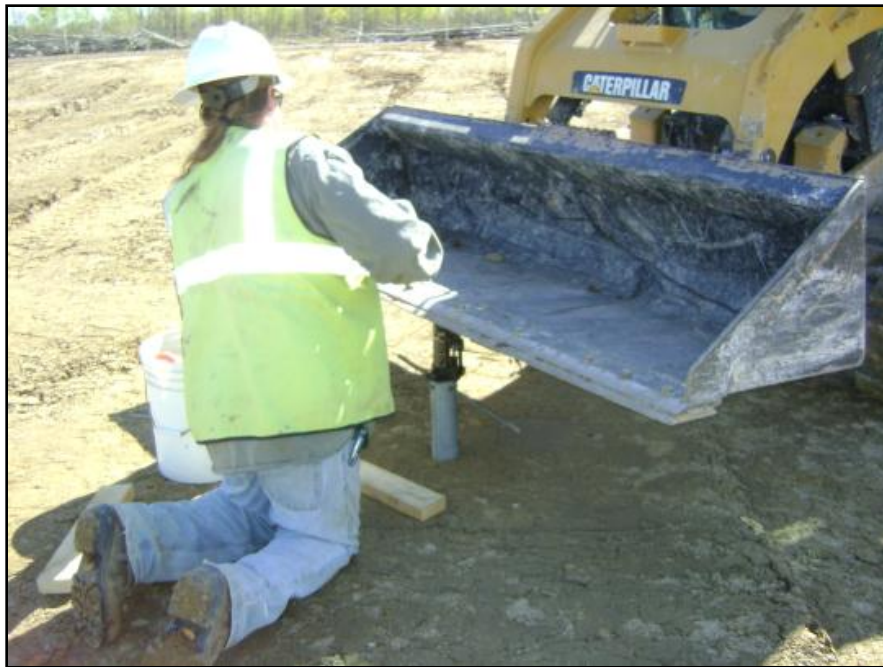
**Photograph 16:** CQA personnel verified the in-place moisture-density of the low permeability soil. Thin-walled (i.e. Shelby) tube samples were obtained from the upper lift, forwarded to an off-site testing laboratory, and tested to confirm the material met the hydraulic conductivity requirement.

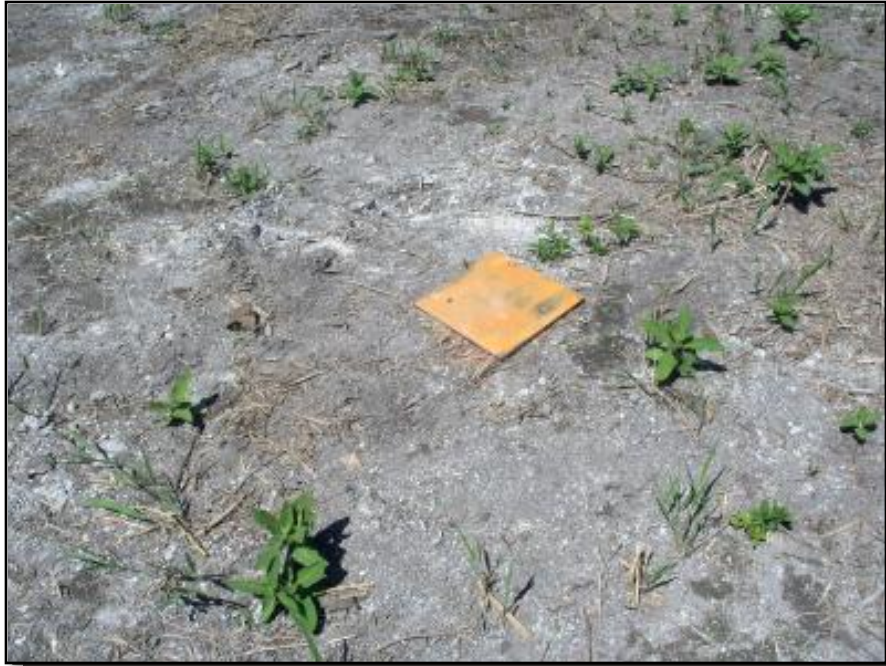
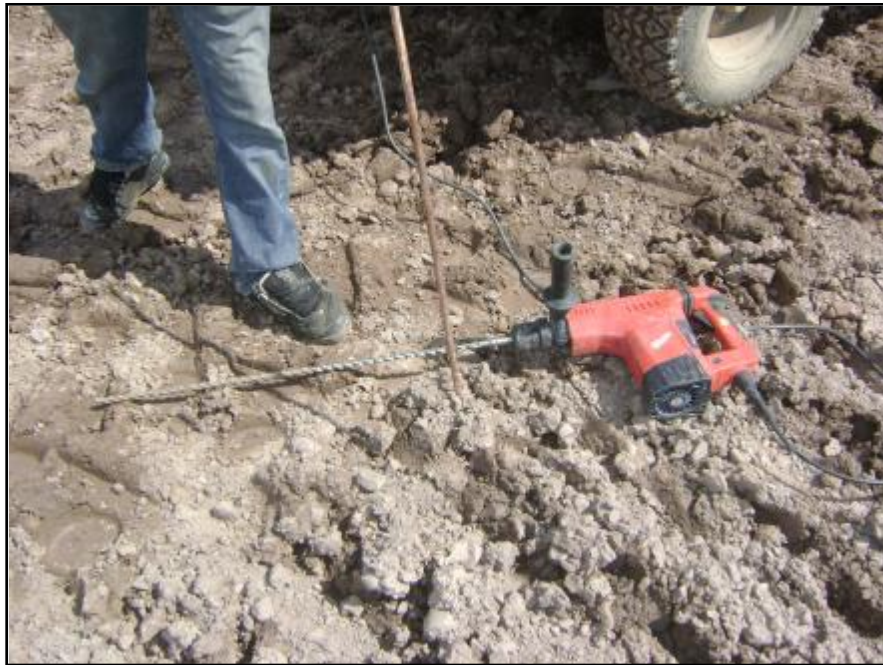
**Photographs 17 and 18:** Steel plates were installed within the Phase I sump corridor area. After low permeability placement, a drill was used to confirm that minimum clay thicknesses were achieved. Holes were backfilled using granular bentonite.

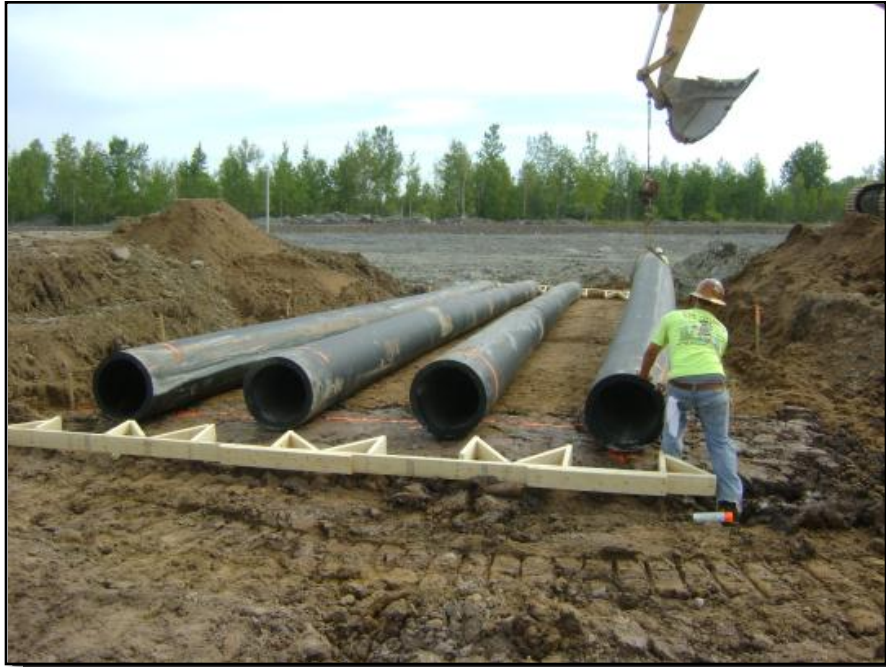
**Photograph 19:** Four 24-in dia. drainage pipes were installed through the eastern and western berms to connect to the Sediment Management System (SMS) stormwater basins.

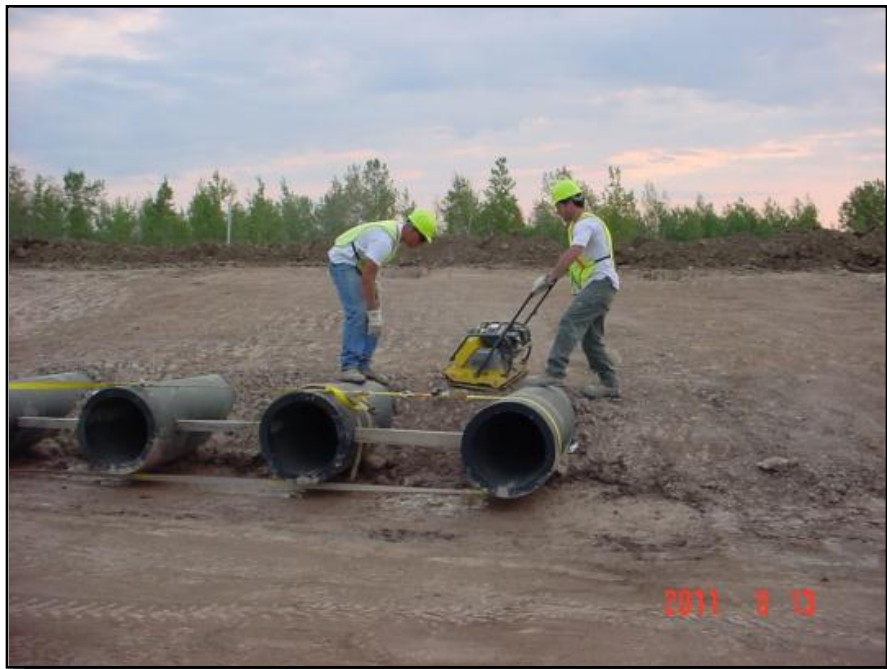
**Photograph 20:** Pipe bedding material was manually compacted. Engineered fill above the bedding material was compacted using a walk-behind compactor plate.

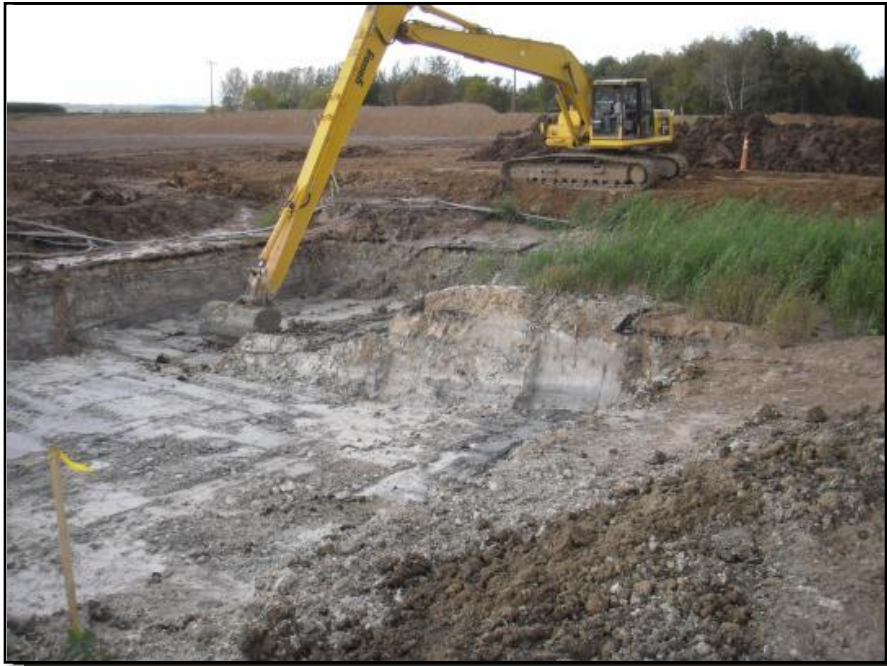
**Photograph 21:** Two sumps were excavated. The Solvay waste was re-located and the sump was lined with low permeability soil.

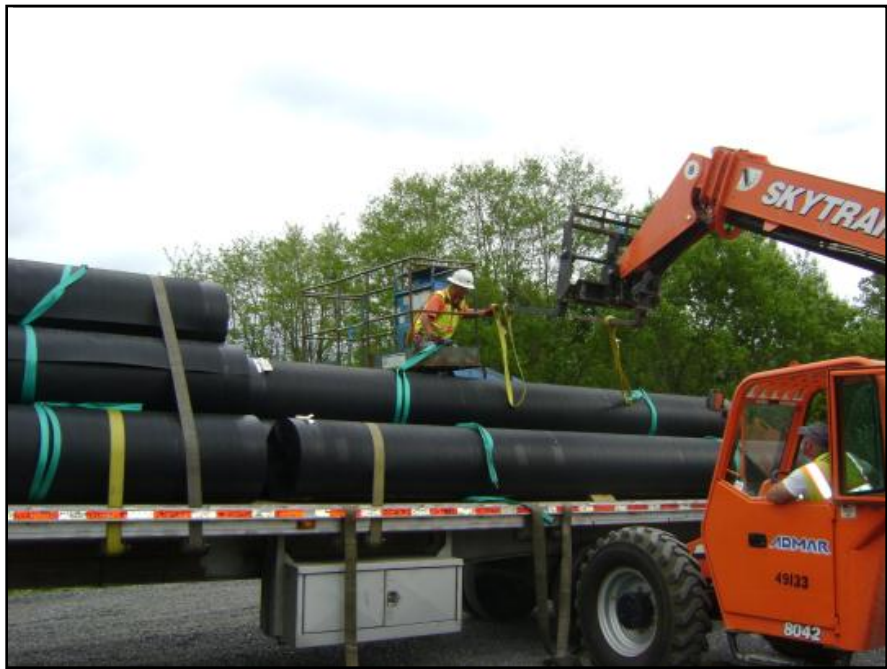
**Photograph 22:** Geomembrane rolls were delivered and stockpiled in an area east of the construction area, near the construction support trailers. A telehandler or lull was used to manage the rolls.

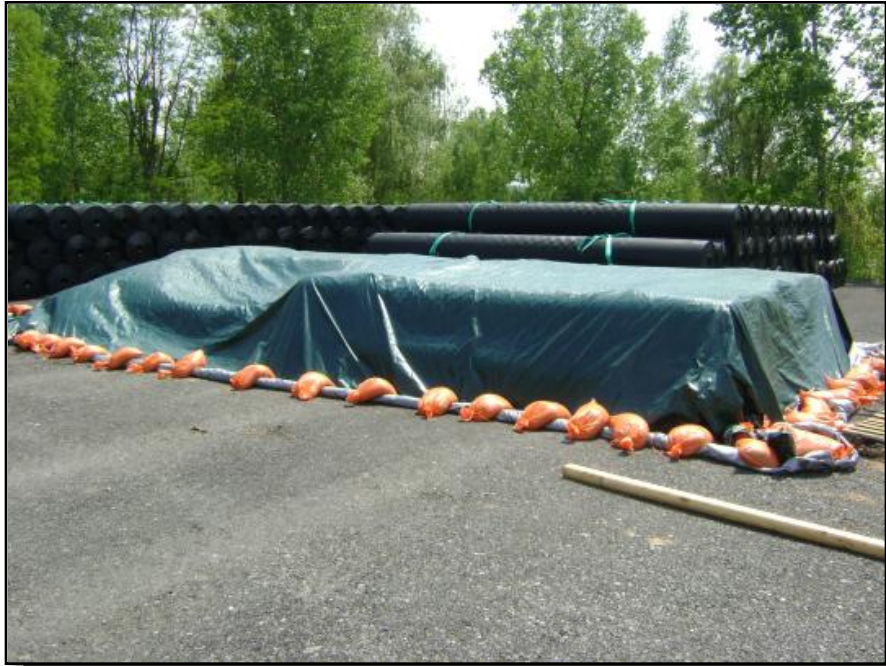
**Photograph 23:** Geosynthetic clay liner (GCL) was required in the sump areas. Rolls were stockpiled and covered next to the geomembrane rolls.

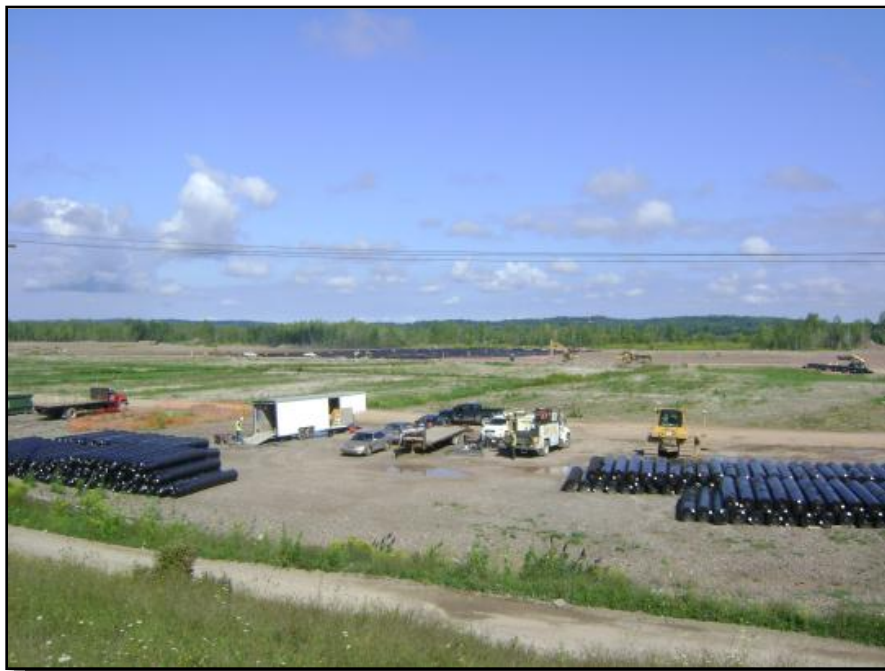
**Photograph 24:** The rolls of cushion geotextile were generally stored south of the construction area, adjacent to the installer's trailer.

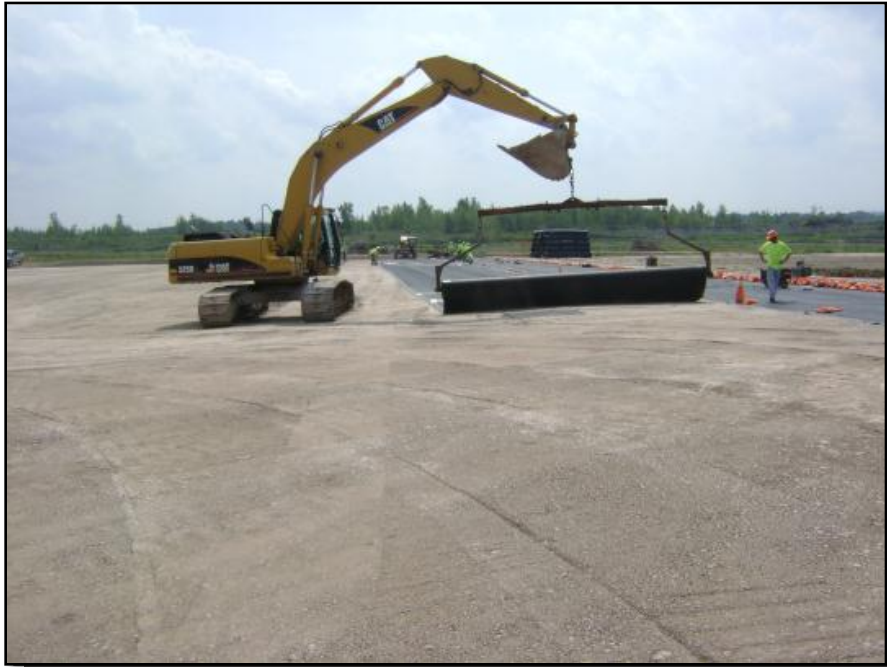
**Photograph 25:** Geomembrane rolls were deployed using a spreader bar attached to a piece of equipment, such as a Caterpillar 3250 excavator as shown above.

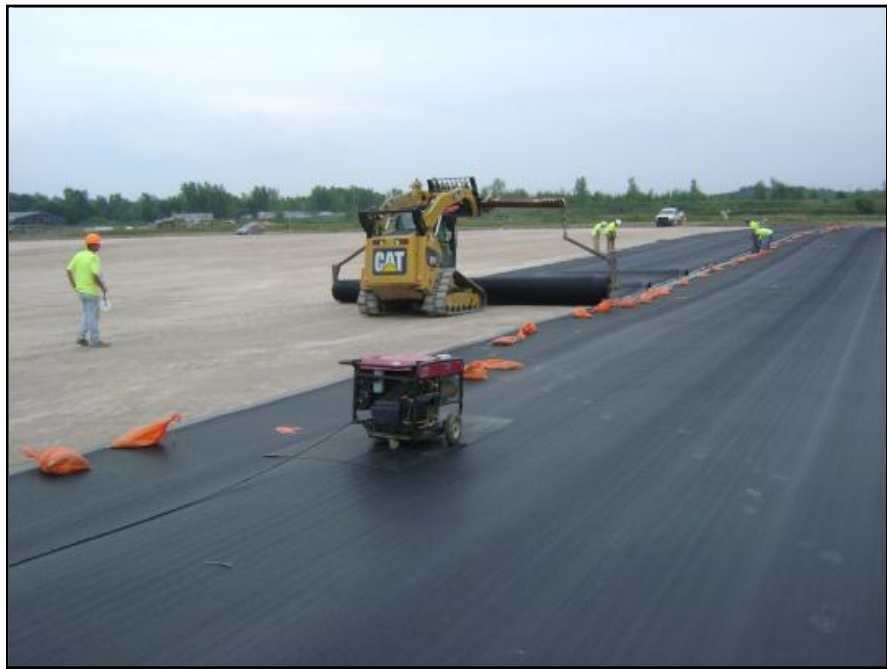
**Photograph 26:** A skid loader was also used to deploy geomembrane rolls. Panels were manually positioned before being welded. A wire was deployed under geomembrane panels to facilitate the leak location survey.

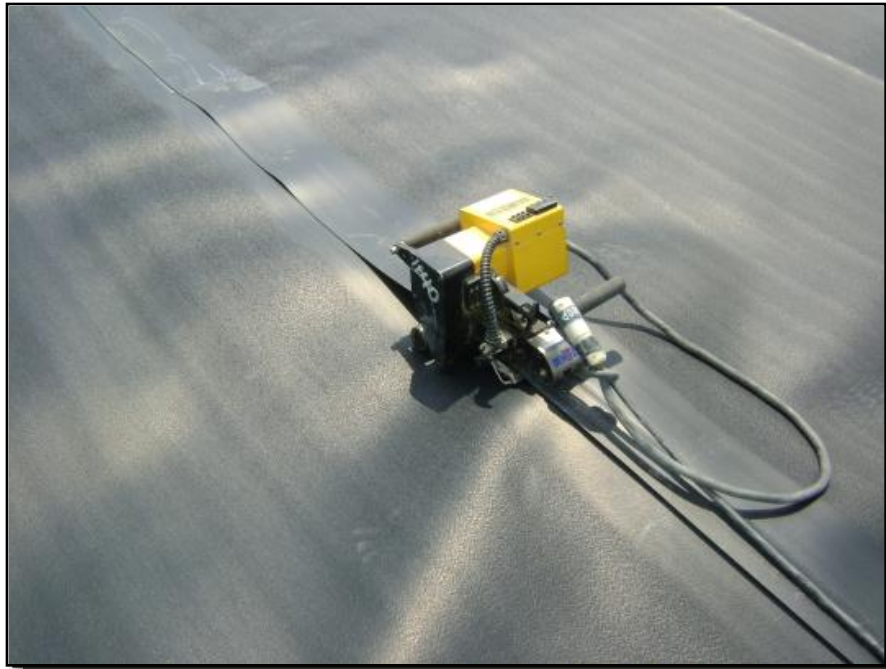
**Photograph 27:** A dual track fusion welder used to seam geomembrane panels together.

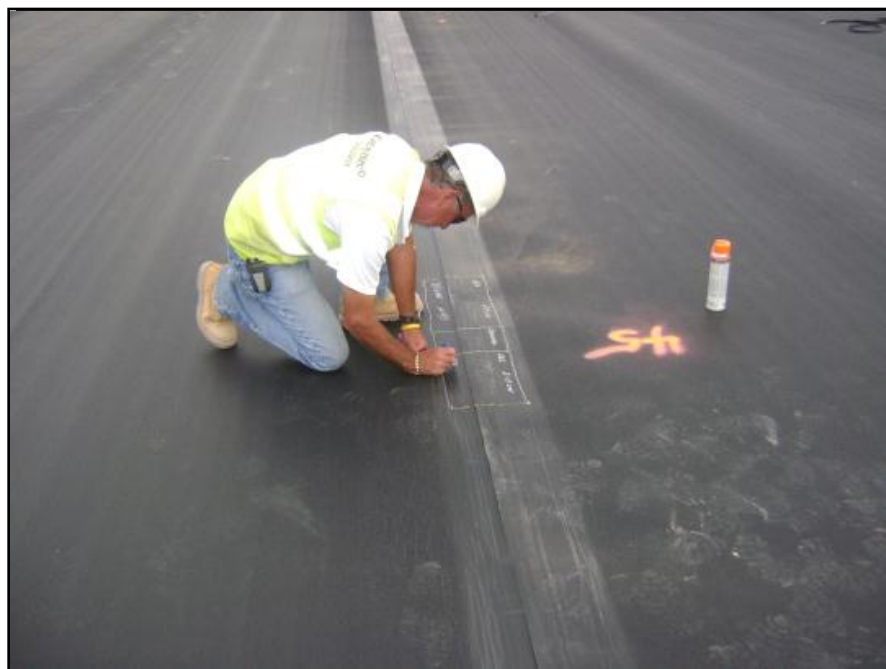
**Photograph 28:** CQA personnel monitored the geosynthetics installation and marked out destructive seam samples, as shown above. The samples were removed and tested to confirm the strength of the welds. The installer performed non-destructive test to confirm the integrity of the seams.

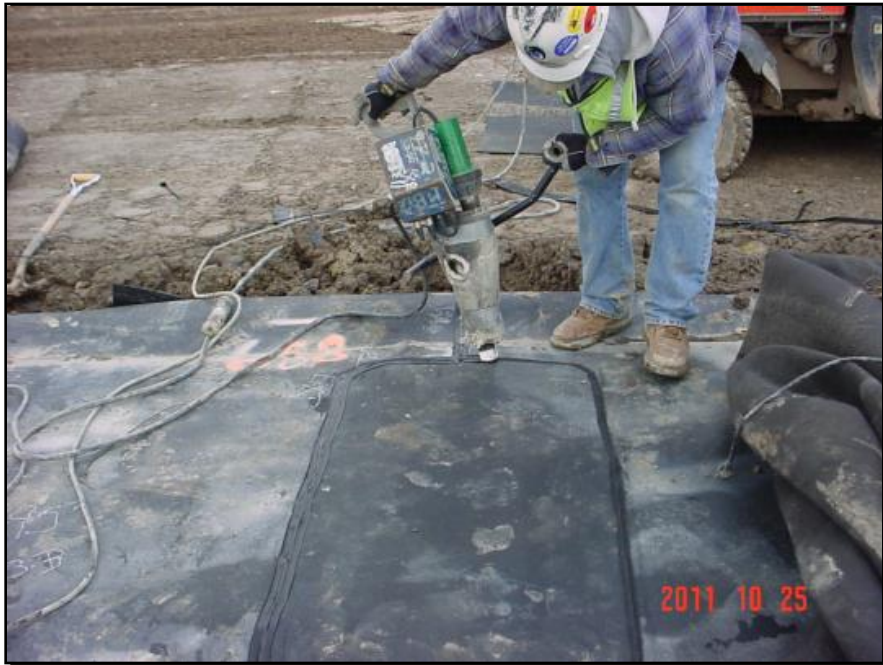
**Photograph 29:** The installer repaired the geomembrane liner by extrusion welding patches, as shown above.

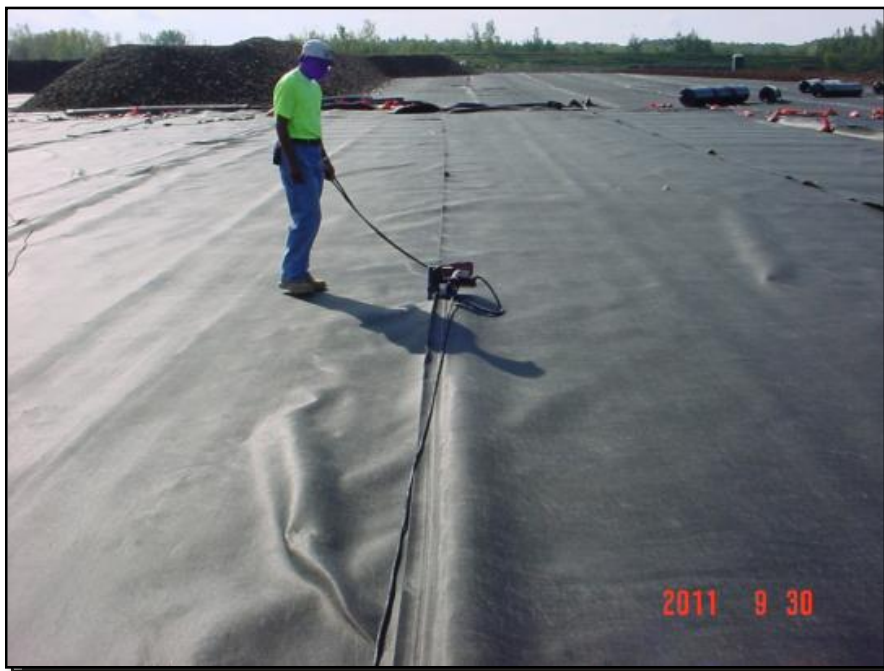
**Photograph 30:** A non-woven geotextile cushion was deployed over the geomembrane. Adjacent panels were thermally bonded using a single fusion welder.

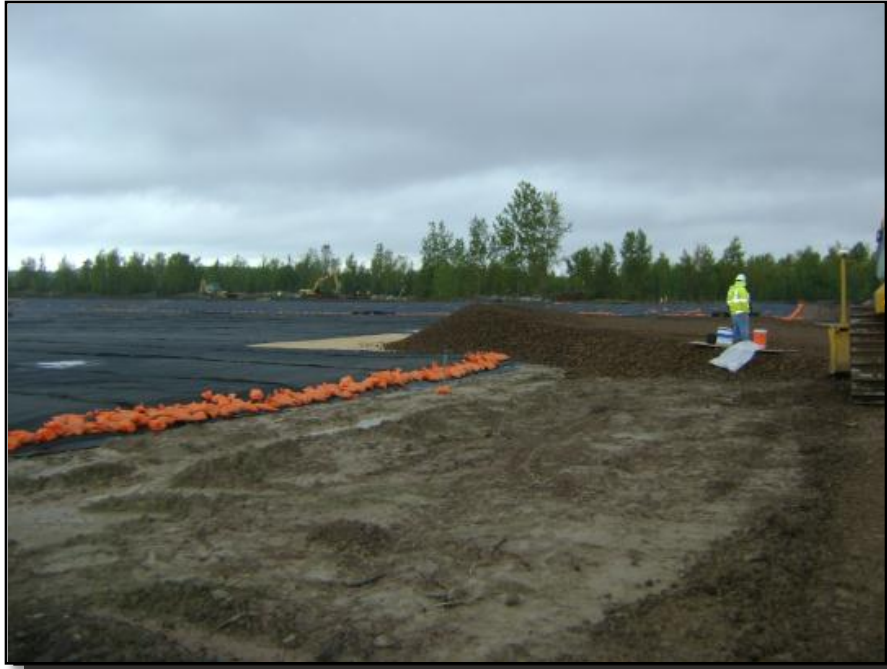
**Photograph 31:** Prior to placement of the gravel drainage layer, plywood was installed over the geosynthetics and gravel placed on top to establish access ramps.

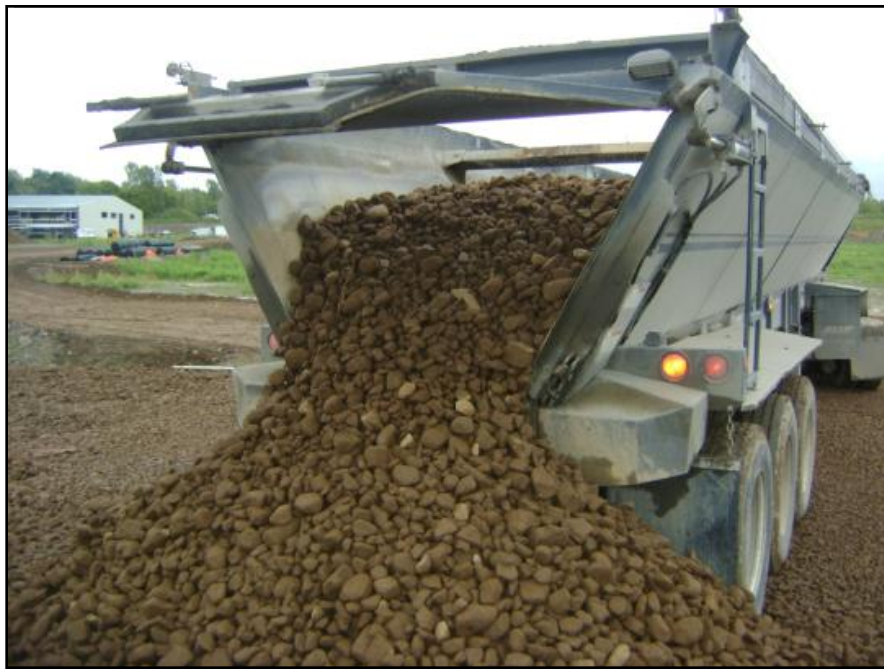
**Photograph 32:** Gravel was delivered primarily from the Granby source using live bottom trucks.

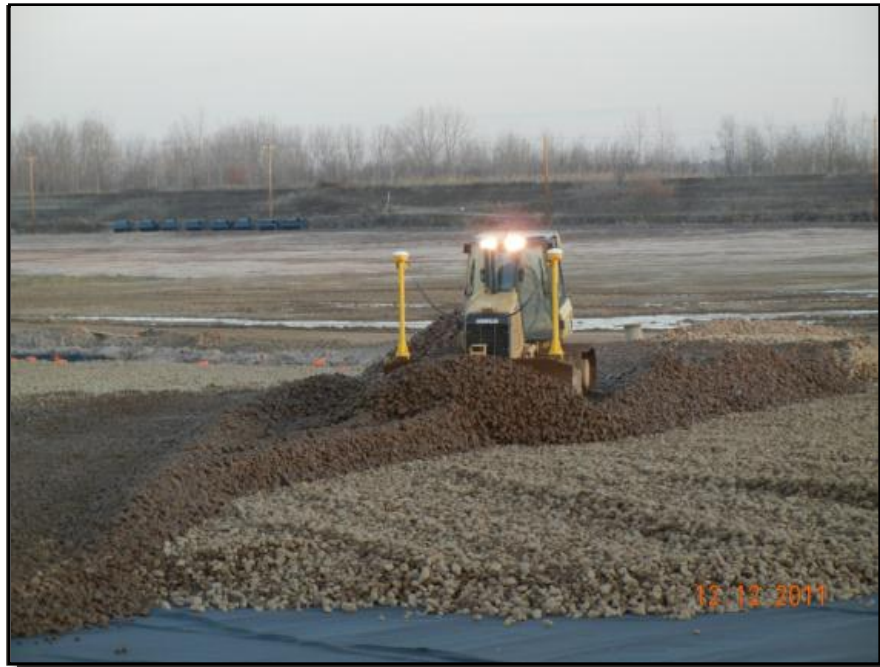
**Photograph 33:** Low-ground pressure dozers were used to place the gravel in a single lift.

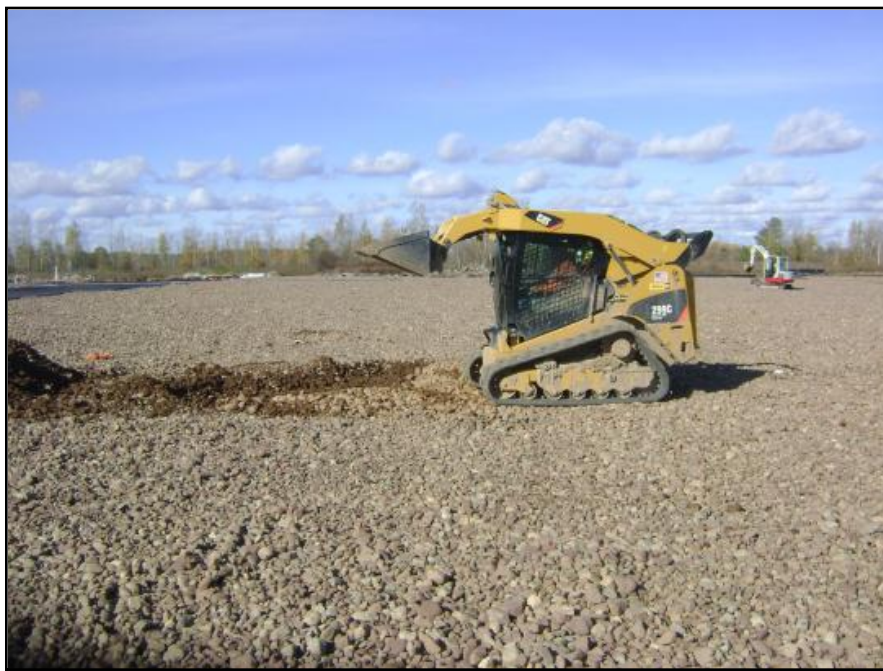
**Photograph 34:** Low-ground pressure equipment such as the Caterpillar 299 compact skid loader and Hitachi TB235 mini-excavator were used to remove areas of excessive fines.

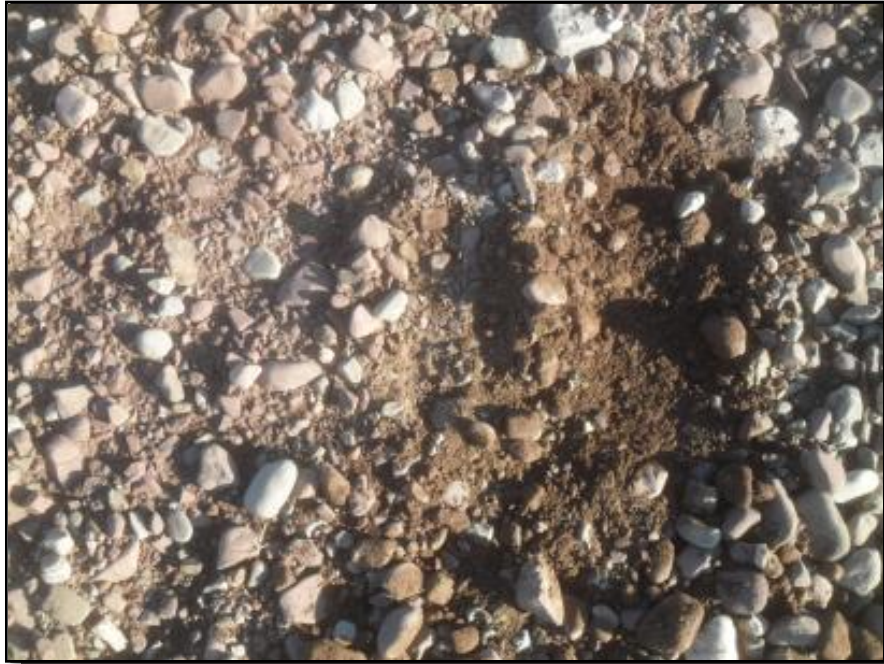
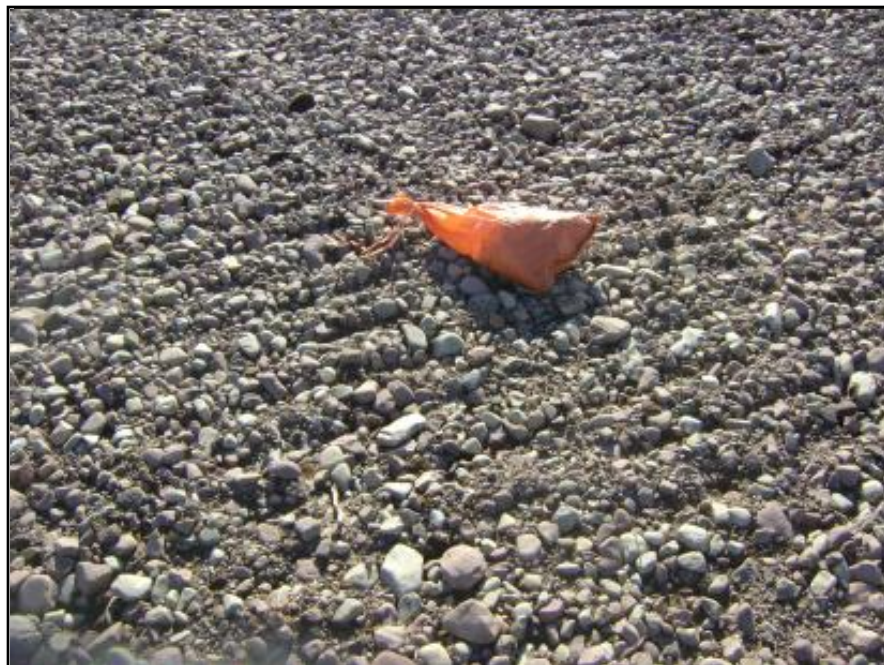
**Photographs 35 and 36:** Areas of excessive fines were noted in the gravel drainage layer. These areas were marked out using orange sand bags.
