**Honeywell International Inc.**

**ONONDAGA LAKE BOTTOM  
PHASE I – SEDIMENT CONSOLIDATION  
AREA CONSTRUCTION  
CONSTRUCTION QUALITY ASSURANCE (COA)  
FINAL REPORT – Volume I  
ONONDAGA COUNTY  
TOWN OF CAMILLUS, NEW YORK**

Project Number GJ4706B

May 2012 (Revision 0)  
August 2012 (Revision 3)

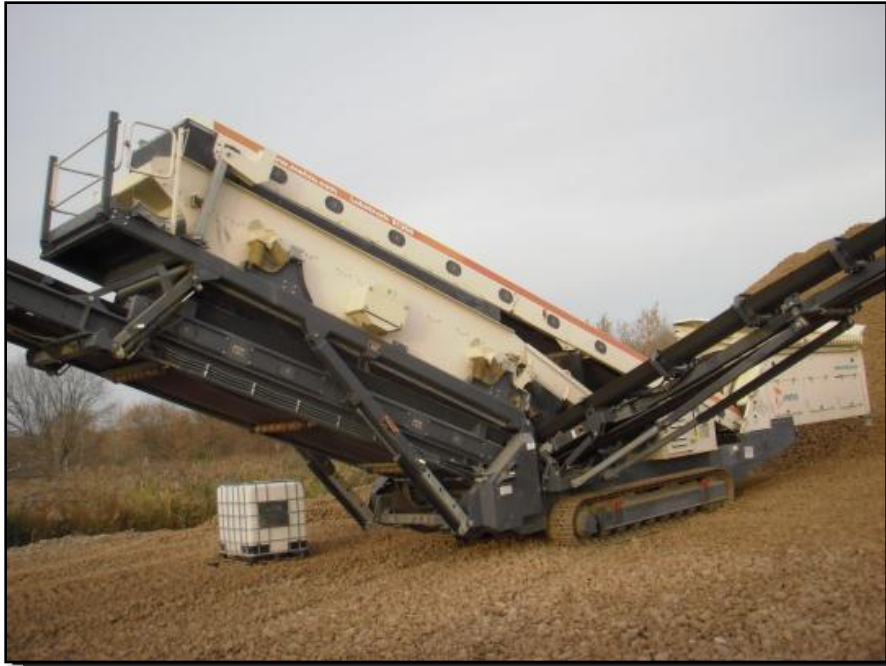
**Photograph 37:** On 2 November 2011 a screening unit fitted with a wash bar was mobilized to the site to process the gravel on site.

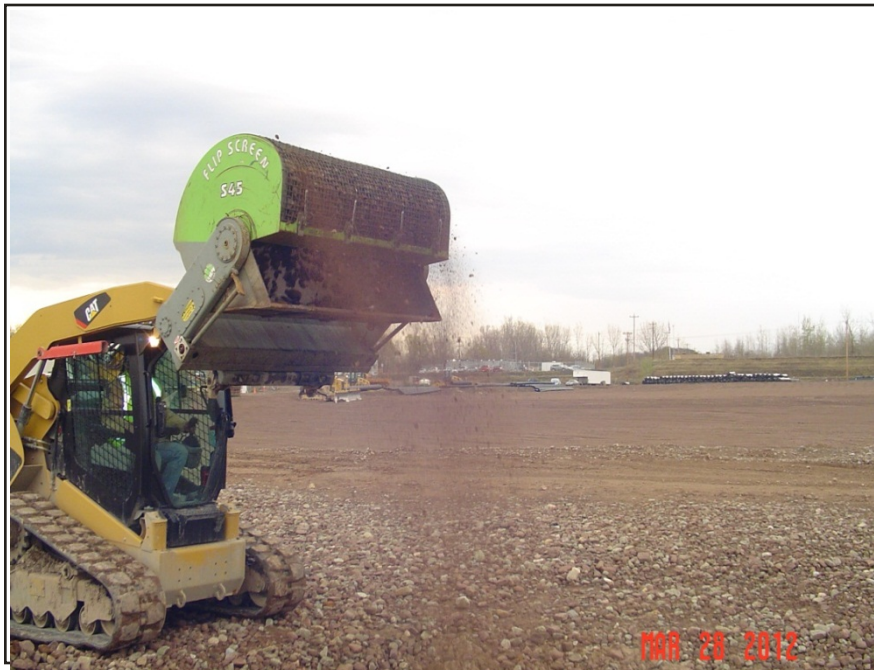
**Photograph 38:** In May 2012, a flip screener was used to further remediate areas of observed fines in the gravel drainage layer.

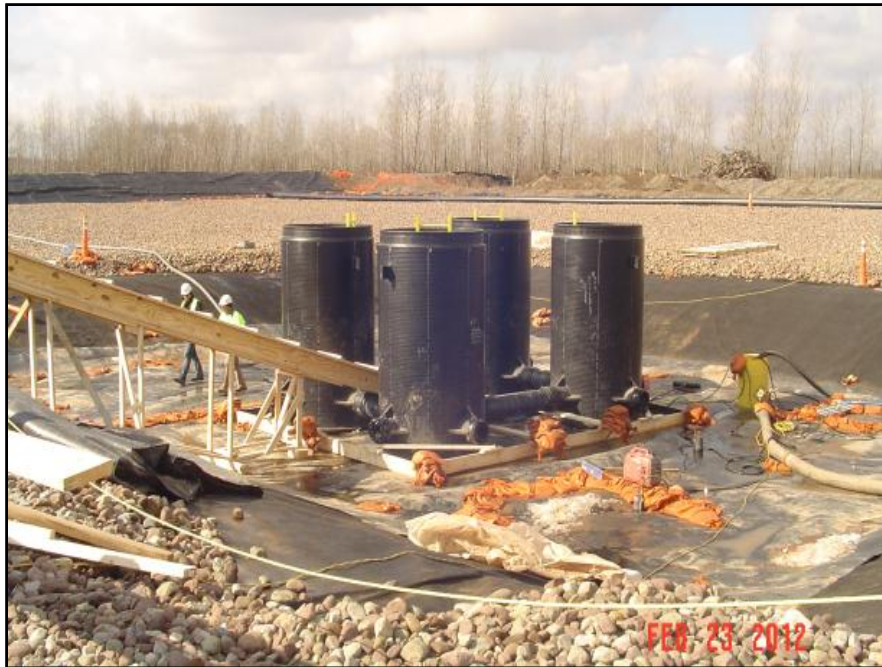
**Photograph 39:** In February 2012, polyethylene manholes were installed in the two sump areas. Concrete was placed around the four manholes. Gravel was later placed in the sump.

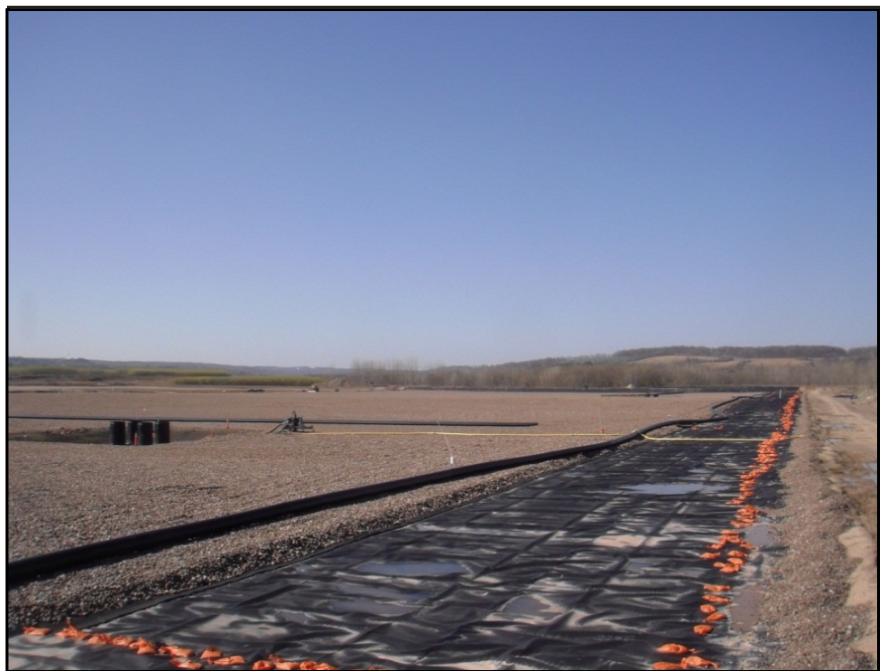
**Photograph 40:** A view of the substantially completed Phase I area from the north west corner.

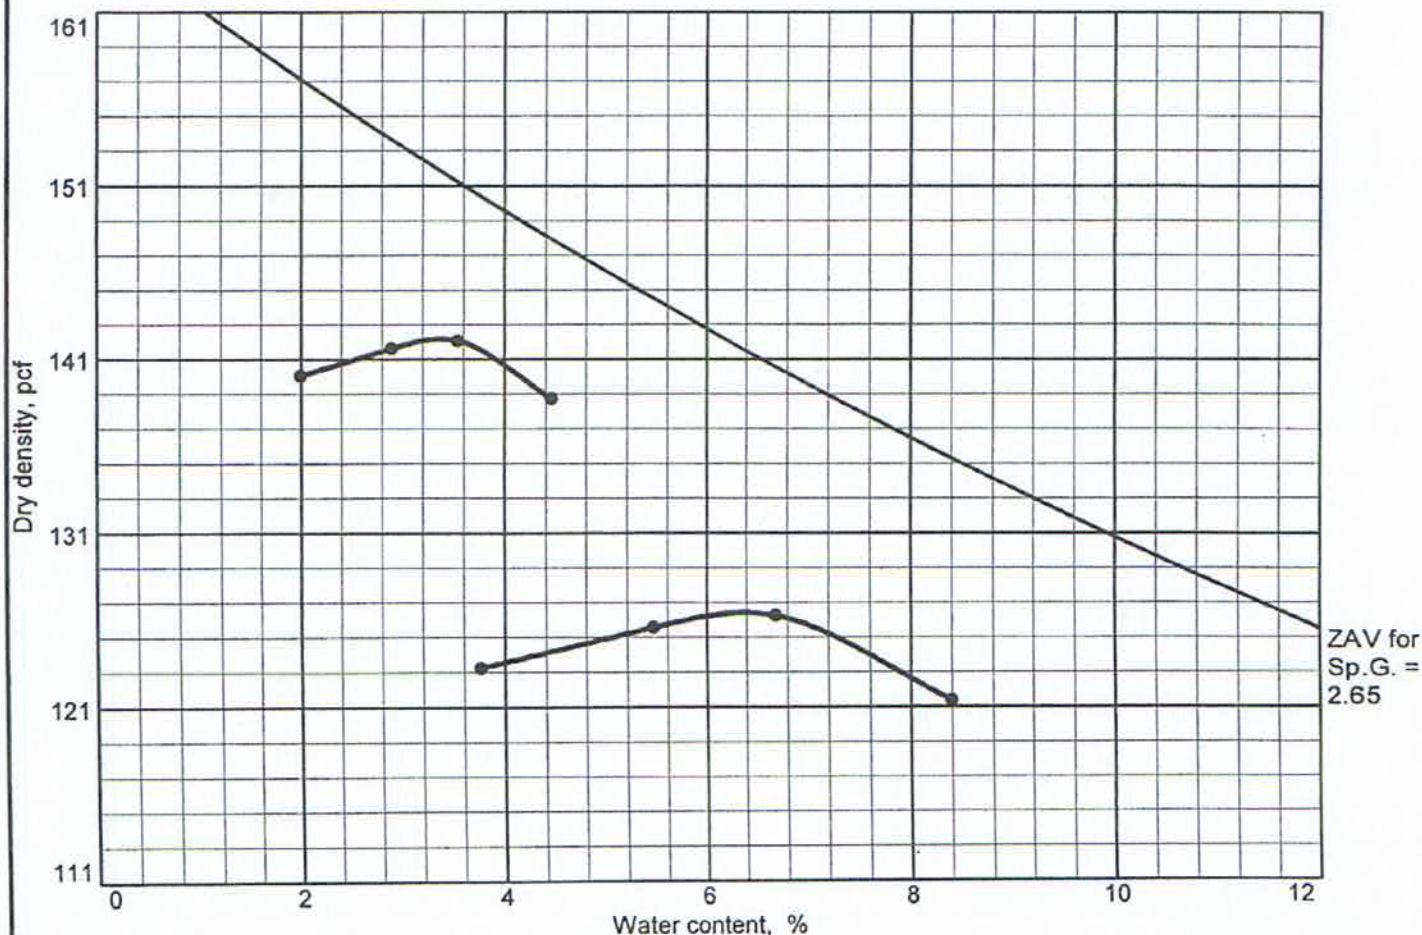
## COMPACTION TEST REPORT

Test specification: ASTM D 698-00 Method C Standard  
Oversize correction applied to each point

Elev/ Depth	Classification		Received Moist.	Sp.G.	LL	PL	PI	% > 3/4 in.
	USCS	AASHTO						
---	GP w/ Sand	---	5.6	2.65	NP	NP	NP	47.0

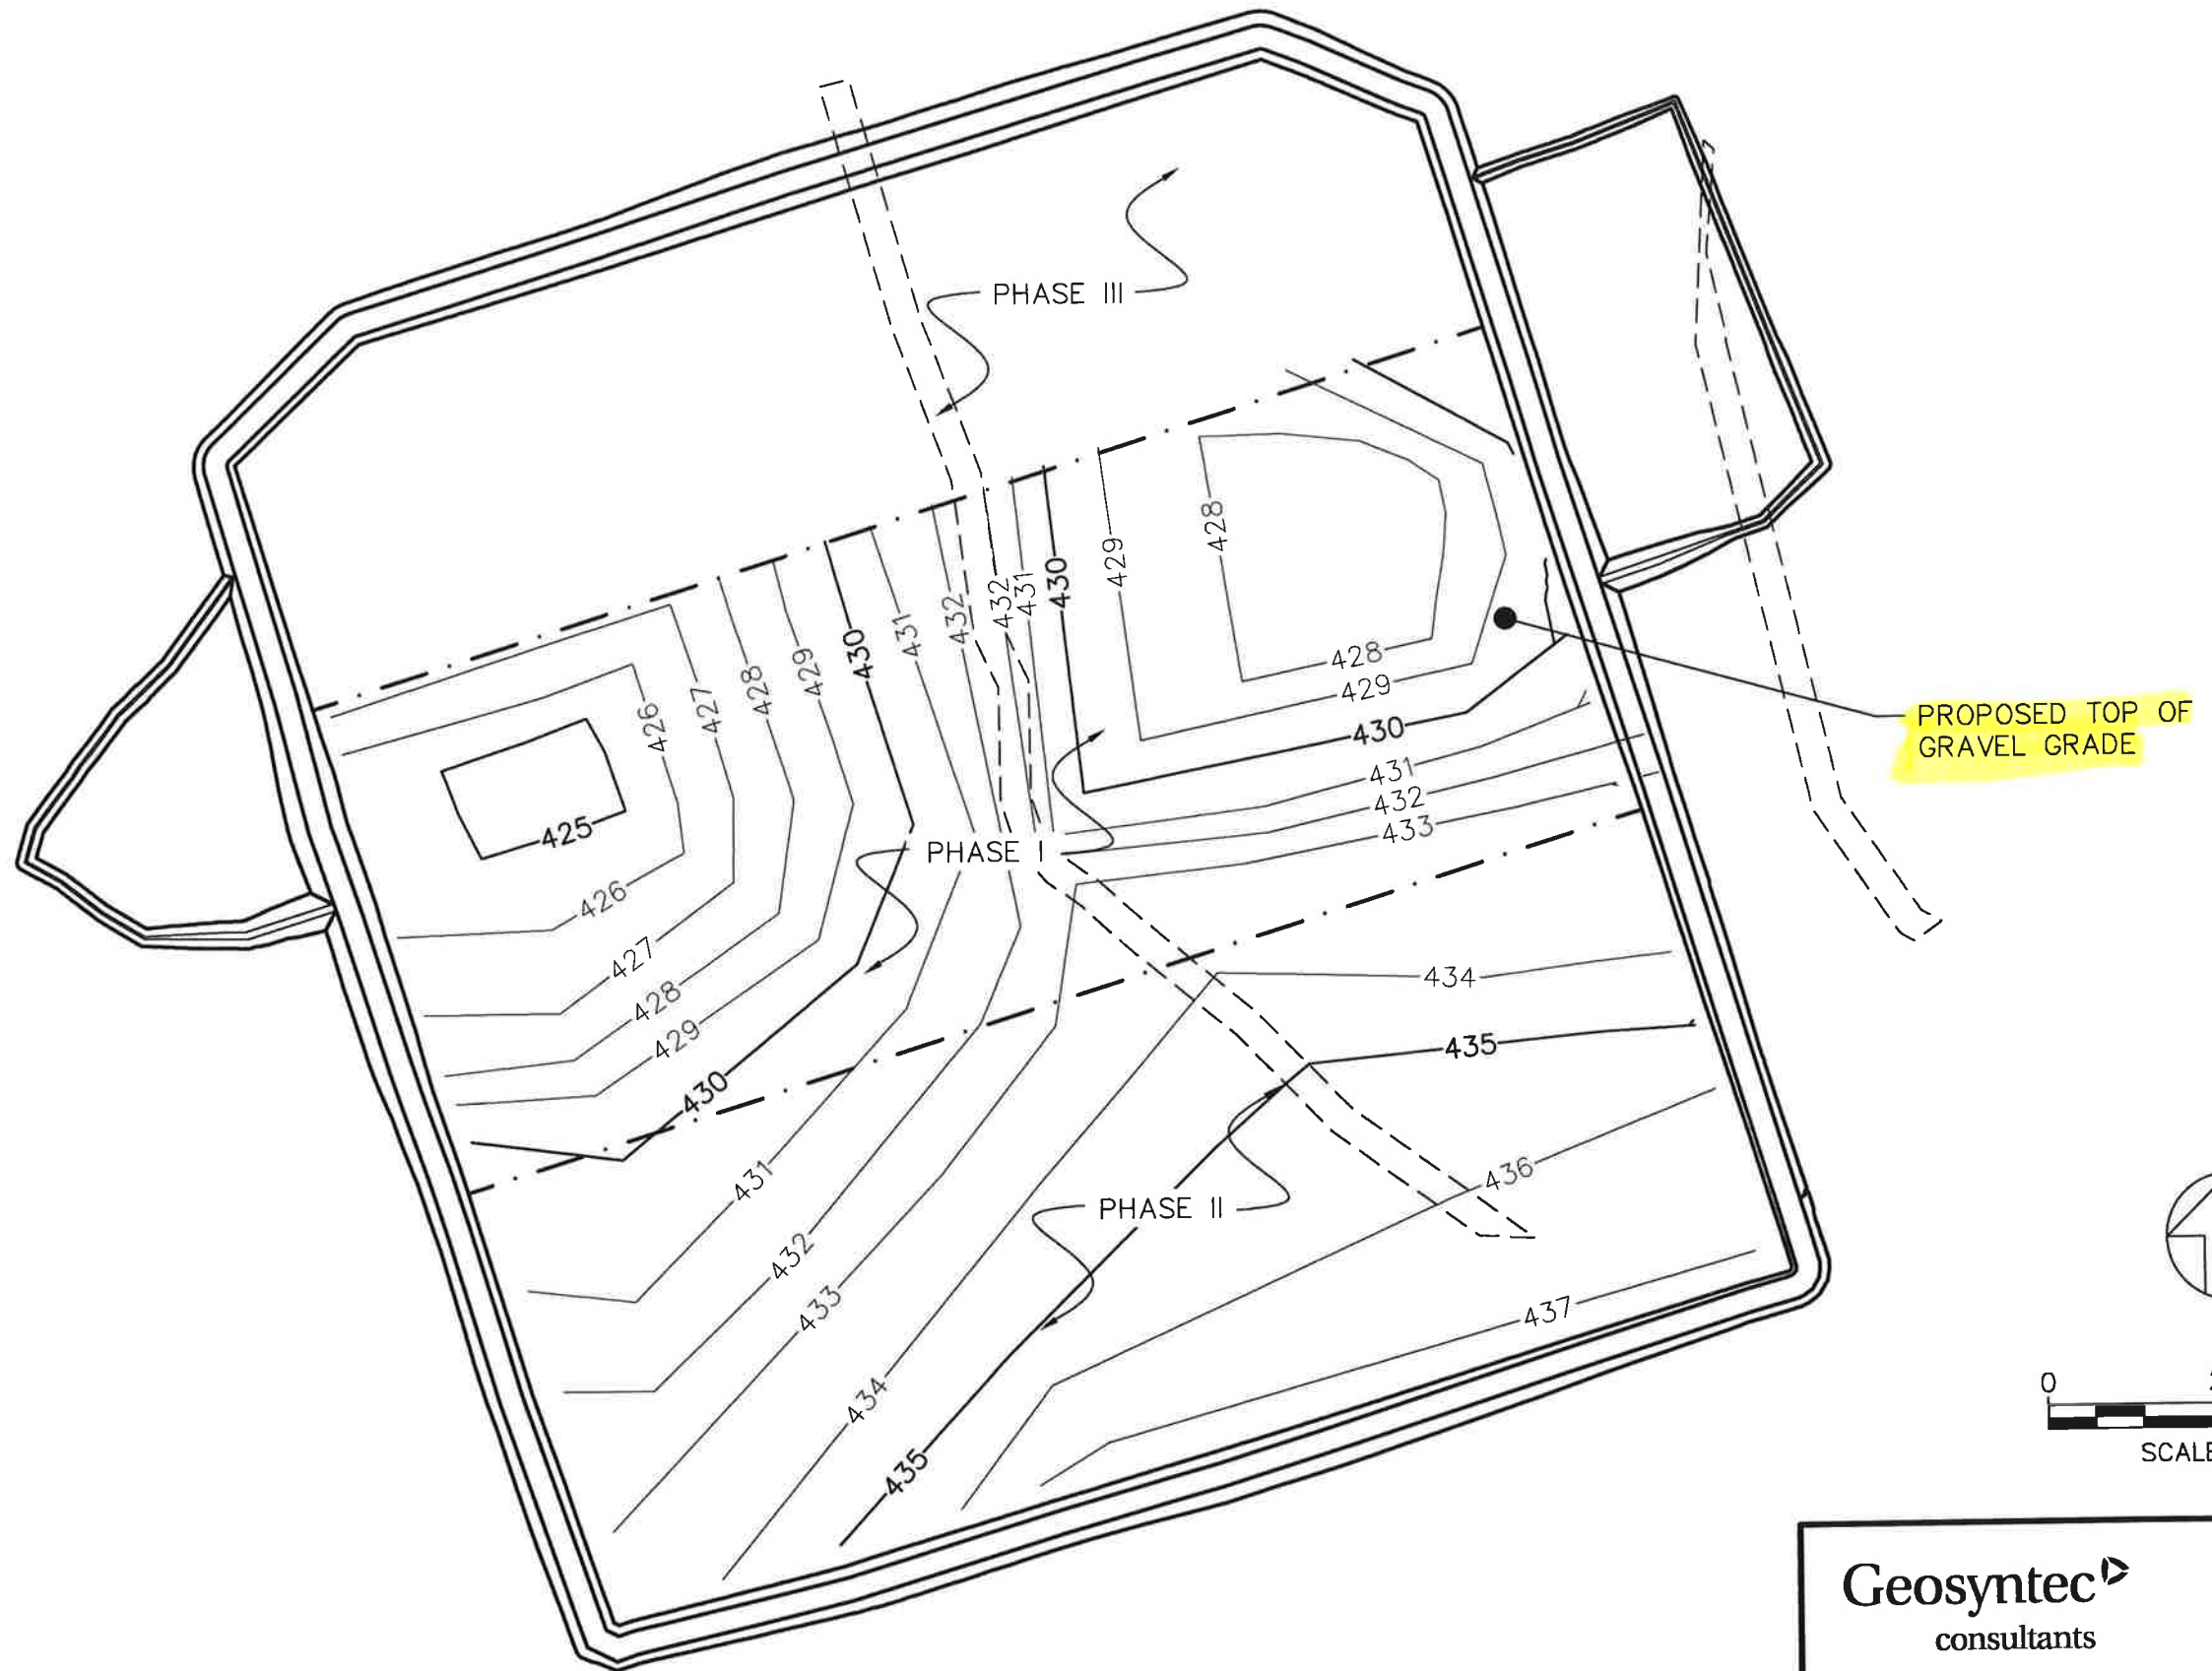
Geosyntec <sup>®</sup>		KENNESAW, GA	
consultants			
DATE:	Aug-11	SCALE:	AS SHOWN
PROJECT NO.	GJ4706.08	FILE NO.	—
DOCUMENT NO.	—	FIGURE NO.	2

Original Analysis - Before survey bust, minimum berm elevation of 434 ft msl

- 1.) It is noted that the minimum height of the berm is considered to be 2 ft above the Top of Gravel. This results in a minimum berm elevation of 434 ft msl in Phase I and 436 ft msl in Phase II.
- 2.) The minimum freeboard requirement is considered to be 0.5 ft (6").
