## A-10

### Vegetative Cover Layer Design Package

Client: Honeywell Project: Onondaga Lake SCA Final Cover Design Project/Proposal #: GD5497

#### VEGETATIVE COVER LAYER

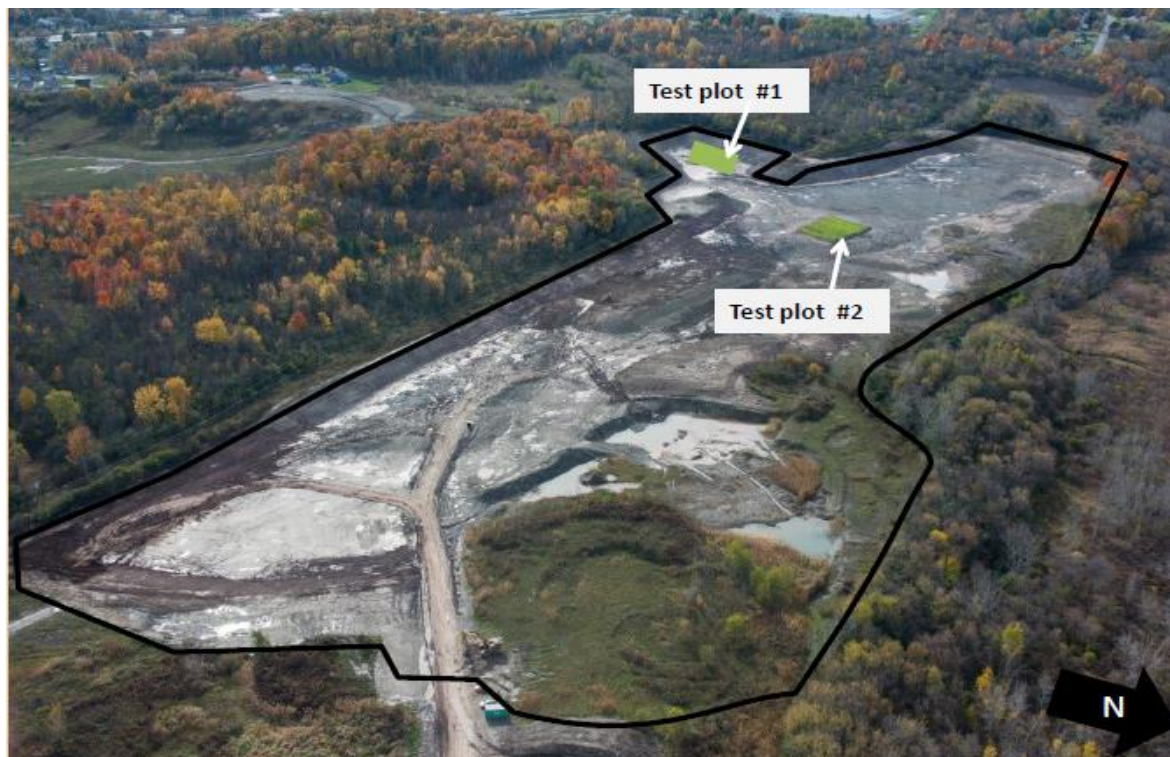
Figure 1. Locations of the two borrow pit test plots studied in the summer and fall of 2015.

The locations of the first and second test plots are shown in Figure 1. The first test plot was 200' x 100'. The second test plot, located in a different location, was slightly smaller and measured 140' x 100'. In each test plot, the same four vegetative cover layer types were tested along with three different fertilization levels. Vegetative cover layer combinations were created by placing layers and tracking each layer with a D6T dozer with 2.6 inch grousers. Layers consisted of borrow material as the base layer, followed by sand then topsoil. The vegetative cover layer types are shown in Figure 2 and were as follows:

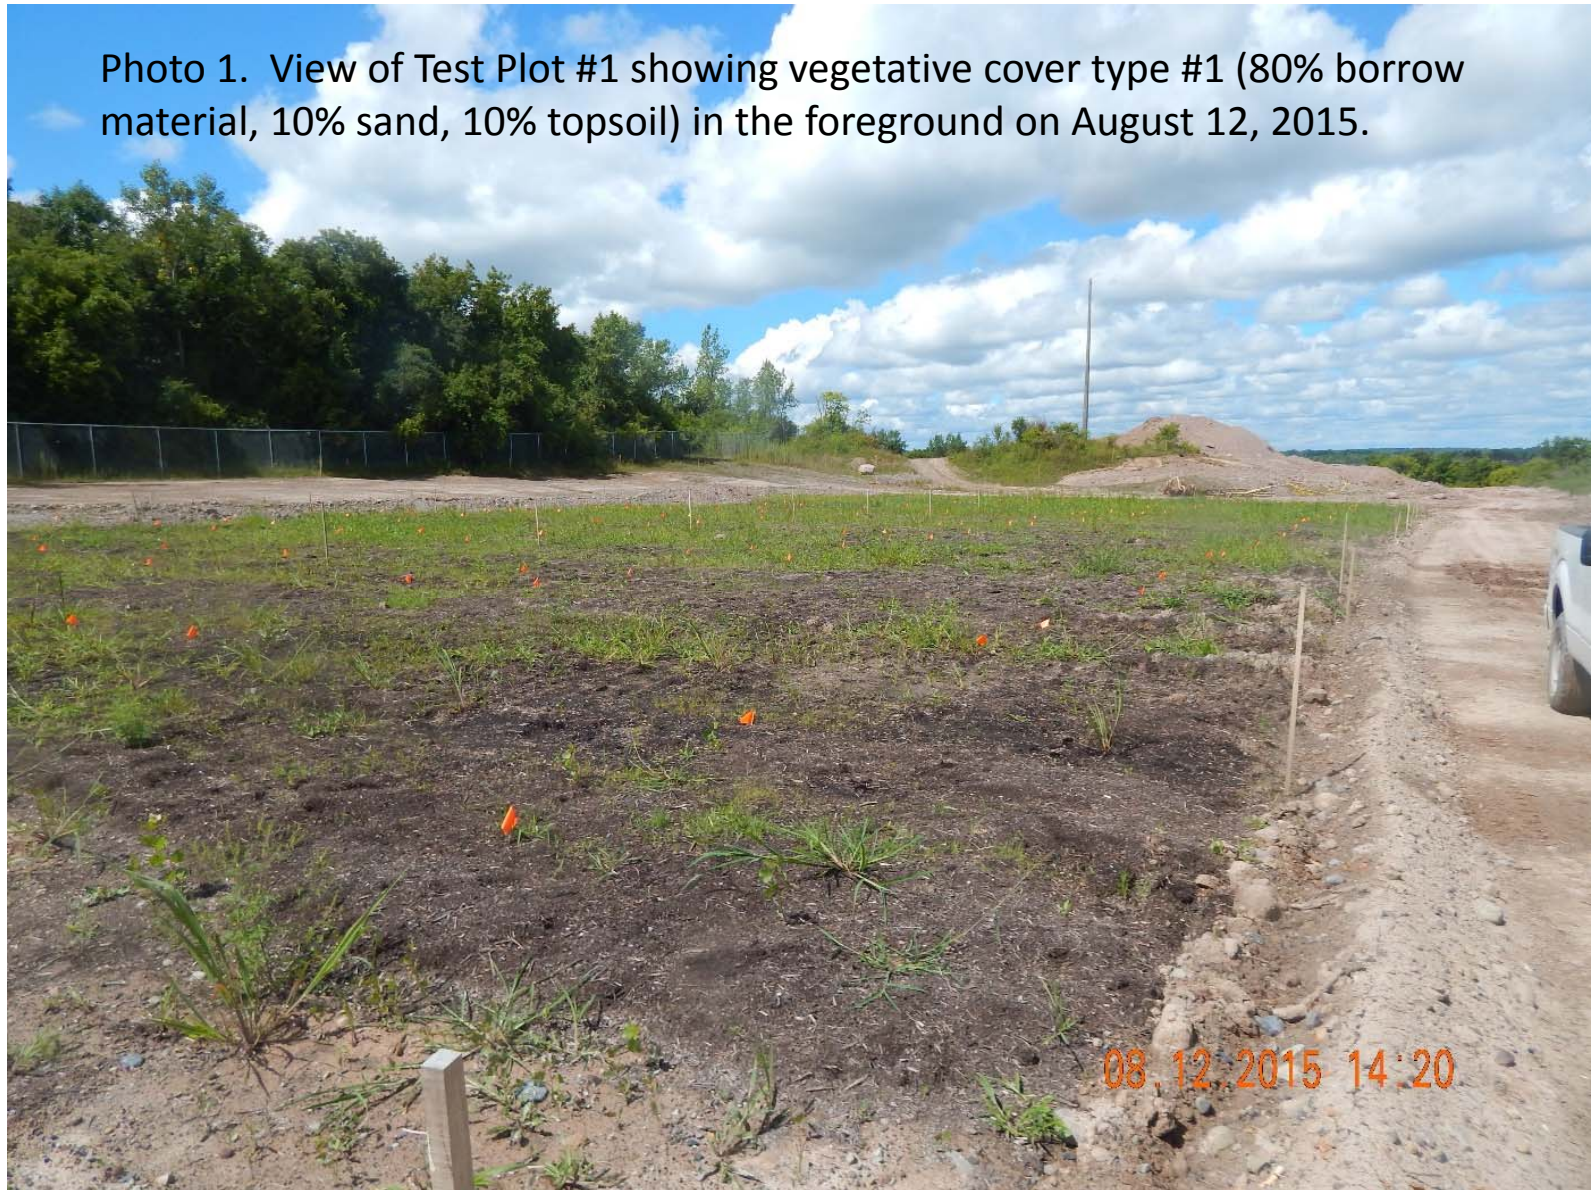
Photo 1. View of Test Plot #1 showing vegetative cover type #1 (80% borrow material, 10% sand, 10% topsoil) in the foreground on August 12, 2015.

mid to late fall for cool season species and those requiring a period of cold stratification. However, once seed began to germinate, it grew quickly. By the time the quantitative monitoring took place a month later, on October 29<sup>th</sup>, the average percent cover of vegetation ranged from 34% to 74% across the four vegetative cover types. The overall average across all material types was 52% and was significantly higher than the first plot ( $p < 0.05$ ). The difference in growth compared to the first test plot can be easily seen in the attached photographs 1 to 4 and 15 to 17.

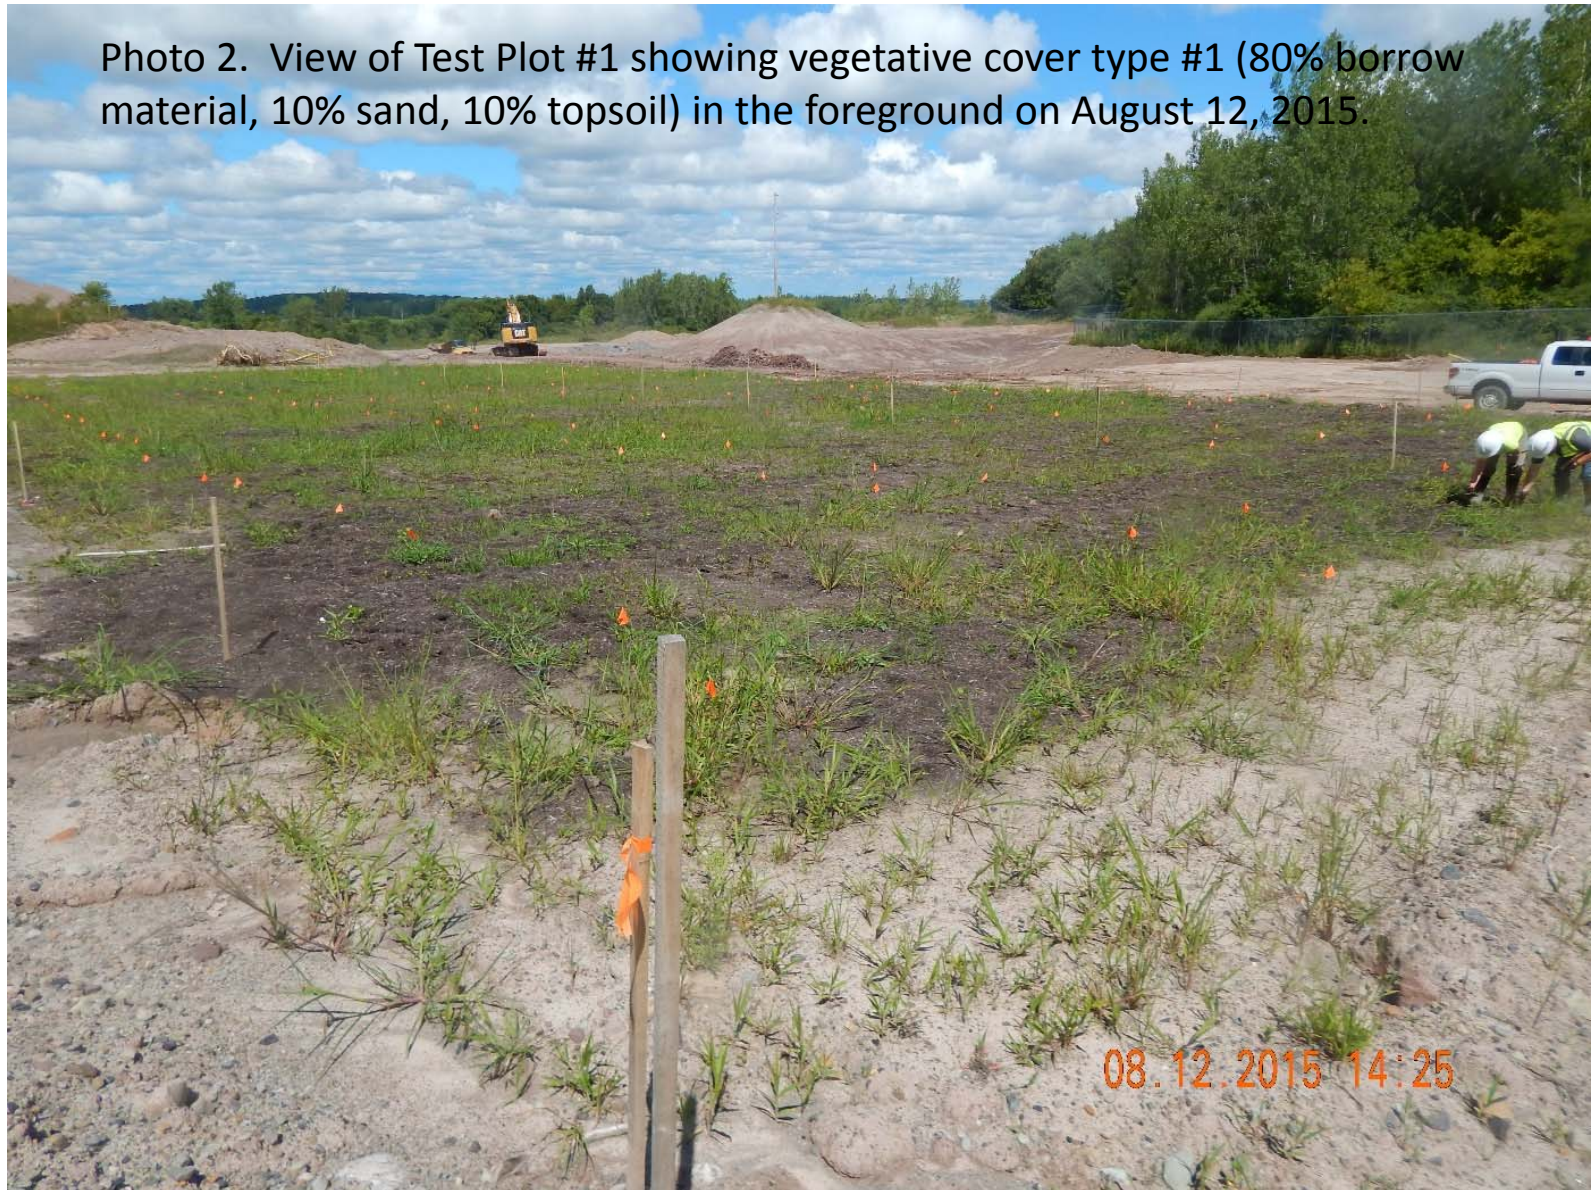
Photo 2. View of Test Plot #1 showing vegetative cover type #1 (80% borrow material, 10% sand, 10% topsoil) in the foreground on August 12, 2015.

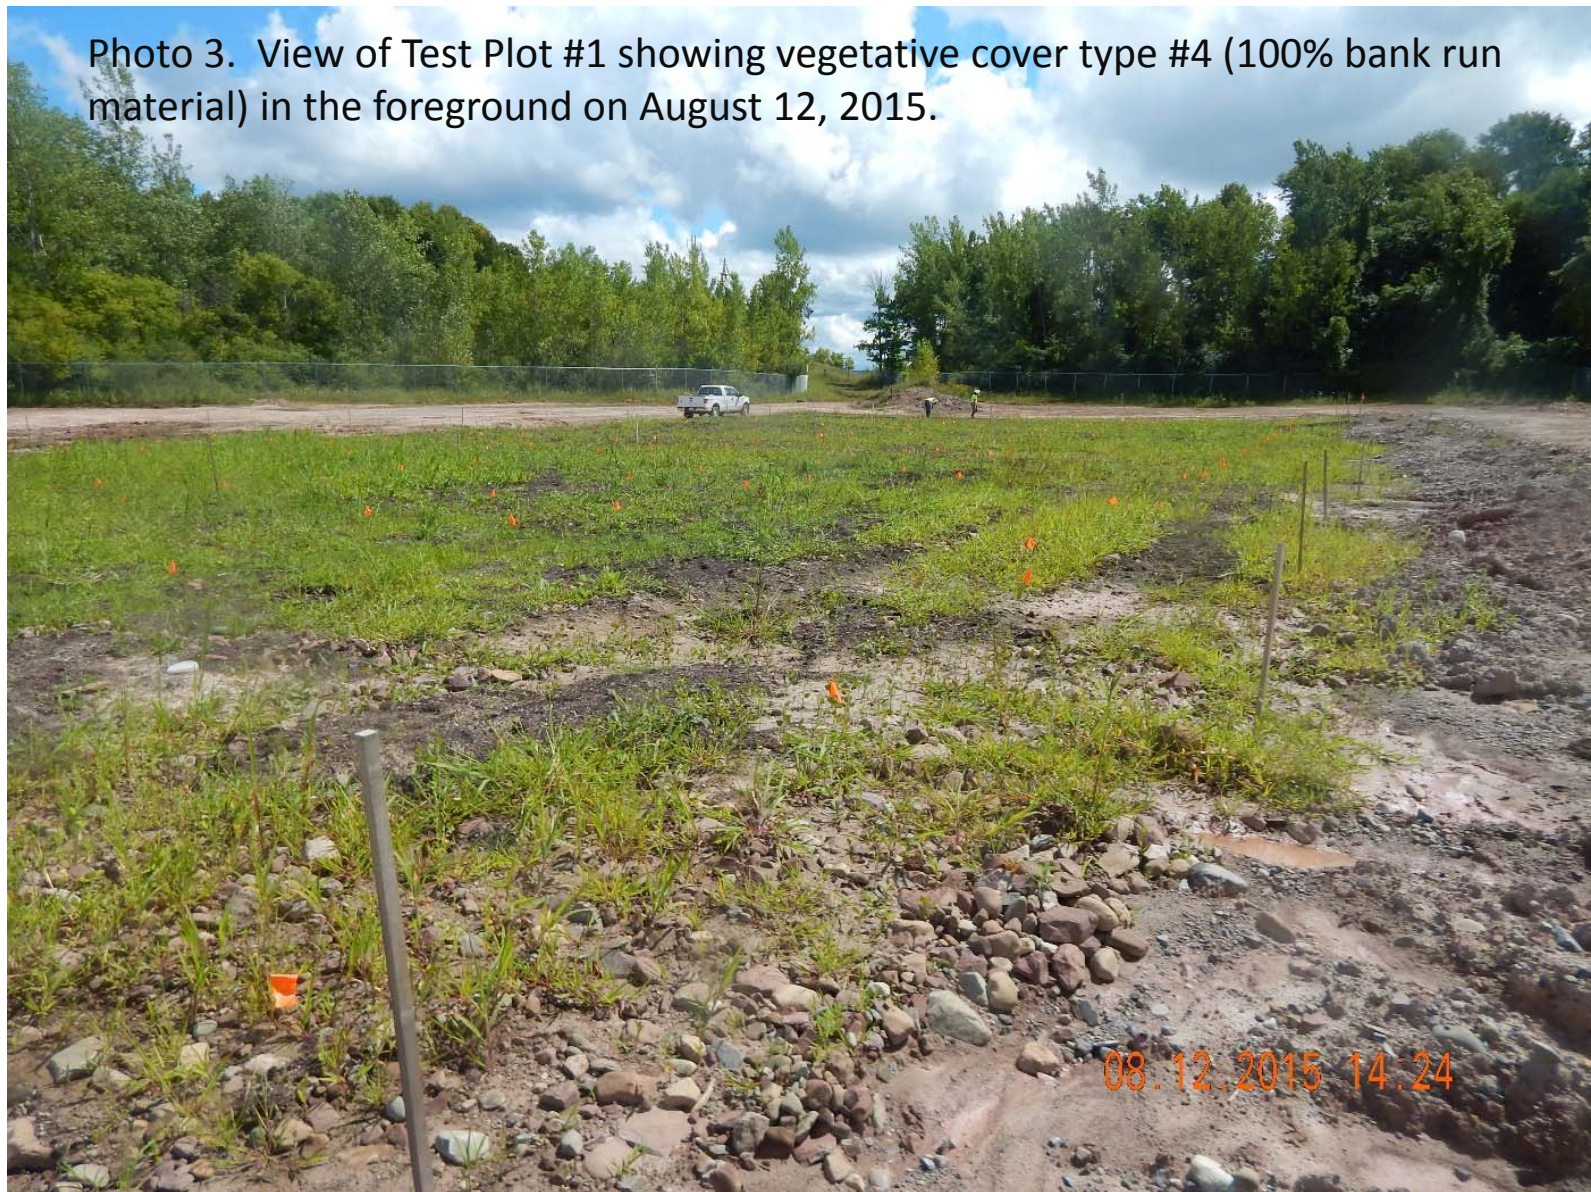
Photo 3. View of Test Plot #1 showing vegetative cover type #4 (100% bank run material) in the foreground on August 12, 2015.

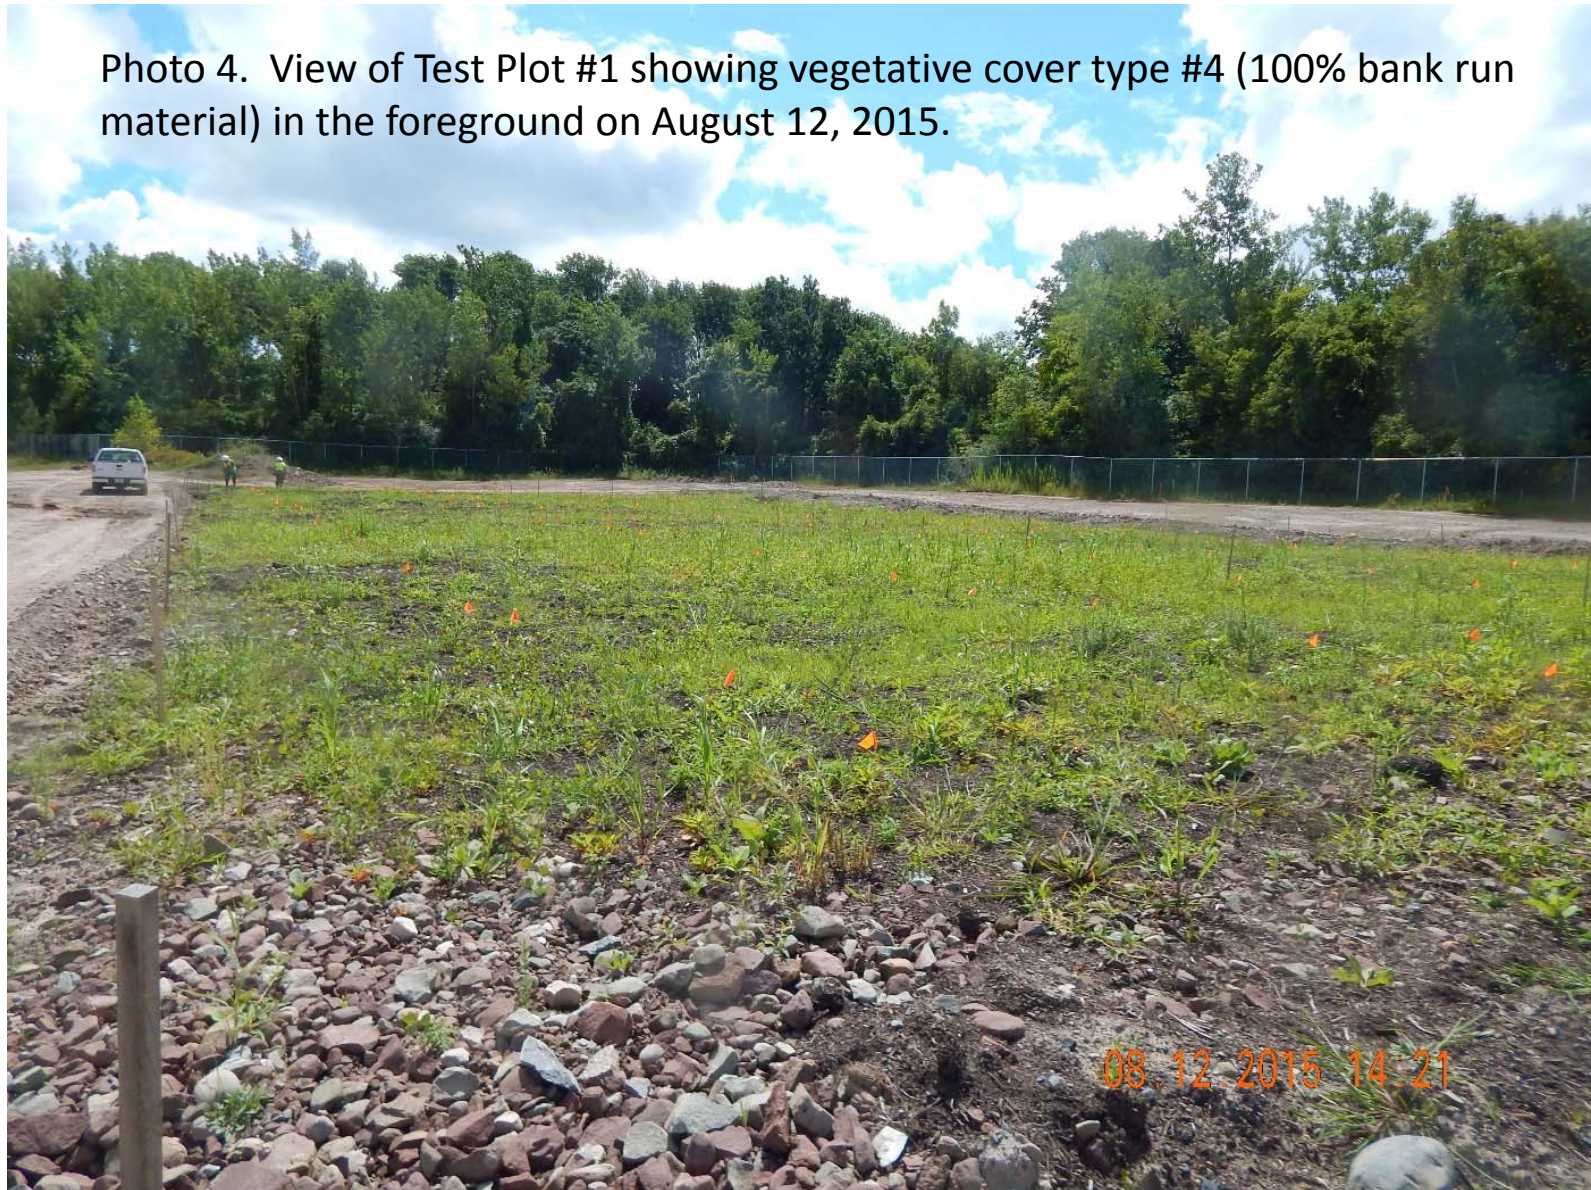
Photo 4. View of Test Plot #1 showing vegetative cover type #4 (100% bank run material) in the foreground on August 12, 2015.

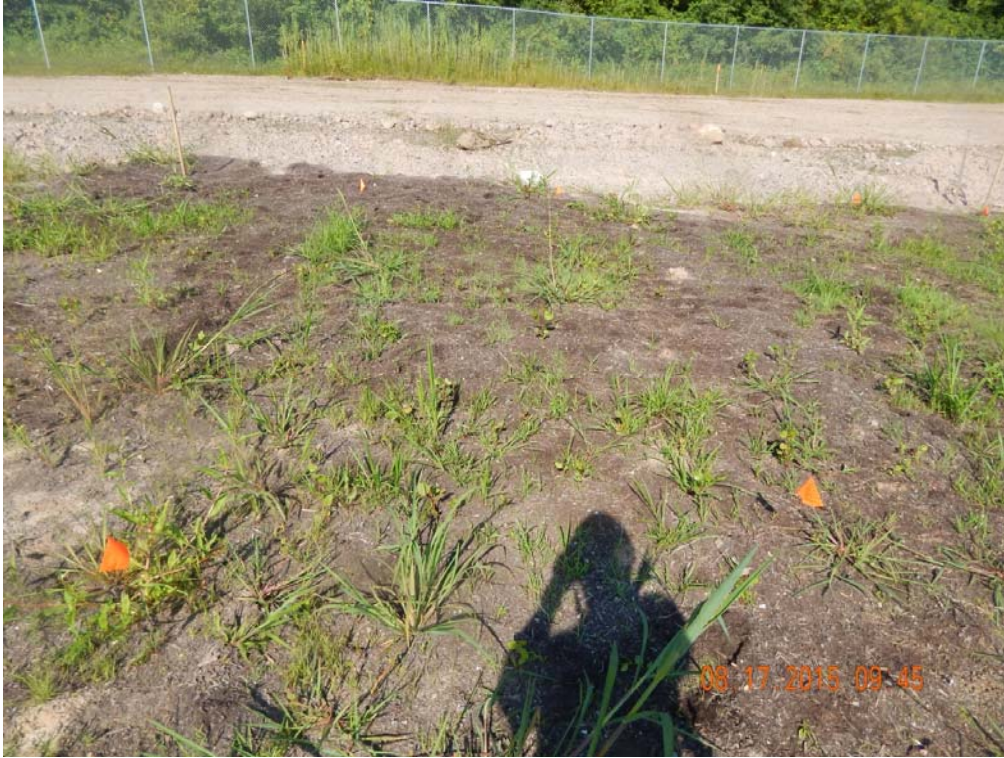
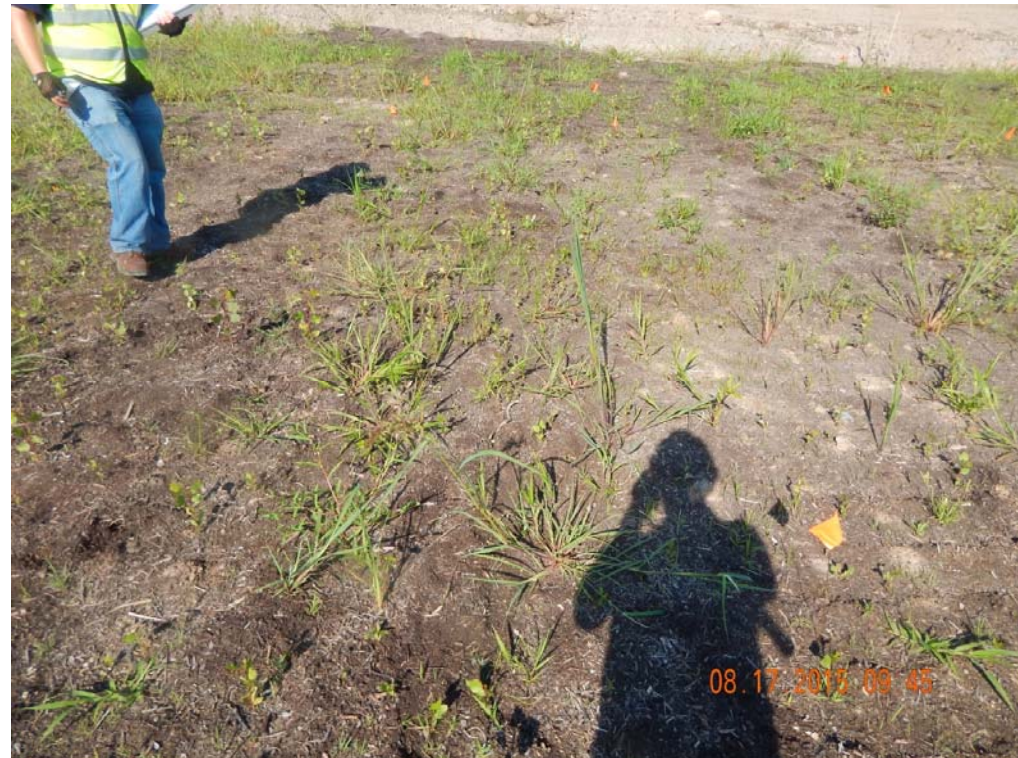
Type 1 (80% borrow material, 10% sand, 10% topsoil)  
Representative photographs

Photo 5 & Photo 6. Photographs of monitoring plot locations taken during final plot monitoring on August 17, 2015.

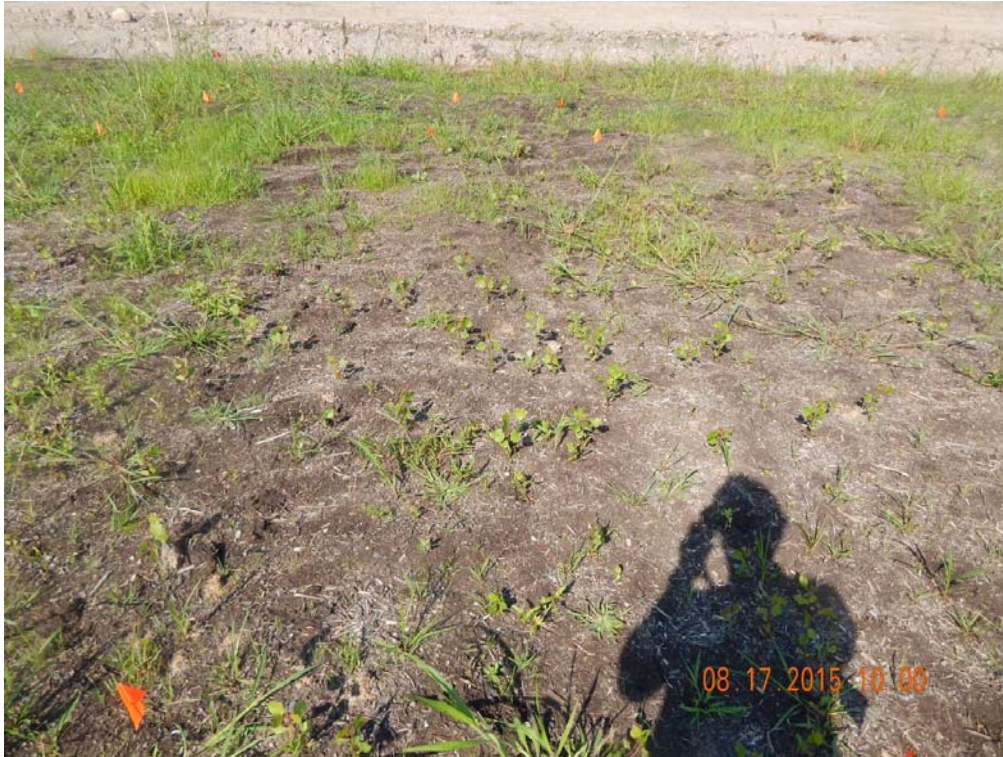
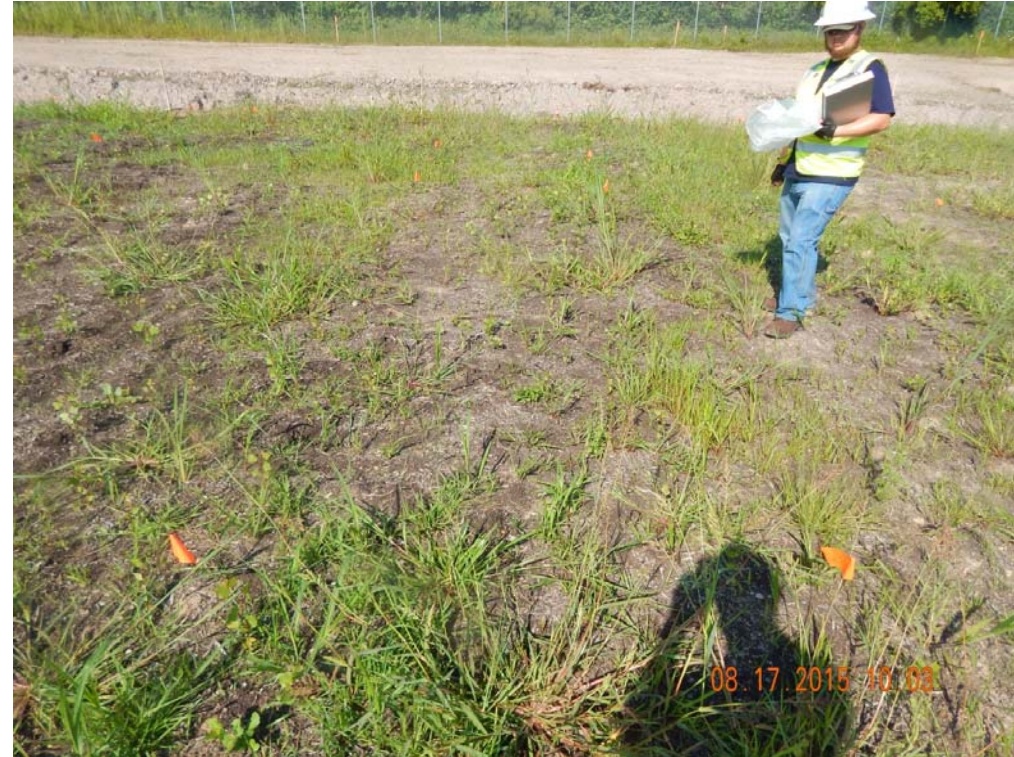
Type 2 (70% borrow material, 20% sand, 10% topsoil)  
Representative photographs

Photo 7 & Photo 8. Photographs of monitoring plot locations taken during final plot monitoring on August 17, 2015.

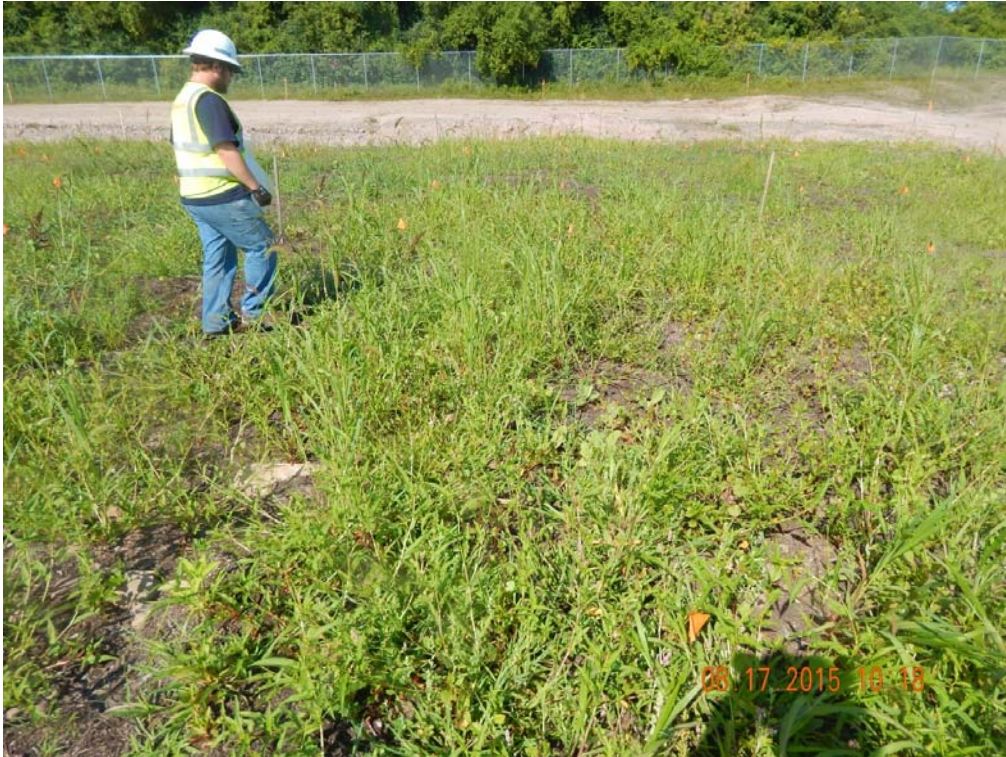
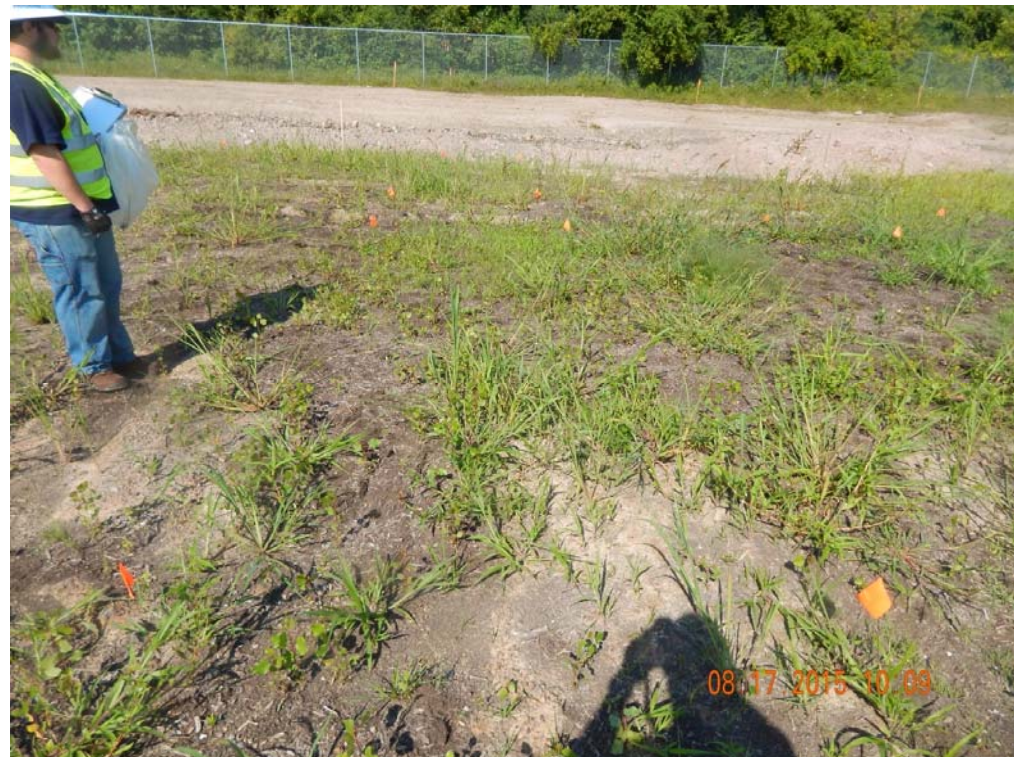
Type 3 (60% borrow material, 30% sand, 10% topsoil)  
Representative photographs

Photo 9 & Photo 10. Photographs of monitoring plot locations taken during final plot monitoring on August 17, 2015.

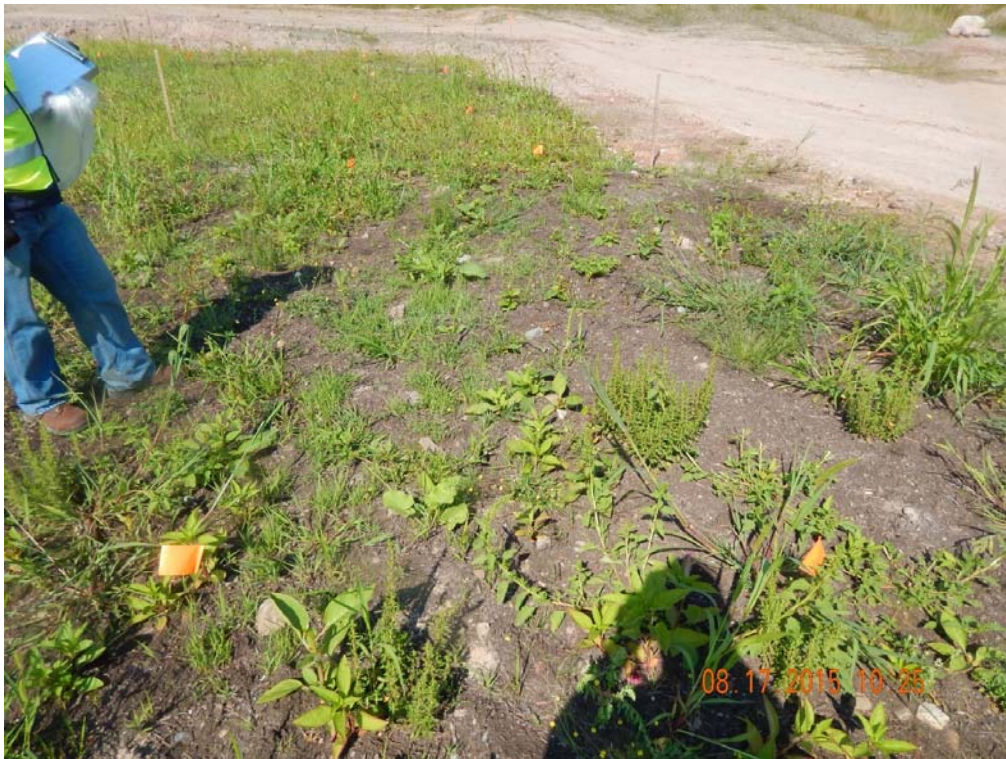
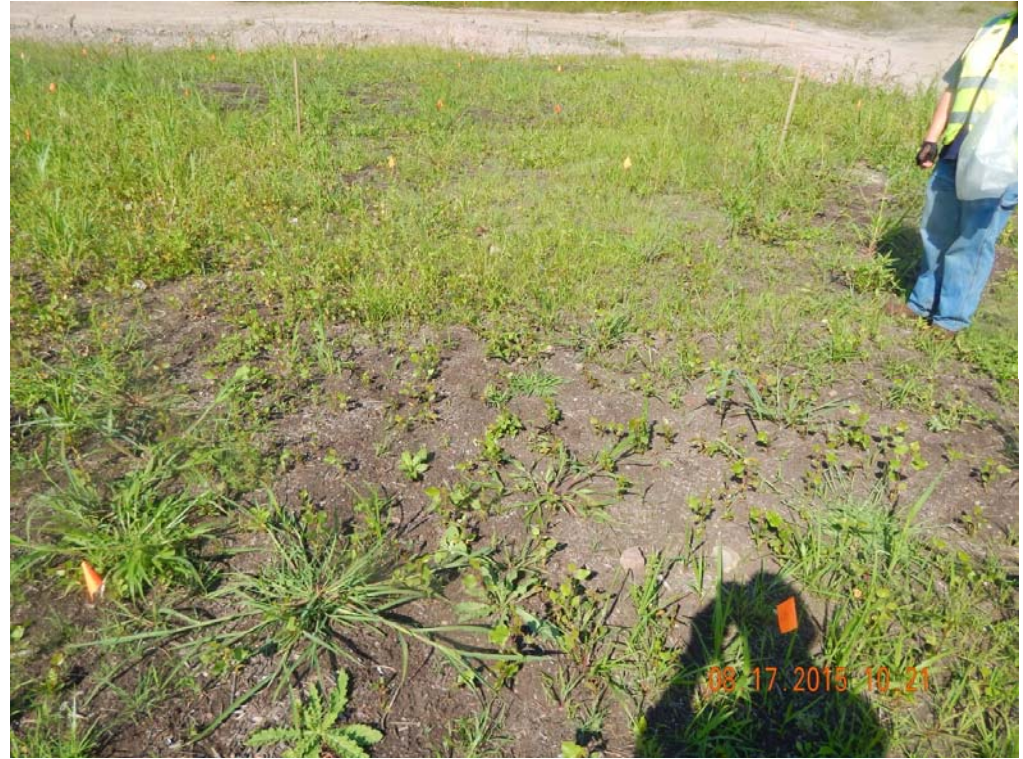
## Type 4 (100% bank run material) Representative photographs

Photo 11 & Photo 12. Photographs of monitoring plot locations taken during final plot monitoring on August 17, 2015.

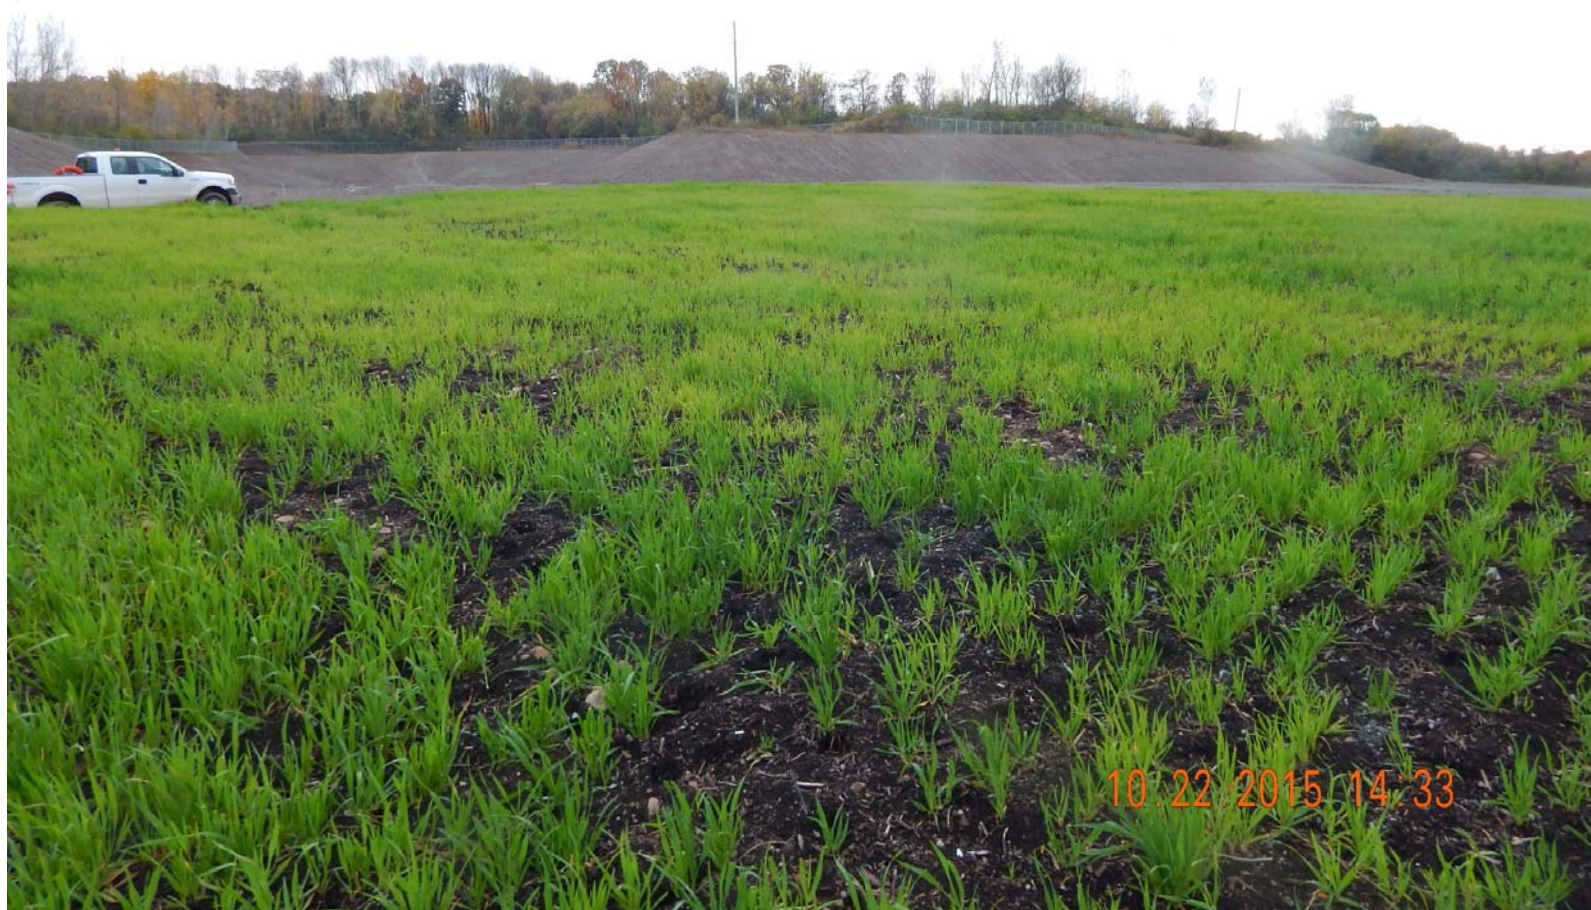
Photo 15. View of Test Plot #2 showing vegetative cover type #1 (80% borrow material, 10% sand, 10% topsoil) in the foreground on October 22, 2015.

Observations showed that most growth appeared in narrow and evenly spaced rows (see photographs 15 to 17). This appears consistent with the area having been tracked as intended and seed settling into the track depressions. Another possibility is that seed to ground contact was better in these depressions, allowing for increased germination (seed to ground contact is critical for achieving successful establishment). Compared to a more uniform growth pattern, tracking likely reduced the overall percent cover somewhat by concentrating growth into narrow bands. If the full scale project is implemented at the SCA and a more uniform vegetative cover is desired, then alternative methods for installing seed, such as a drill seeder, should be explored.

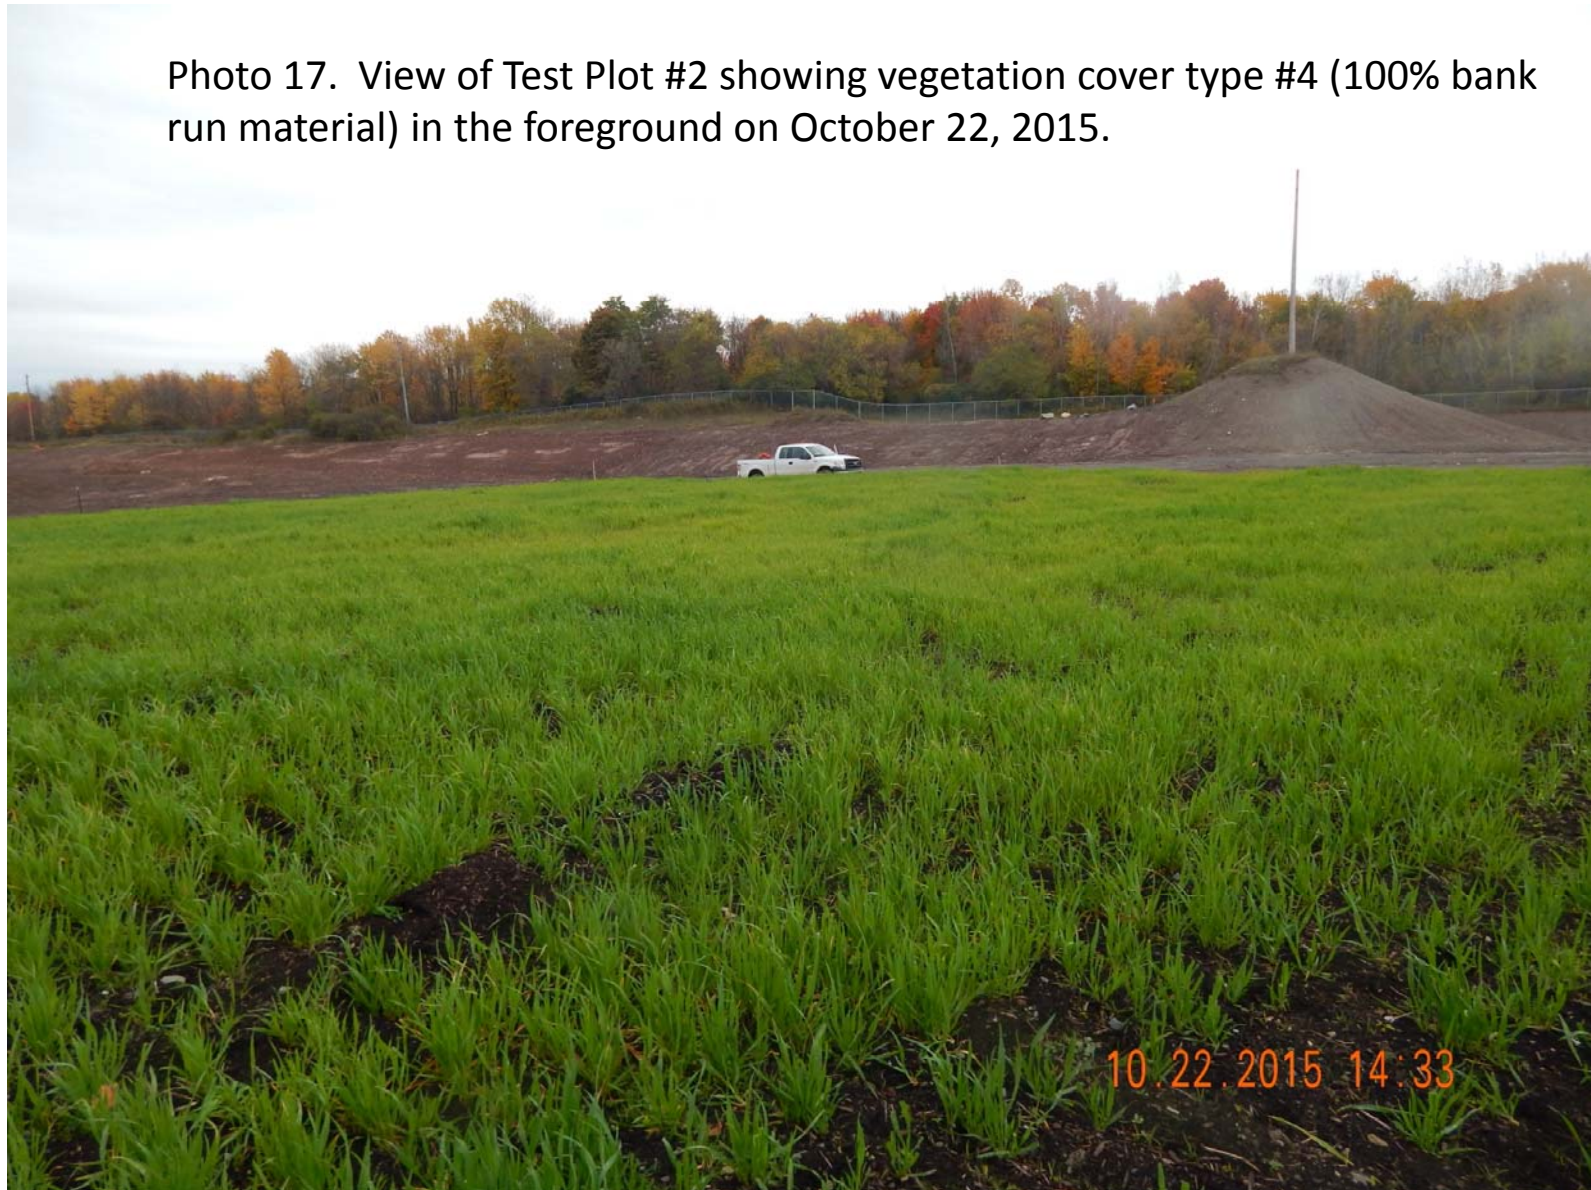
Photo 17. View of Test Plot #2 showing vegetation cover type #4 (100% bank run material) in the foreground on October 22, 2015.

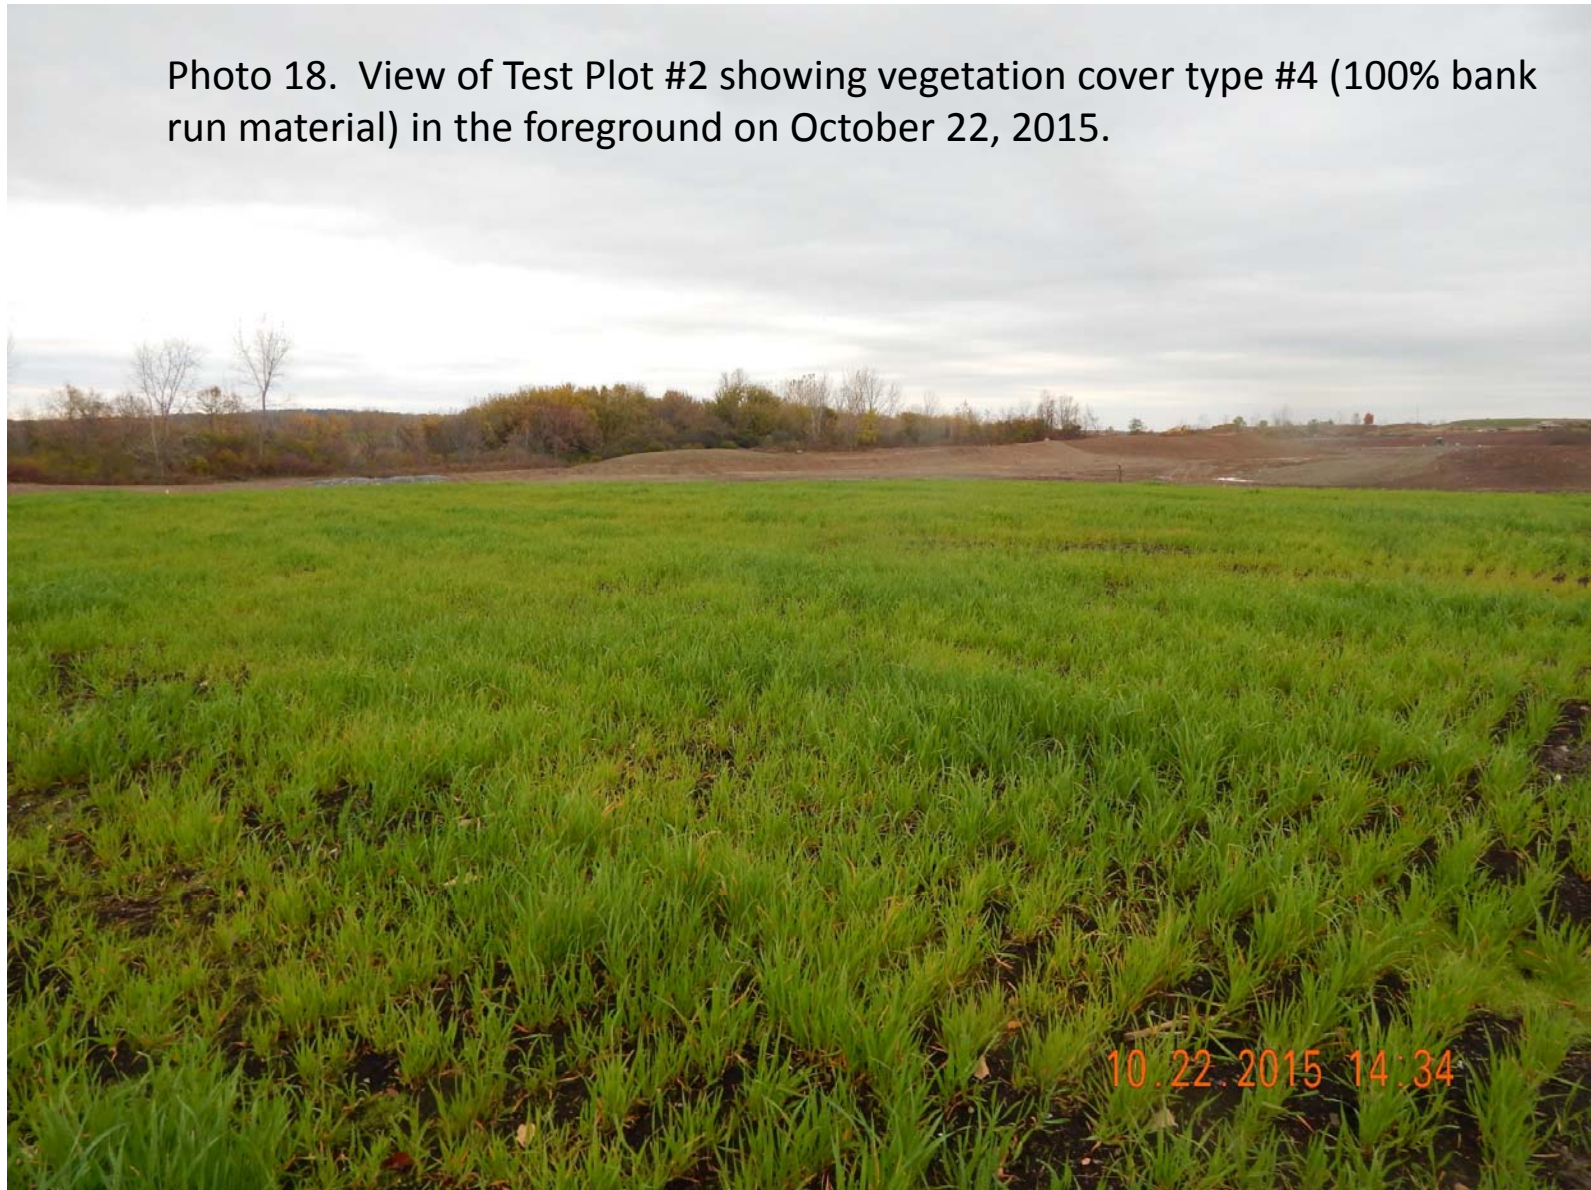
Photo 18. View of Test Plot #2 showing vegetation cover type #4 (100% bank run material) in the foreground on October 22, 2015.

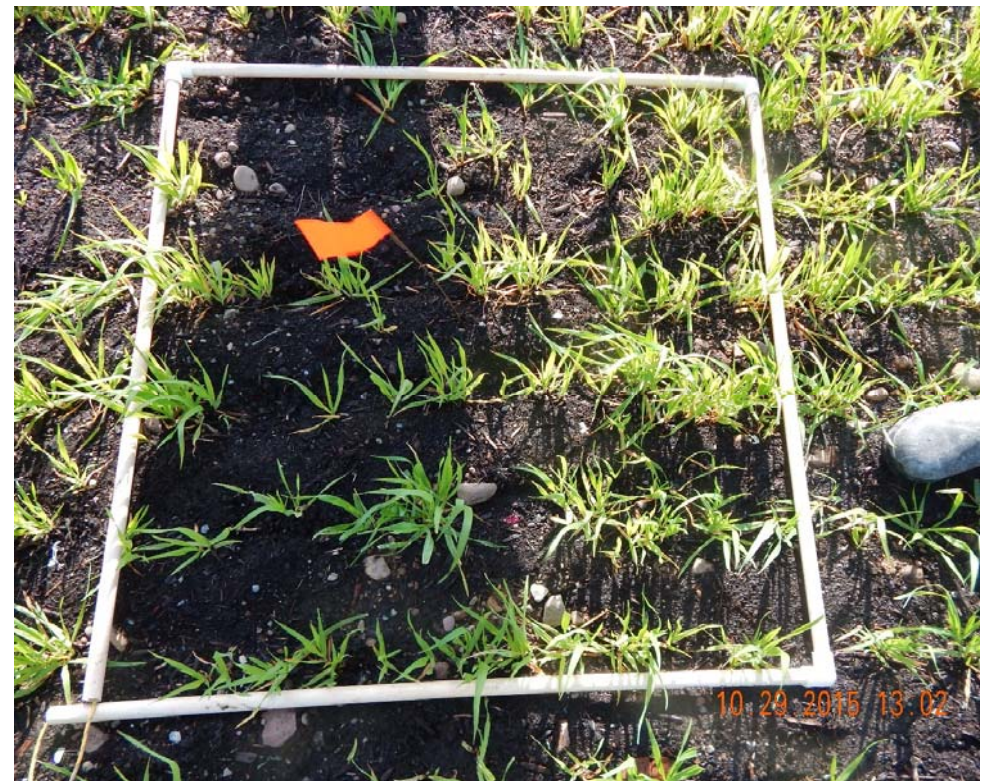
Type 1 (80% borrow material, 10% sand, 10% topsoil)  
Representative photographs

Photo 19 & Photo 20. Photographs of monitoring plot locations taken during final plot monitoring on October 29, 2015.

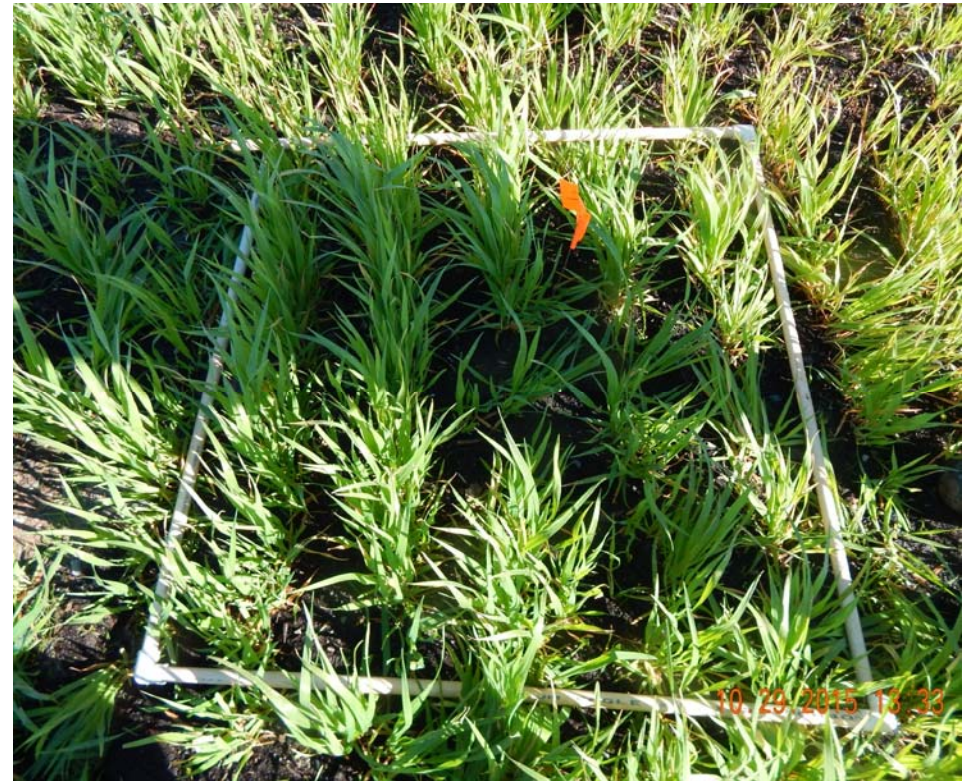
## Type 3 (60% borrow material, 30% sand, 10% topsoil) Representative photographs

Photo 23 & Photo 24. Photographs of monitoring plot locations taken during final plot monitoring on October 29, 2015.

Throughout the monitoring period, the growth in the vegetative cover on Type #3 and #4 areas appeared denser and more robust than the other plots. This was substantiated by the quantitative sampling with the Type #3 material (60% borrow, 30% sand, 10% topsoil) having significantly more growth ( $p < 0.05$ ) than any of the other material types with an average of 74% cover (range of other plots was 34% to 60%) (see Table 3). The Type #4 material (100% bank run) also appeared to perform relatively well with an average of 60% cover, which was significantly more ( $p < 0.05$ ) than the Type #1 or #2 materials.
