## A-10

### Vegetative Cover Layer Design Package

Client: Honeywell Project: Onondaga Lake SCA Final Cover Design Project/Proposal #: GD5497

#### VEGETATIVE COVER LAYER

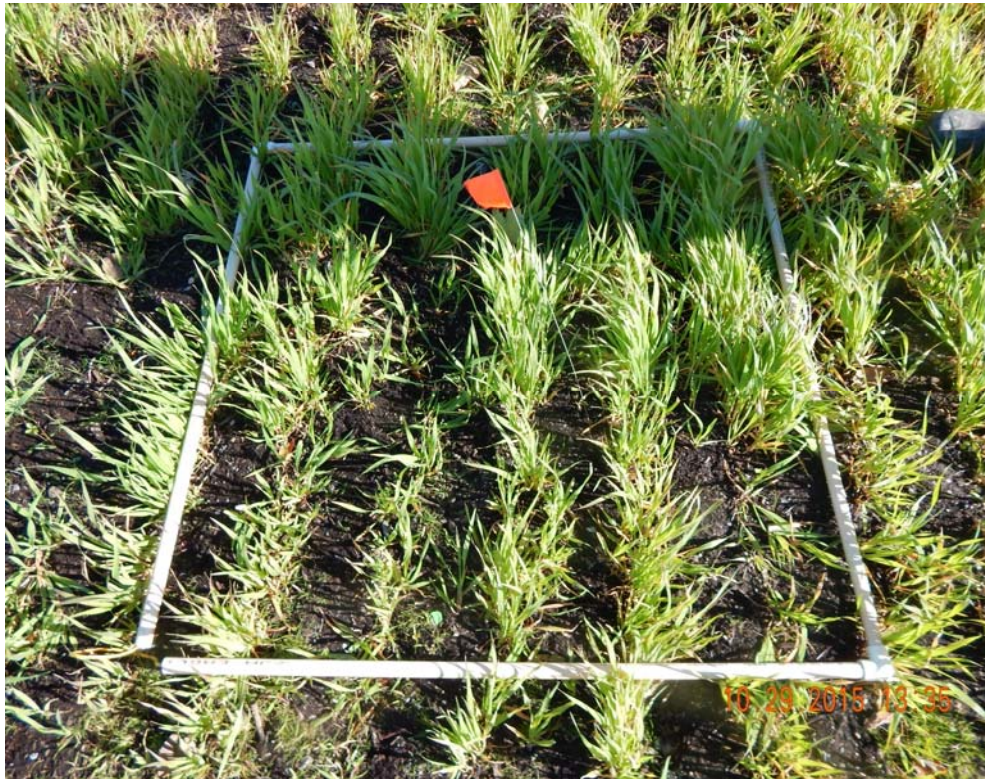
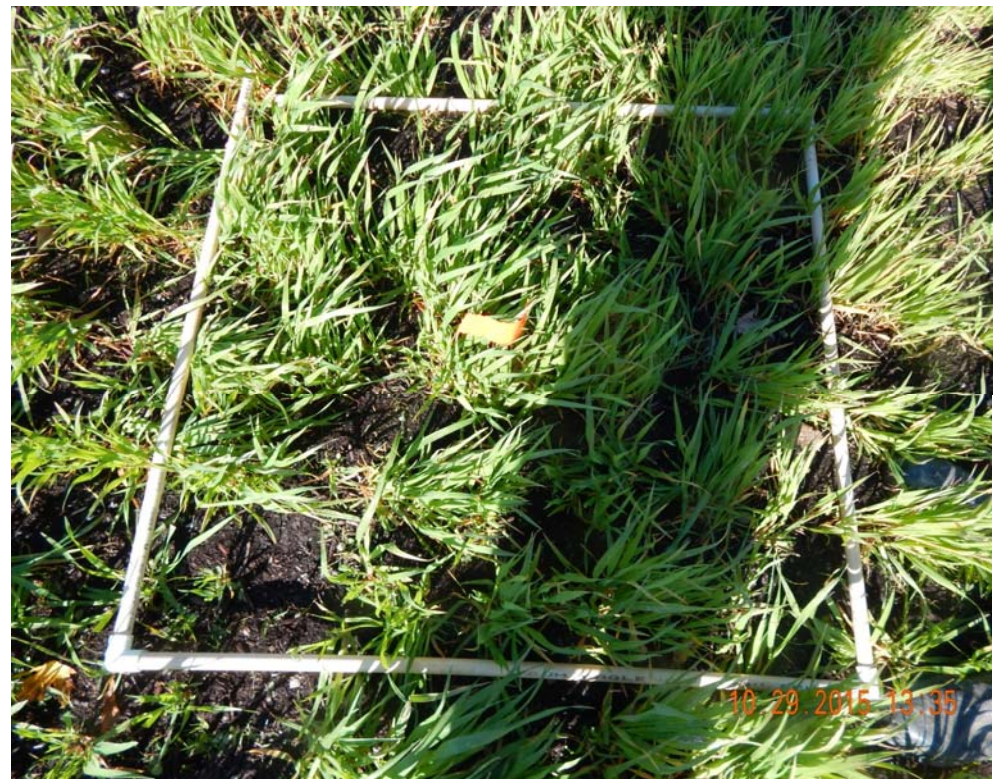
Type 4 (100% bank run material)  
Representative photographs

Photo 25 & Photo 26. Photographs of monitoring plot locations taken during final plot monitoring on October 29, 2015.
