# ONONDAGA LAKE SEDIMENT MANAGEMENT UNIT 8 MICROBEAD MARKER PLACEMENT REPORT

**Honeywell**

**PARSONS**

**OCTOBER 2014**

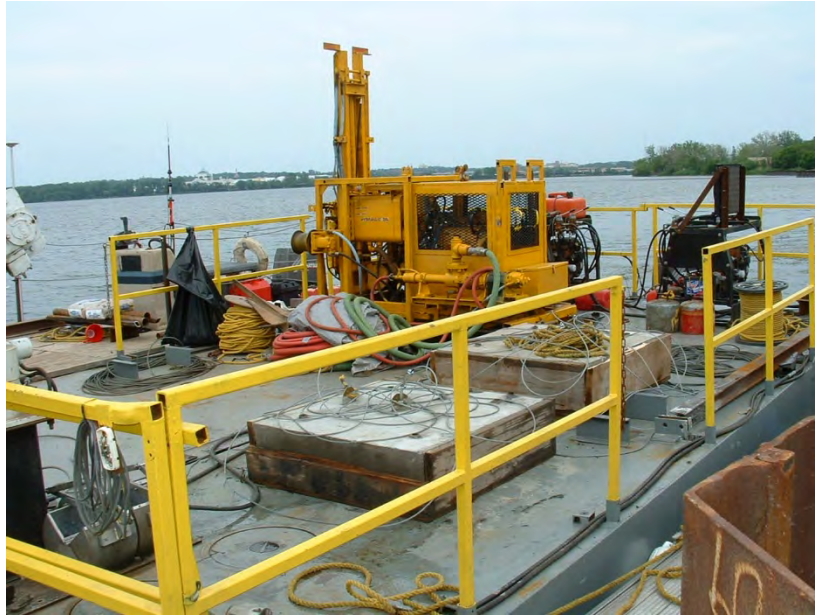
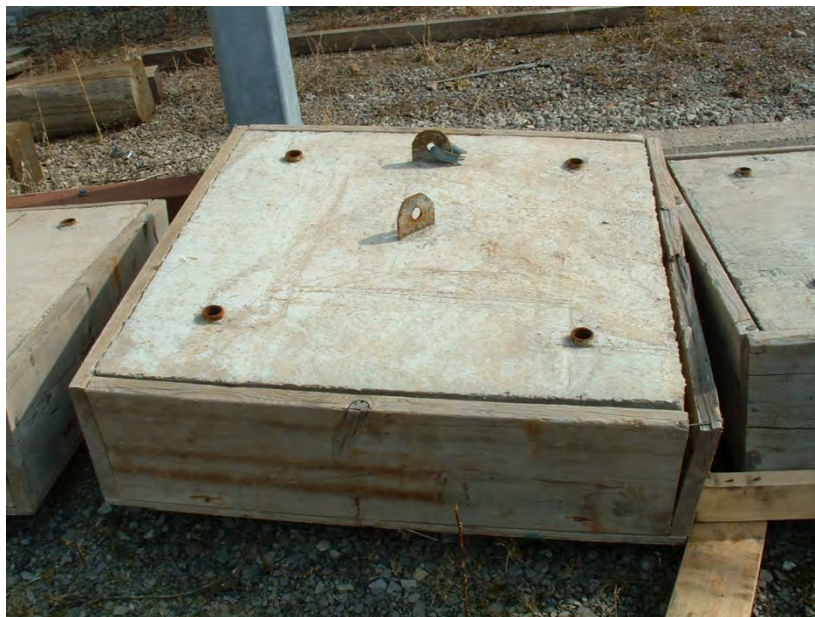
Barge was positioned using four concrete block anchors that were placed at 45 degree angles from each corner of the plot area and approximately 300 ft. from the center of the plot.

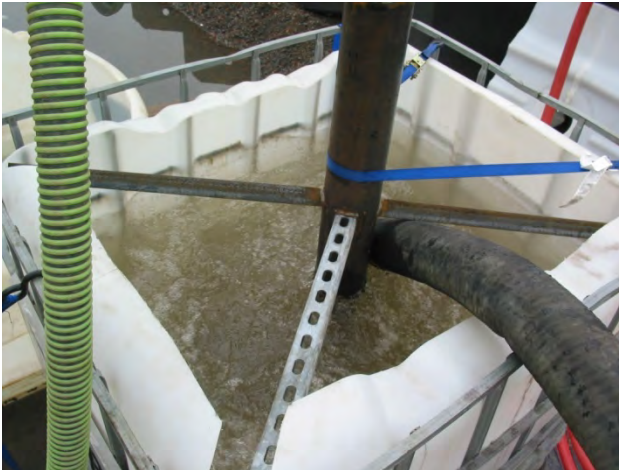
Silt Marker A slurry:

Microbead material and native sediments from SMU 8 were slurried.

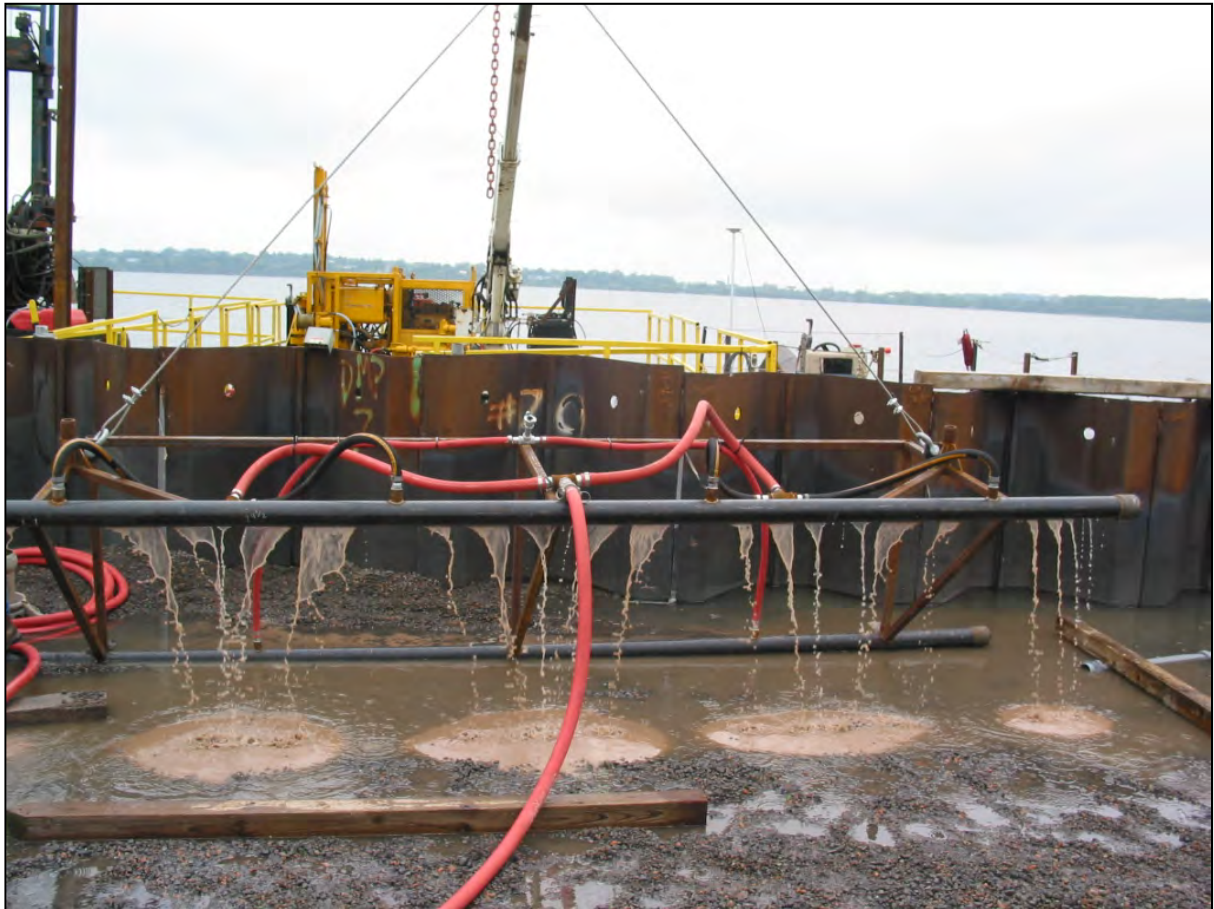
Microbead material was pumped to two horizontal dosing bars.

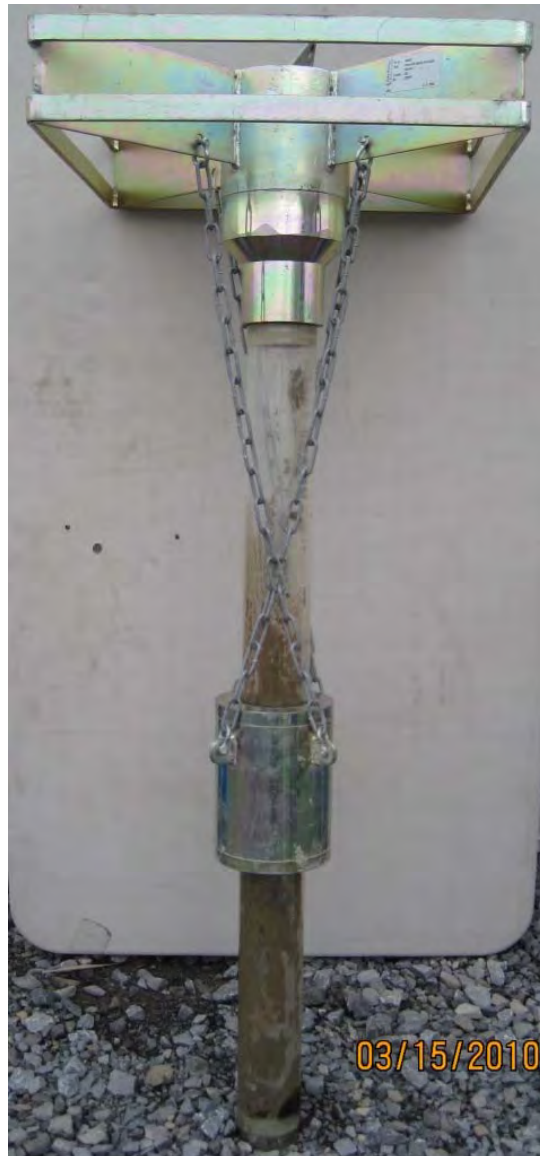
SMU 8 sediments were sampled with a gravity corer.

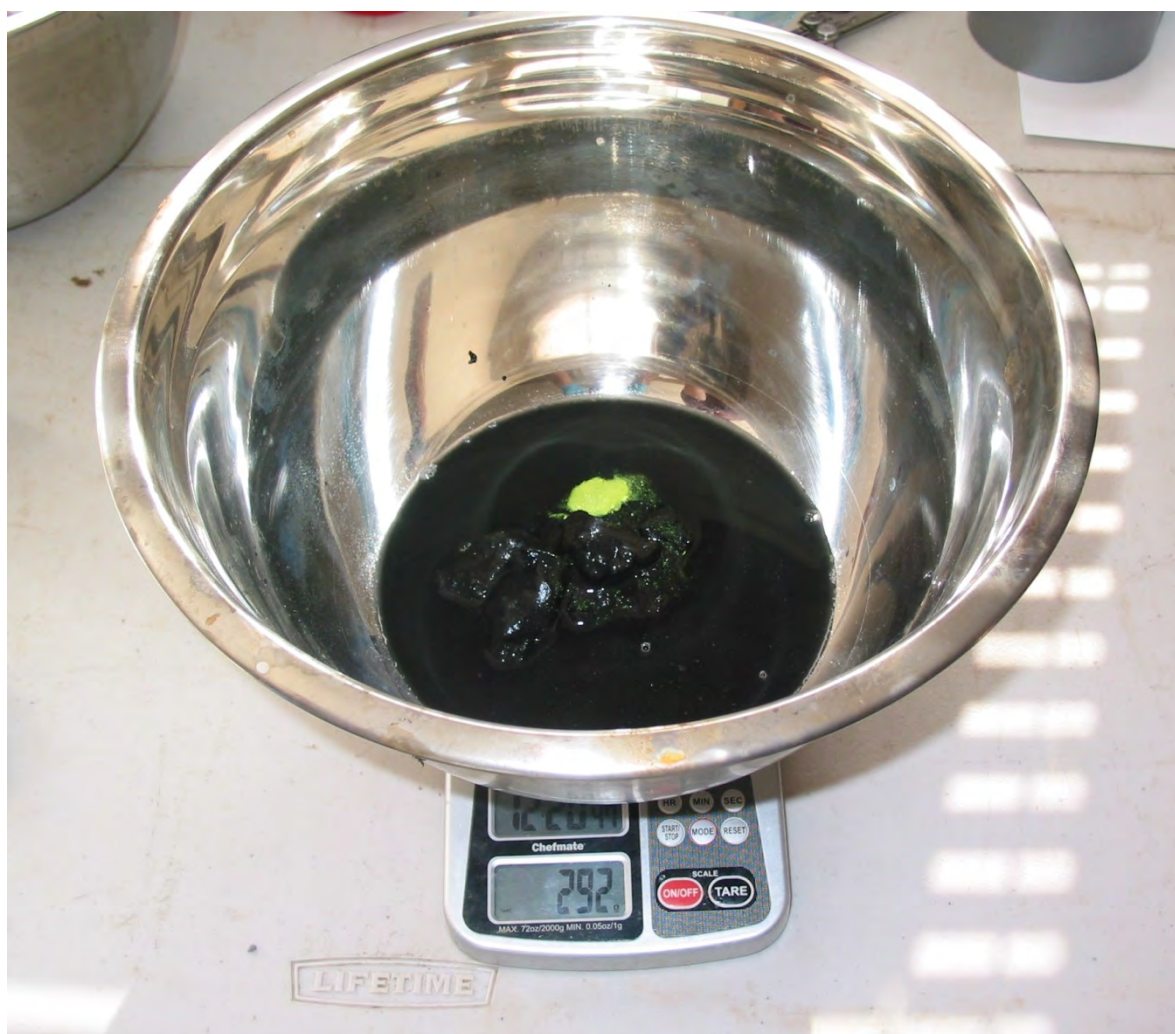
#### Step 1:

Marker material was mixed with SMU 8 sediment

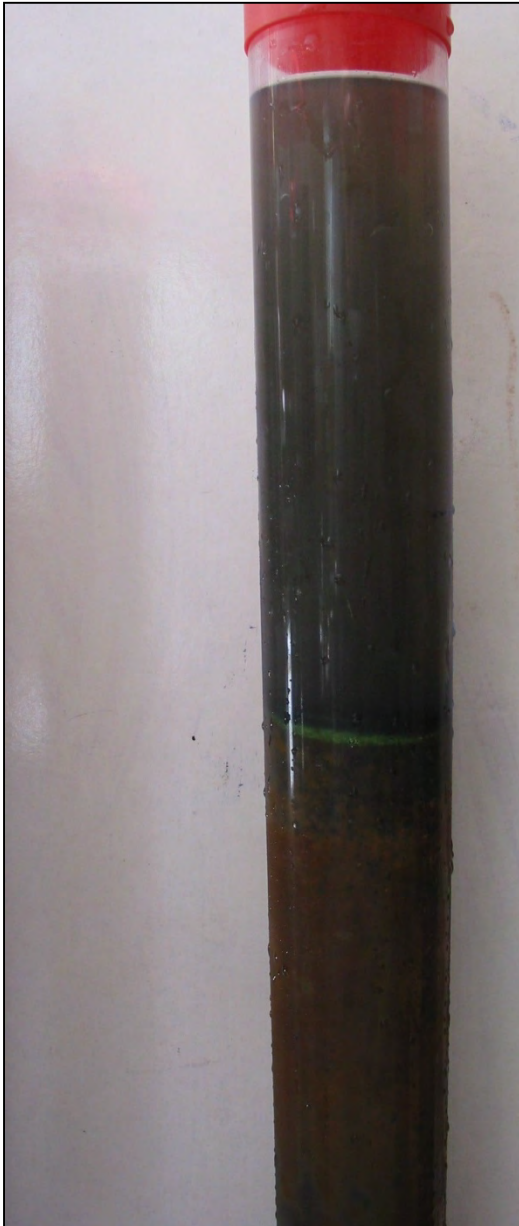
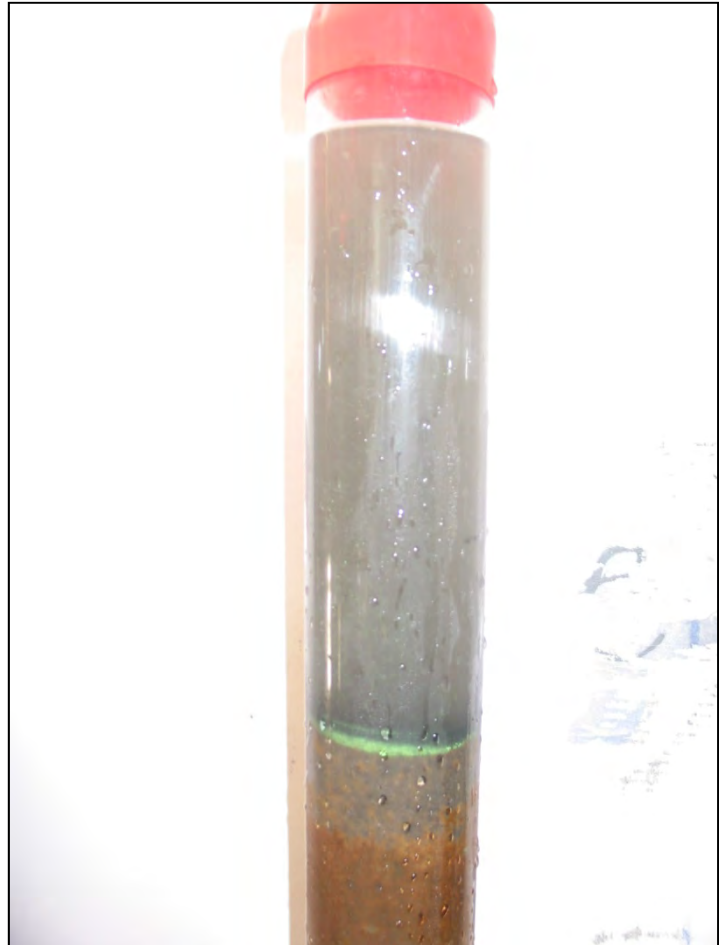
**Step 2:**

Mixed material was placed in 20 core tubes and allowed to settle.

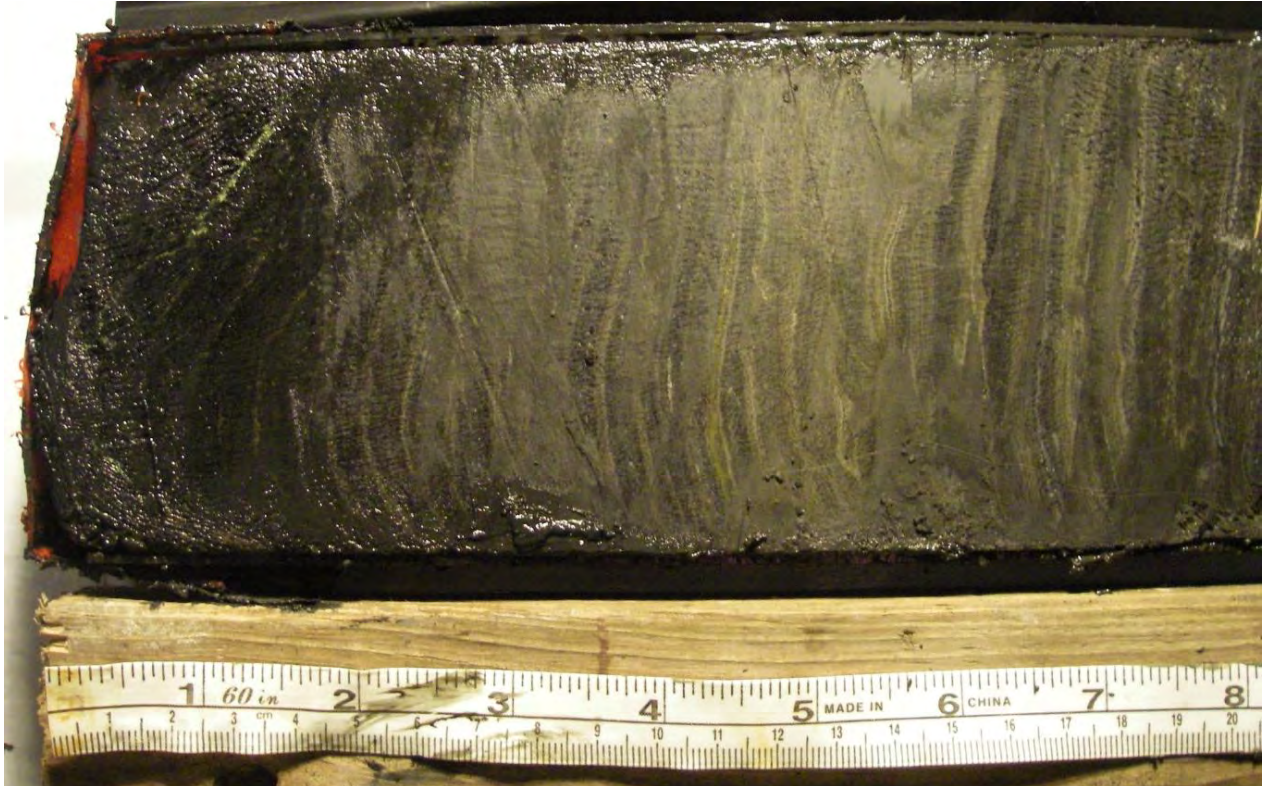
Visual inspection of Core #1 from OL-MB-80095 (see photo on page 4) indicated laminations beginning at 0.5 cm from the top of the core. The core was dark brown to tan in color. The detailed descriptions of the laminations present are as follows:

- Dark brown sediment at surface to the depth of the green microbead marker (0.5 cm)
- Gray/tan bands (1 mm thick) observed every 0.5 cm from a depth of 1 cm to a depth of 2 cm
- Bands (1 mm thick) observed every 1 cm from a depth of 2 cm to a depth of 4 cm
- Tan band (2 to 3 mm thick) observed at a depth of 5 cm
- Tan band (1 to 2 mm thick) observed at a depth of 6 cm
- Tan band (1 to 2 mm thick) observed at a depth of 7 cm
- Tan bands (2 mm thick) observed every 0.5 cm from a depth of 7.5 cm to a depth of 10.5 cm

- Greenish-brown band observed at a depth of 11 cm
- Tan bands (3 mm thick) observed every 0.5 cm from a depth of 11 cm to a depth of 14 cm
- Alternating bands of dark brown (0.5 cm thick) to tan (0.5 thick) from 14 cm depth to 19 cm depth

**Core #1 from Microbead Plot OL-MB-80095 – Vertical Cross Section Showing Presence of Banding after Thawing**

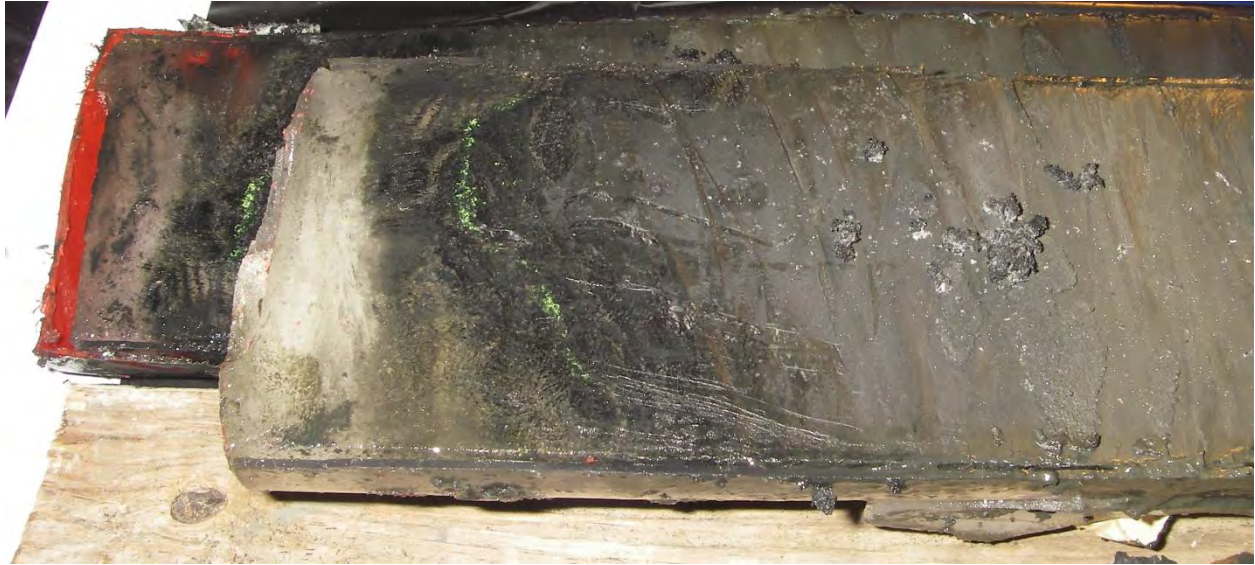
there was no evidence of mixing (see photo below). Observations of banding were not recorded for this second core collected from microbead plot OL-MB-80095.

**Core #2 from Microbead Plot OL-MB-80095 – Vertical Cross Section Showing Presence of Microbead Marker**

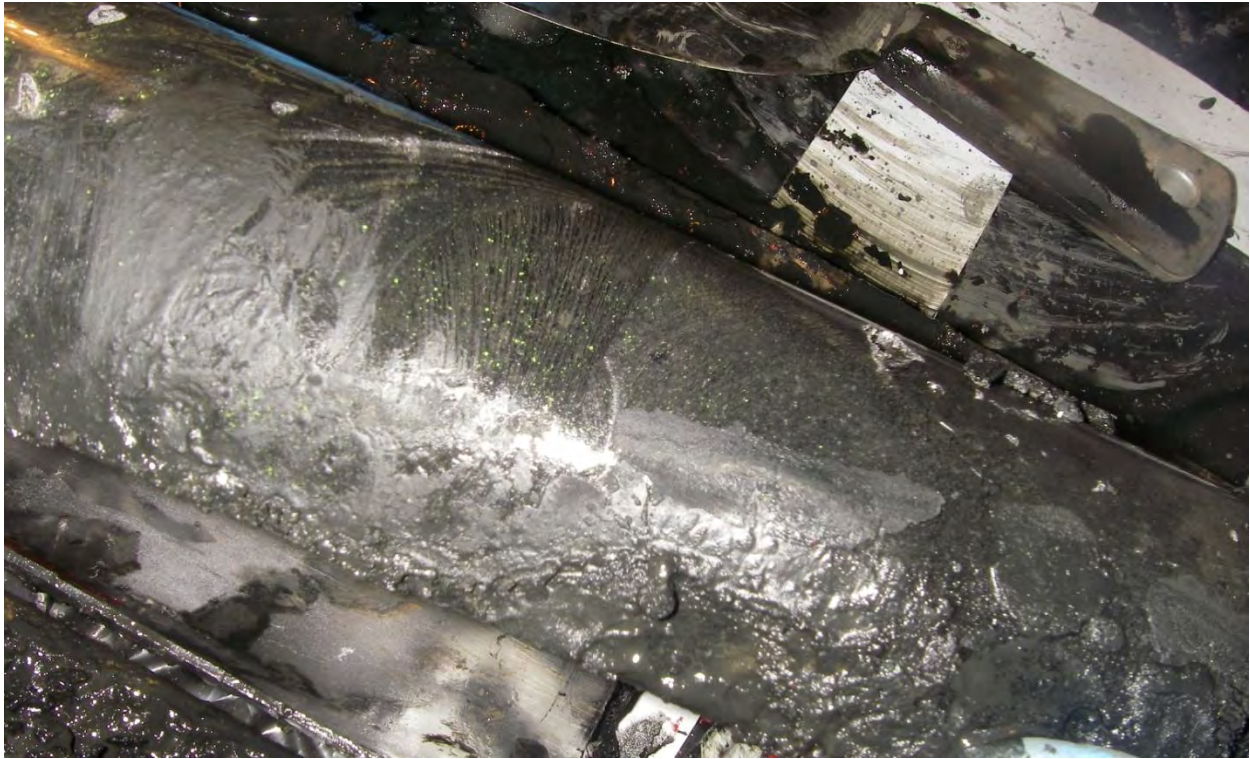
Prior to slicing the frozen core, green sand marker material was observed through the lexan core tube along the sides of the core throughout the core length, as shown in the photo on page 6. However, the microbead marker material was not observed in the vertical cross section. It is likely that the core was collected on the edge of the microbead plot.

**Core #1 from Microbead Plot OL-MB-80099 – Outside of the Core Showing Presence of Microbead Marker**

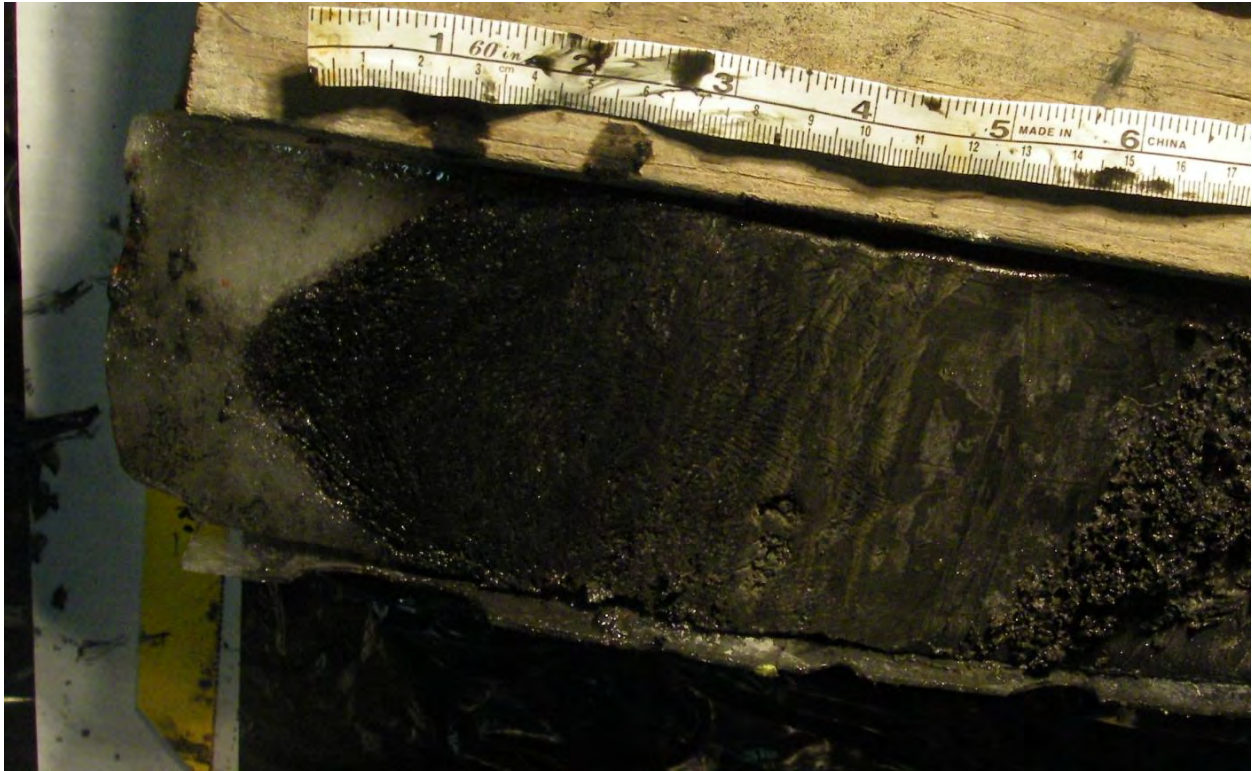
**Figure 6**

Visual inspection of the vertical cross section of the core indicated banding starting at a depth of 2 cm. The core was black to gray in color. Descriptions of the varves/layers present are as follows (see photo on page 7:

- Black sediment at surface to a depth 2 cm, where a 2 mm thick gray band was observed
  - Gray band (3 mm thick) observed at a depth of 3 cm
  - Gray band (2 mm thick) observed at a depth of 4.5 cm
  - Gray band (3 mm thick) observed at a depth of 5.5 cm
  - Gray band (3 mm thick) observed at a depth of 6.5 cm
  - Gray band (4 to 5 mm thick) observed at a depth of 7 cm
  - Gray band (4 to 5 mm thick) observed at a depth of 7.5 cm
  - Gray band (3 to 4 mm thick) observed at a depth of 8.5 cm
  - Gray band (3 to 4 mm thick) observed at a depth of 9.5 cm
-

**Core #1 from Microbead Plot OL-MB-80099 – Vertical Cross Section Showing Presence of Banding**
