Re: Documentation of Anomaly 13 (A13), Subsite of the Onondaga Lake Superfund Site
Onondaga County, New York, Dated November 2016

**Documentation
of Anomaly 13 (A13),
Subsite of the Onondaga Lake Superfund Site,
Onondaga County, New York**

**Phase 3 Underwater Archaeological
Documentation of Anomaly 13 (A13),
Subsite of the Onondaga Lake Superfund Site,
Onondaga County, New York**

November, 2016

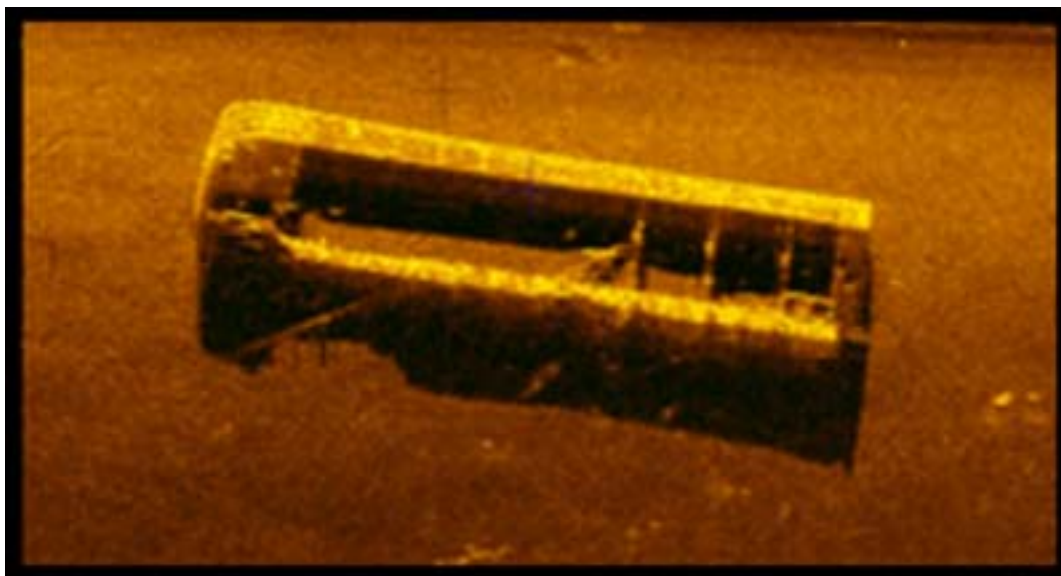
Figure 4: Sonar image from 2005 showing Anomaly 13 (courtesy CRE)

Historic damage, while significant, is limited to the port side and the above deck structures of the cargo hold and stern. On the forward half of the port side a large section of hull planking is missing or severely damaged. This is also true of the above deck structures like the cargo hatch coaming and the cabin trunk which are also believed to have been damaged historically. These missing structures and the damage to the port side are visible in the side scan sonar image captured in 2005 well before the commencement of remedial actions.

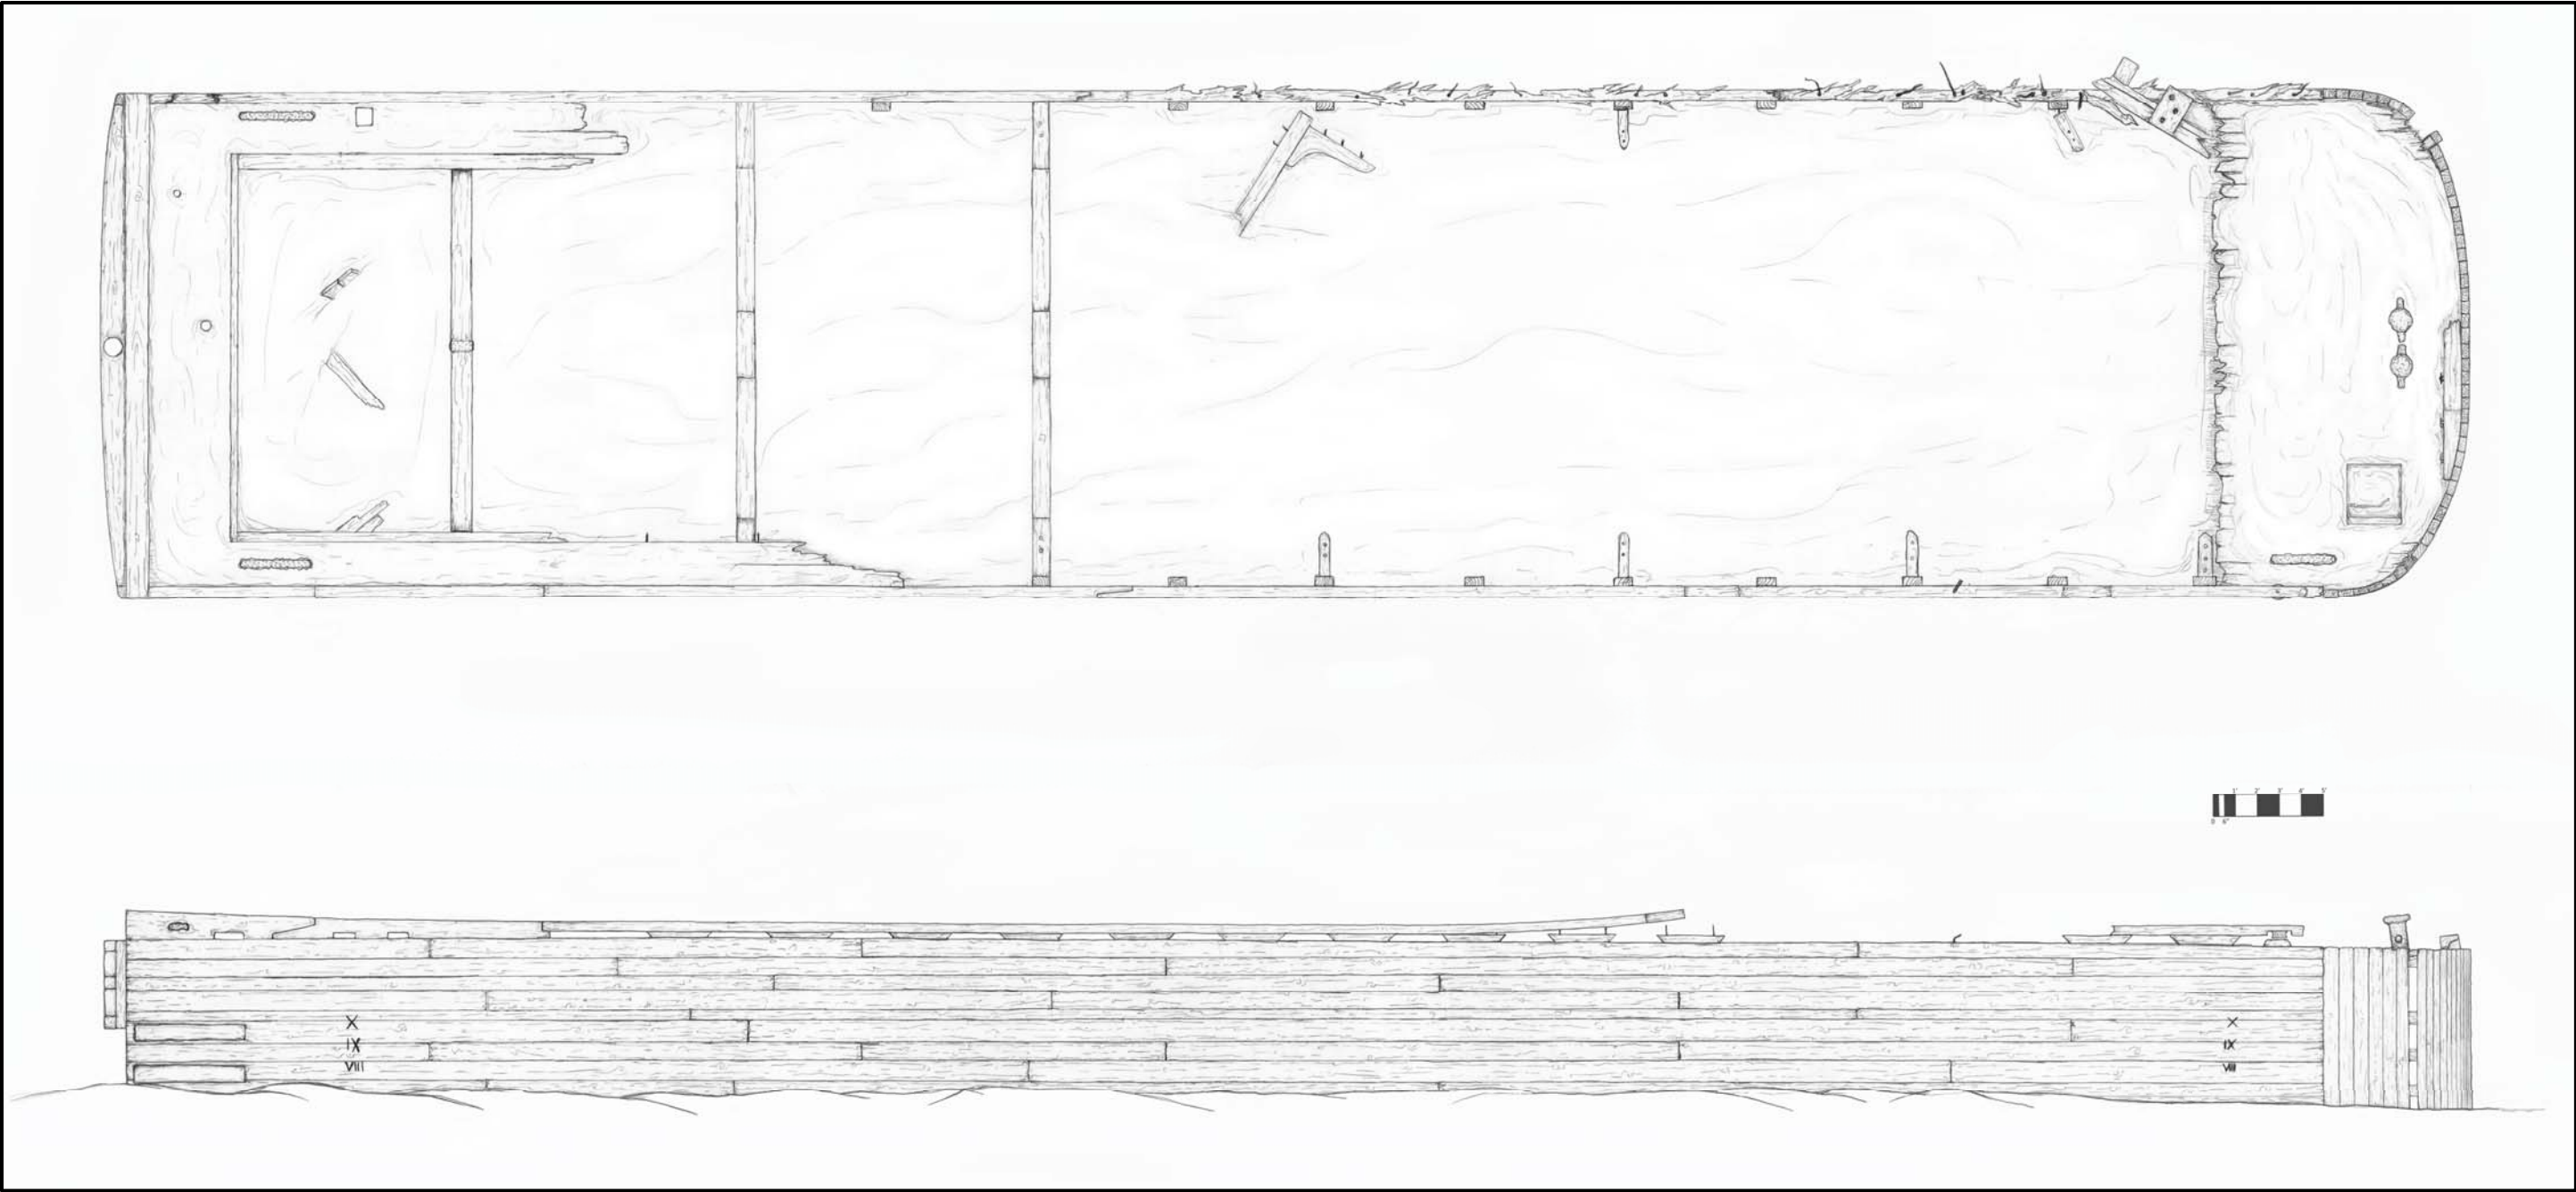
Figure 16: A13 Site plan, Plan and Profile Views (Christopher R. Sabick)

Generally speaking, wreck A13 is extremely well preserved. The wood, which makes up the majority of the vessel structure, is still hard and joints between extant timbers are tight. However, the vessel is not completely intact and careful examination of the wreck, and of the various forms of documentation that have been captured of it since it was first discovered in 2005 (video, sides scan sonar, and archaeological documentation were all consulted), demonstrate that the vessel was subjected to both historic impacts and damaged caused by remedial actions that are related to the Superfund cleanup operations.

More recent impacts associated with the remediation activities were mostly caused by a dredge spoil pipe sinking to the lake bottom when full and coming to rest on the wreck. This pipe was often maneuvered with powerful tugboats pulling it across the lake bottom. In doing so this pipe appears to have snagged on, and broken free of, the wreck a large number of times causing a significant amount of damage. Along the port side the historic damage, which produced a lot of lose and jagged timbers, was particularly impacted as many of the loose pieces and protruding bolts were torn free or bent over by the pipe impact (Figure 15).

In the bow it appears that the large chock that is positioned forward of the bollards has also been broken and dislocated by this same activity. It has also been noted that several of the vertical bow planks have been disarticulated, possibly at the same time that the bow chock was impacted. Along the starboard side damage to the cap rail and its associated structures was also inflicted upon A13 in recent years. As can be seen on the site plan a portion of the starboard cap rail is missing all together while another section has been pulled up from the deck and is left protruding into the water column.

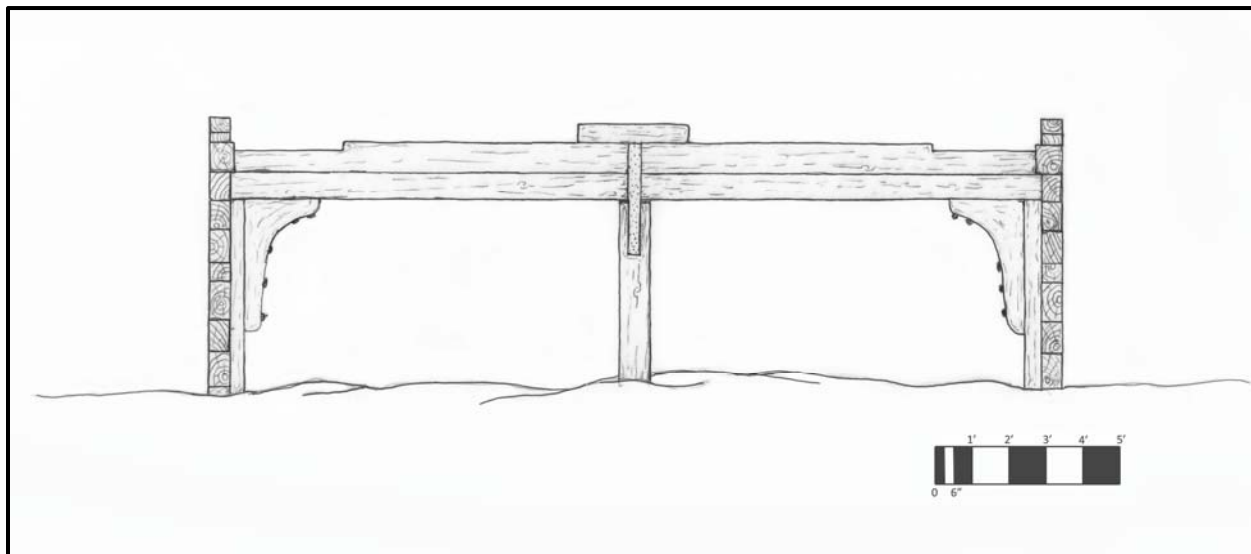
Figure 22: A13 Cross Section taken at 42 feet on the main baseline (Christopher R. Sabick)

The sides of the canal boat A13 were connected by a series of deckbeams that stretched across the hold at regular intervals along its length (Figure 22). Only a three of these decks beams are entirely extant but they give us a good indication of how these structures were arranged. The deck beams themselves are composed of two horizontal timbers stacked vertically. They are supported on either end by substantial hanging knees and amidships by a sturdy stanchion. In most cases this stanchion was attached to the deckbeam by an iron strap that ran up and over the top of the deck beam timbers and back down to the reverse side of the stanchion. The horizontal deck beam timbers are 10 inches (25.4cm) sided by 10 inches (25.4cm) molded and 10 inches (25.4cm) sided by 8 inches (20.3cm) molded. The stanchion measures 10 inches (25.4cm) molded and 10 inches (25.4cm) sided. The metal strap that binds the deckbeams and stanchions together is 3 inches (7.6cm) wide, ½ inch (1.3cm) thick, and extends along the stanchion for 18

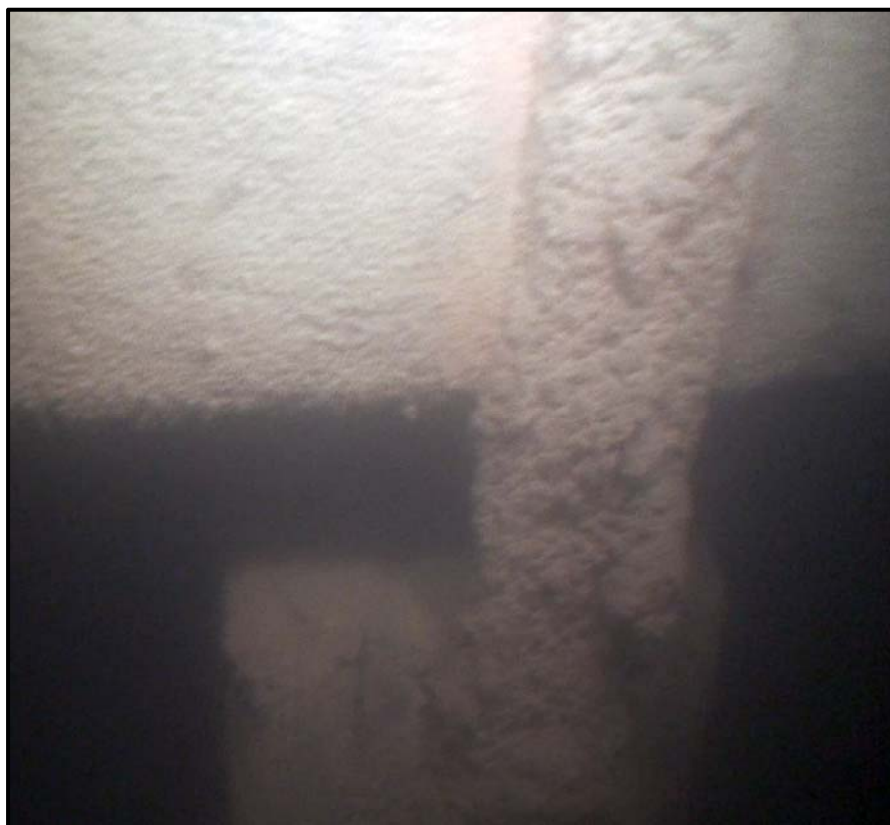
inches (45.7cm) (Figure 23). The knees that supported deck beams at either end have an upper arm that is 24 inches (61cm) long and a lower arm that is 44 inches (1.1m) long. The timbers range from 4-14 inches (10.1-35.6cm) molded and are 6 inches (15.2cm) sided. The knees were fastened to the deckbeams, wale and side planking by a number of large iron bolts.

Figure 23: Iron strap attaching the stanchion to the deck beam (LCMM Collection)

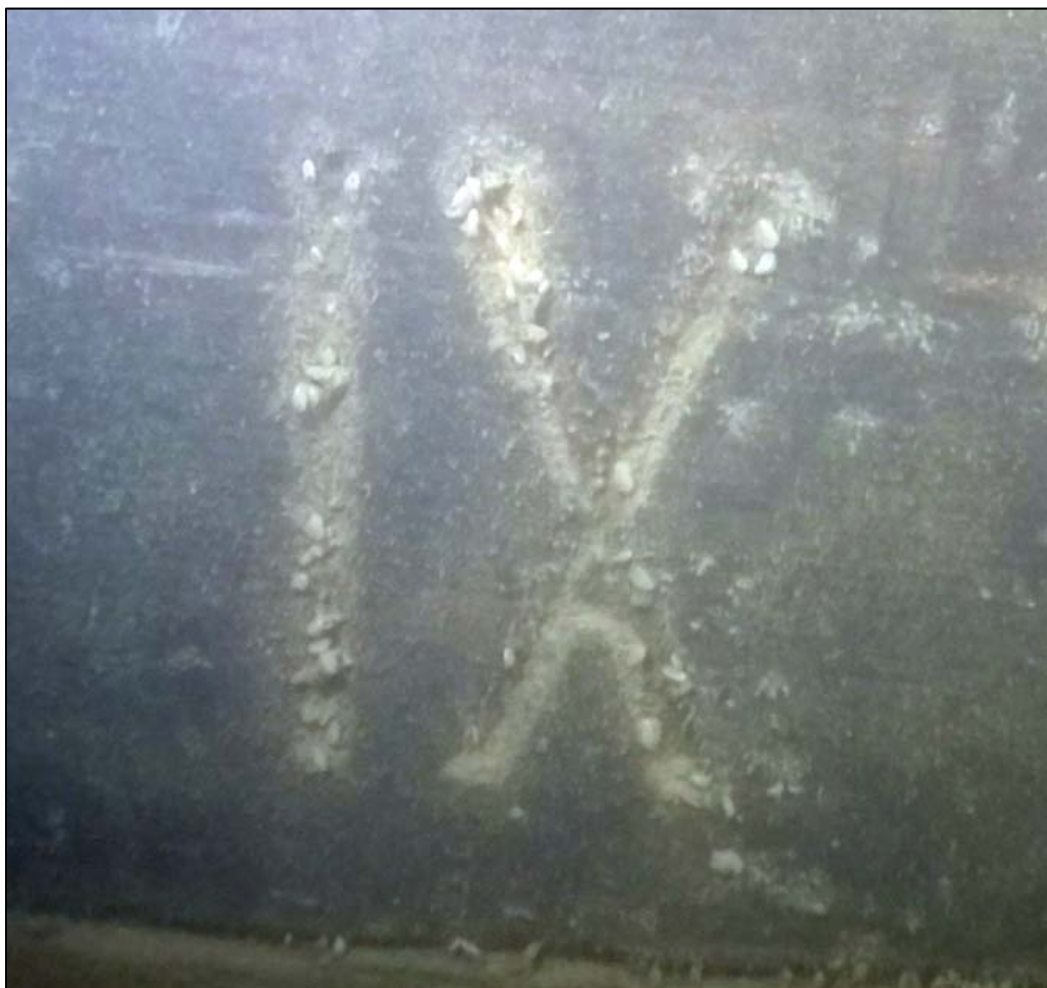
An unexpected discovery that was made during the documentation of A13 was the identification of draught marks on the outer hull planking (Figure 24). The Roman numerals VIII, IX, and X were found carved into the wood on the forward and aft end of the horizontal planking on both sides of the vessel. The presence of these draught marks on each “corner” of the canal boat would have allowed the operators to insure that the vessel was evenly loaded and to know how much water the vessel was drawing with a simple observation.

Figure 24: Draught mark, A13 (LCMM Collection)

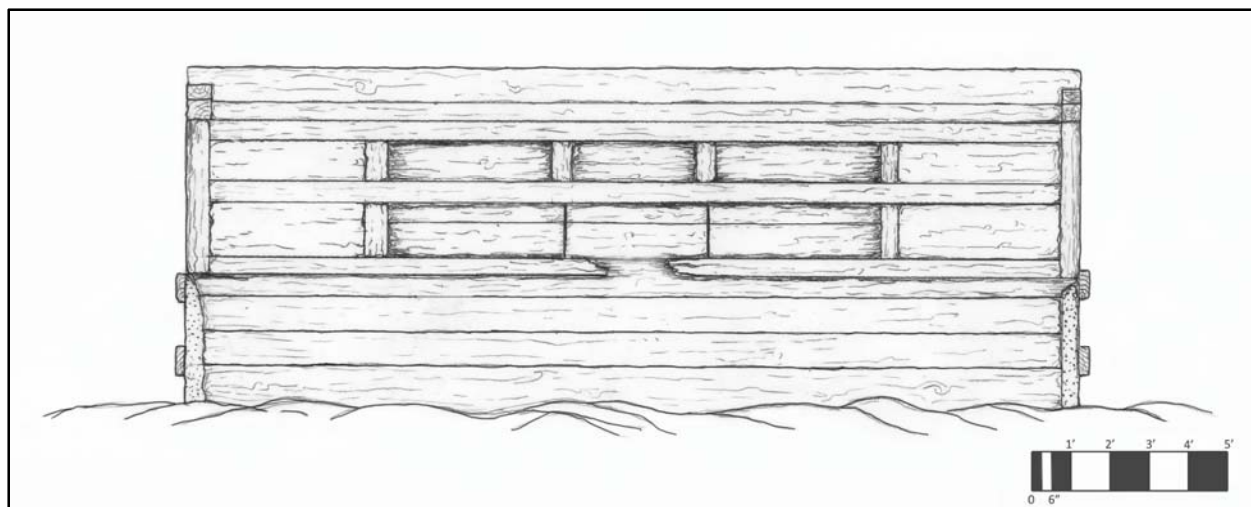
Figure 25: A13 Stern Profile (Christopher R. Sabick)

The top transom timber is 12 inches (30.5cm) wide and 11 inches (28cm) thick. Across the transom are three horizontal bustle timbers that are curved in shape and supported the rudderpost and rudder. The first of these timbers is located 16 inches (40.6cm) below the top of the transom (Figure 25). The others are spaced 16 inches (40.6cm) apart below the first. On their outboard edges these timbers are 4 inches (10.2cm) wide, this swells to 13 inches (33cm) wide amidships before diminishing gradually again on the opposite side. These bustle timbers are 5 inches (12.7cm) thick. The outboard corners of the bustle timbers are protected by a vertical timber that is 4 feet (1.2m) long and 6 inches (15.2cm) wide. The top two transom timbers are pierced by a 9 inch (22.9cm) diameter hole amidships that would have once housed the rudder post (Figure 26). The central portion of the lower transom timber is broken out amidships but presumably also contained this hole for the rudder post when it was intact. No evidence of the rudder or rudder post have been located on site.
