Re: Letter of Transmittal – Onondaga Lake Repository Addition

2015-2016 Source Control Summary for the Onondaga Lake Bottom Subsite May 2017

Re: 2015-2016 Source Control Summary for the Onondaga Lake Bottom Subsite, dated May 2017

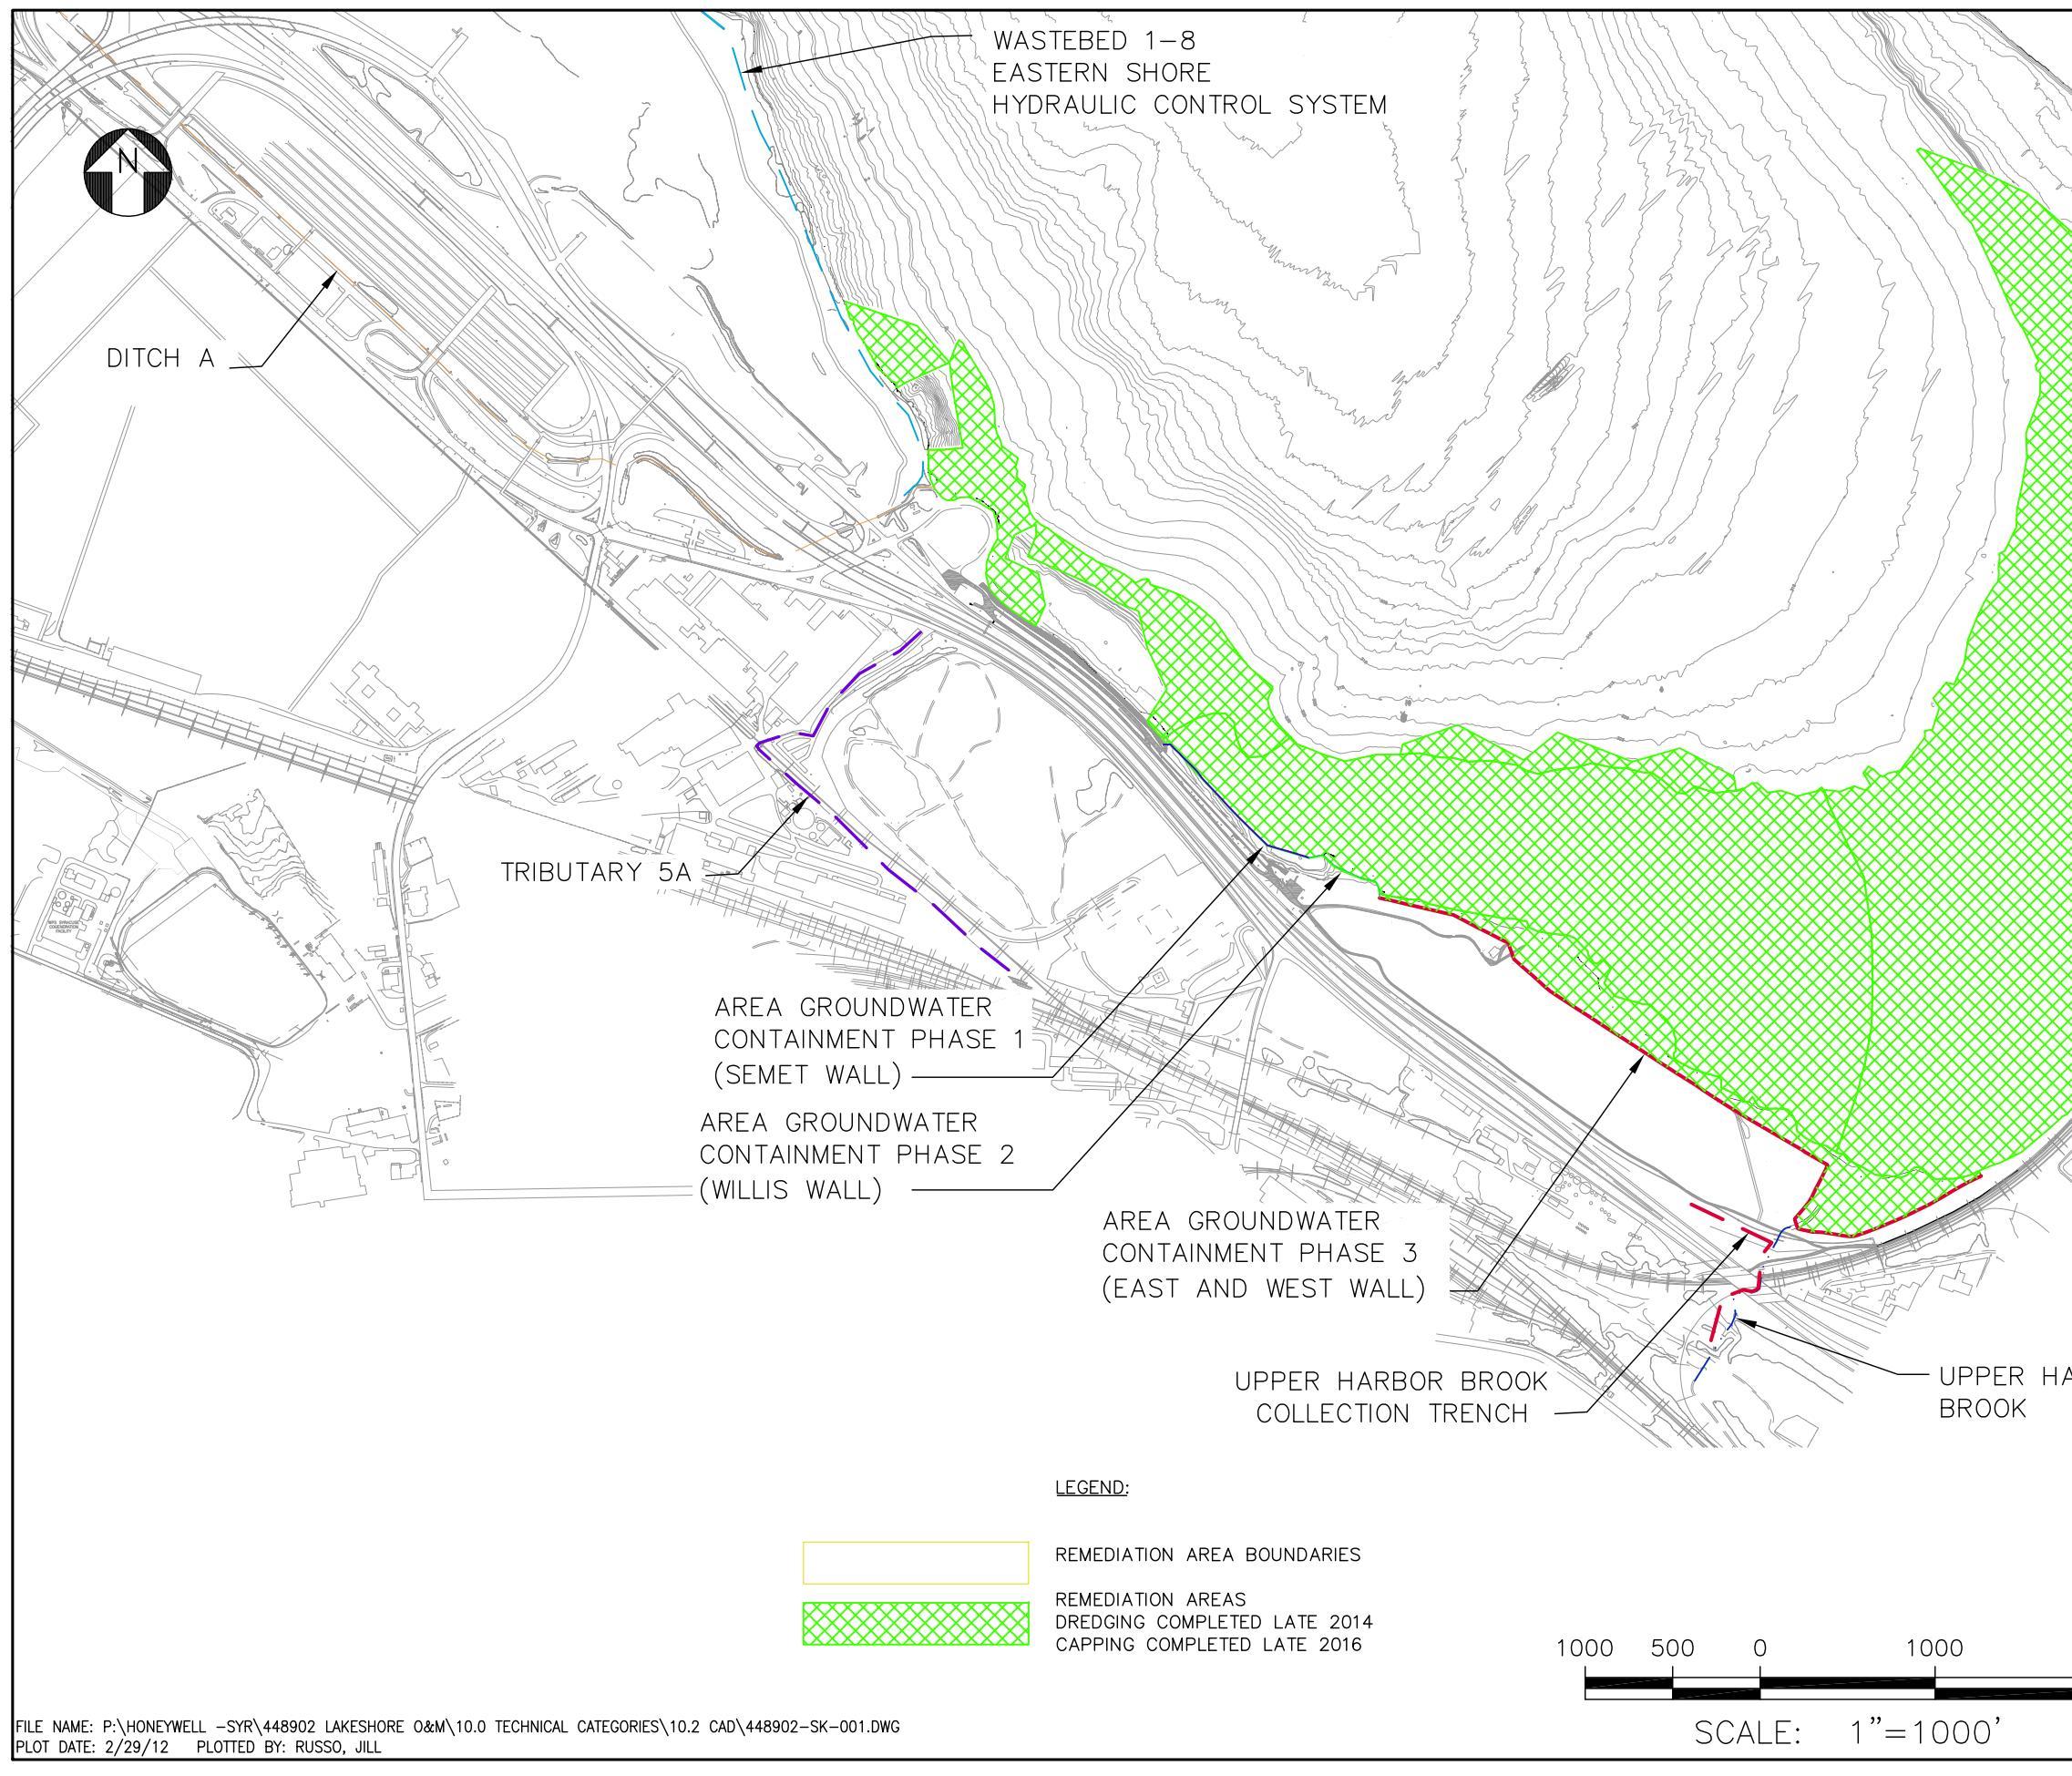
and the second sec	
ARBOR	
	FIGURE 1
	Honeywell Onondaga Lake Syracuse, NY
2000	ONONDAGA LAKE SOUTH-EASTERN REMEDIATION AREAS
	PARSONS 301 PLAINFIELD ROAD * SUITE 350 * SYRACUSE, NY 13212 * 315/451-9560 OFFICES IN PRINCIPAL CITIES

• Main Report, Page 1, Paragraph 2, Sentence 2. The text here as well as Figures 1 and 2 need to be revised to indicate that lake capping was complete in late 2016.

The schedule goal for the lake remediation was to complete dredging to the extent practical in four years (beginning in 2012), and capping in five years (beginning 2012). Dredging was completed in 2014 and lake capping was completed in late 2016. Based on this completion schedule, this report addresses all capping areas, as shown in Figures 1 and 2.

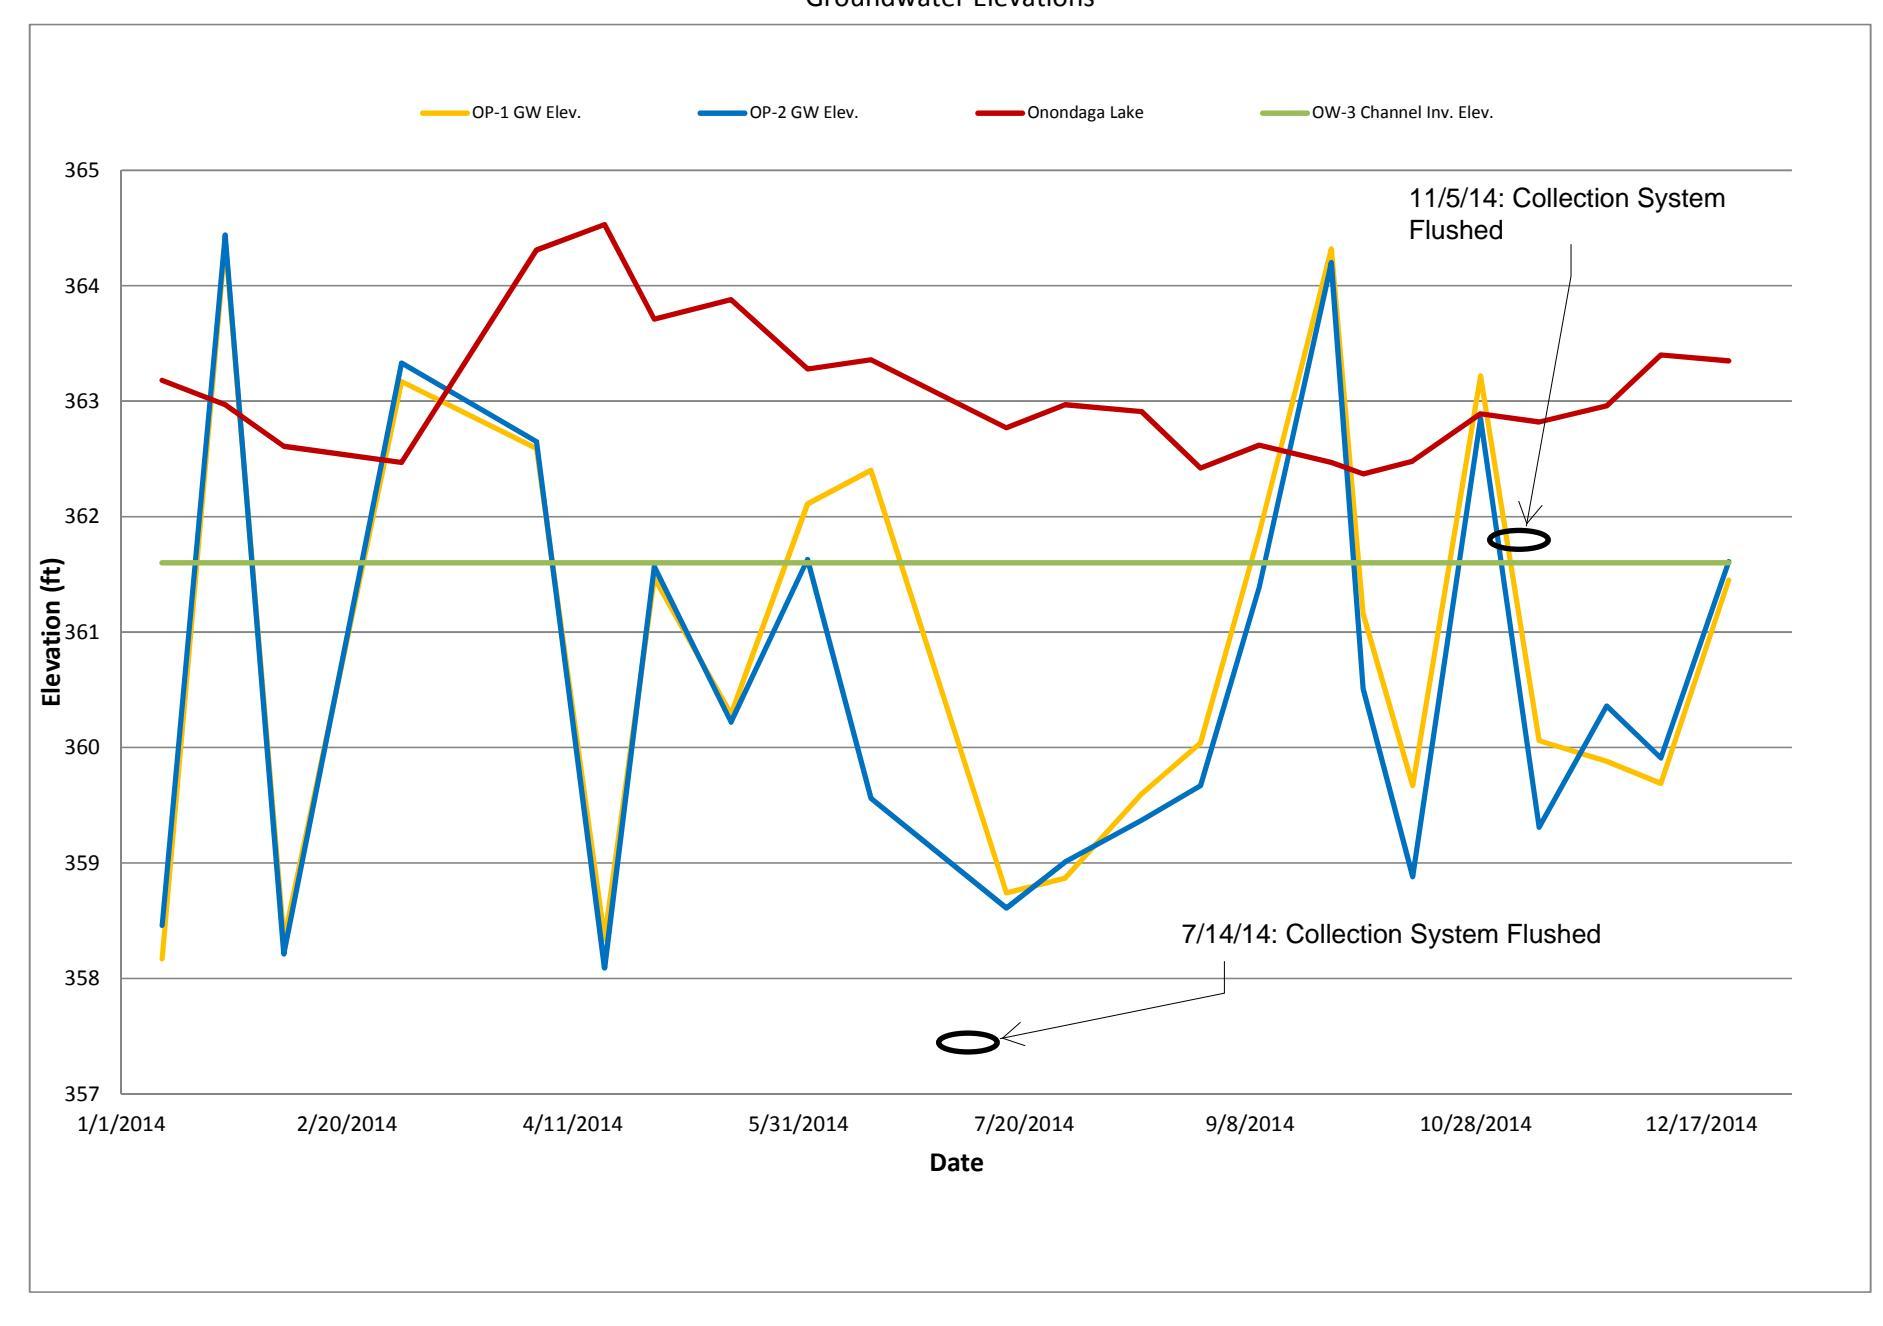
Figure C-3 Harbor Brook-1 2014 Groundwater Elevations

During this monitoring period, the Harbor Brook – 1 and – 2 groundwater collection systems operated as designed and met the performance verification criteria except during five and nine monitoring events, respectively (See **Figures C-3** through **C-8**). Corrective actions performed were successful in achieving the performance criterion in Harbor Brook -1 and -2 collection trenches, which included flushing of collection trench and force main piping, pump maintenance via bulk acid addition to the wet well and pump replacement. The I-690 Drainage Ditch collection system was operational during the monitoring period with only a brief exceedance of the operational goals in February 2016. System flushing was performed, as necessary.
