**Phase 1B Underwater Archaeological Report
for the Onondaga Lake Bottom,
Subsite of the Onondaga Lake Superfund Site,
Onondaga County, New York**

Final Report • October 10, 2011

EXECUTIVE SUMMARY

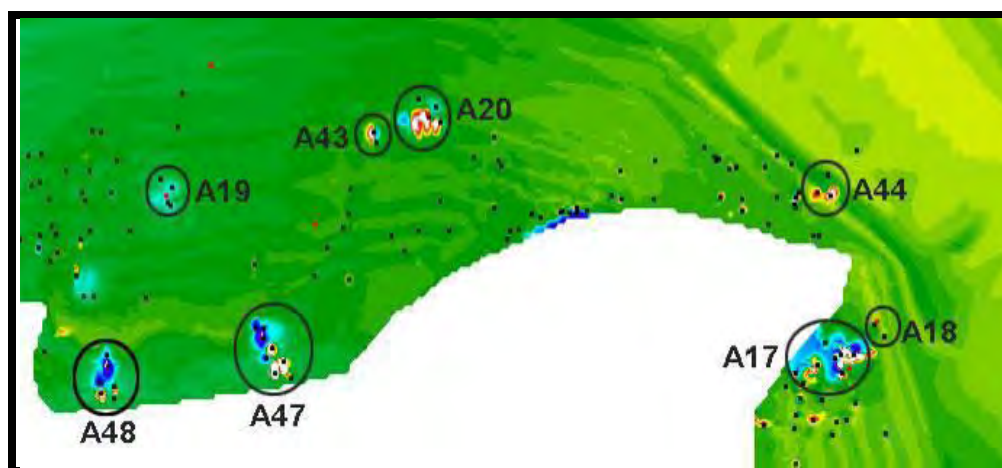
A47 was confirmed visually to be a 12 inch (30.5cm) diameter cast iron pipe running perpendicular to shore. The pipe is likely for draining leachate out of the onshore waste deposit.

Figure 85. Magnetic intensity map of Onondaga Lake showing A47.

LCMM recommends no further work for A47.

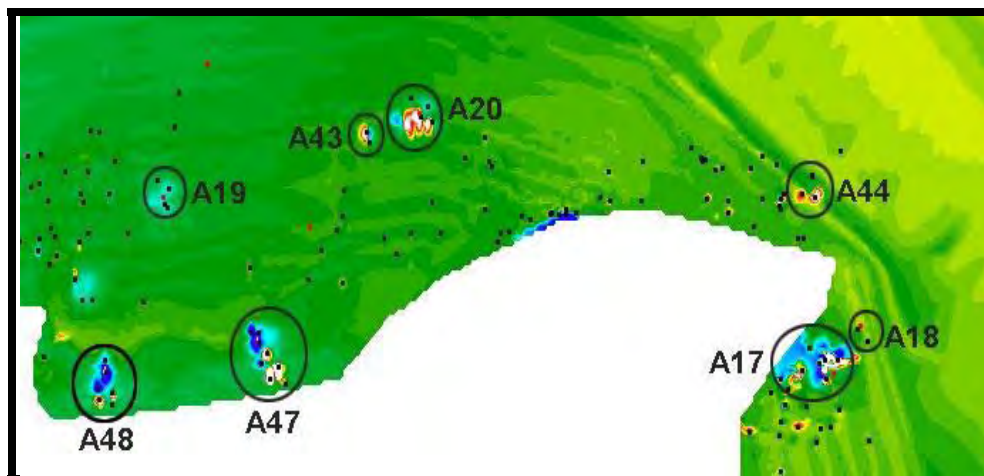
A48 is a linear magnetic anomaly located in 2005 with a signature similar to A47 (Figure 86). The source of the anomaly was searched for using side scan sonar and visually from the survey vessel. The source could not be located, however, A48's proximity and similarity to the pipeline at A47, strongly suggest that A48 is also a buried iron pipeline.

Figure 86. Magnetic intensity map of Onondaga Lake showing A48.

LCMM recommends no further work for A48.

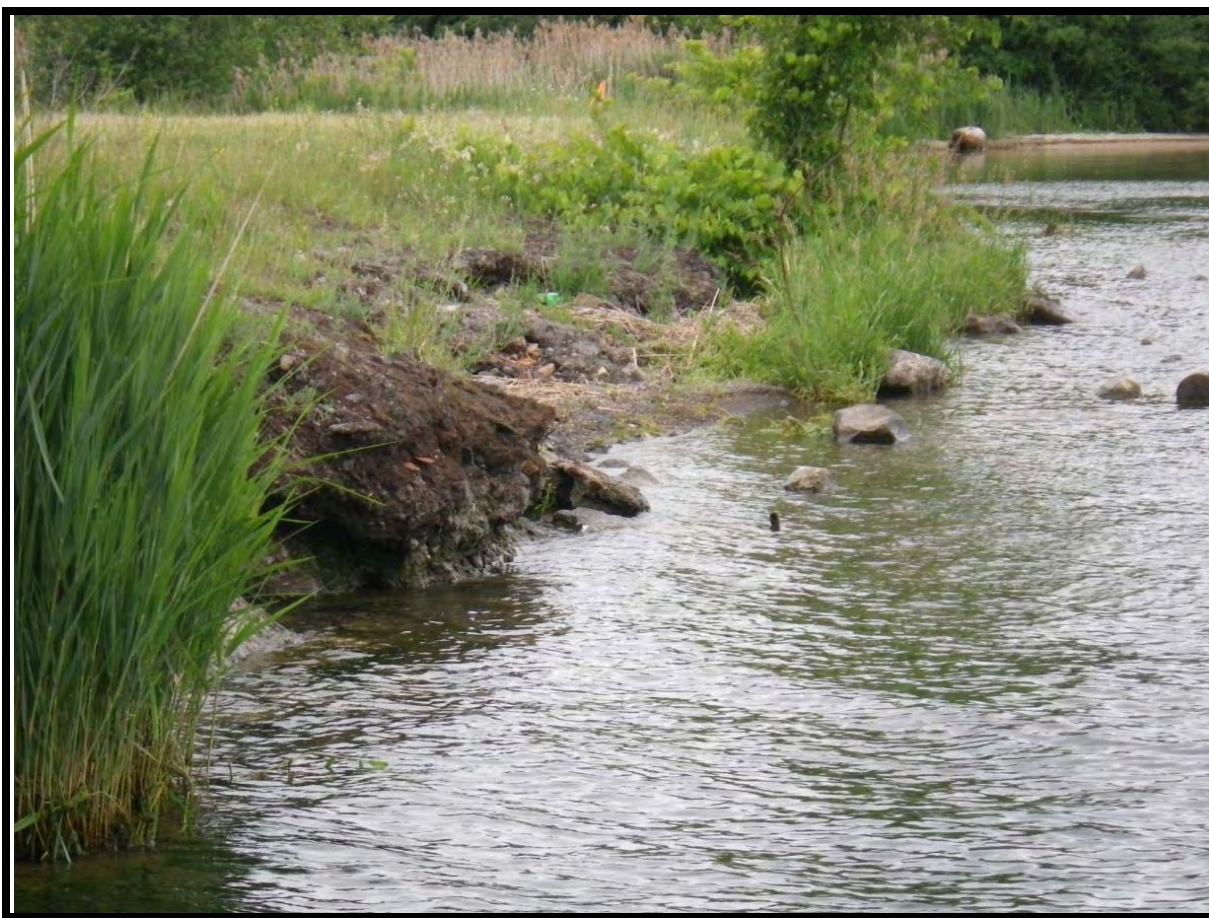
Analysis of lake charts suggests that the actual location of most of the Syracuse Yacht Club is below the peninsula which juts out into the lake (Figure 91). The shoreline is composed of slag fill likely from the adjacent Crucible Steel. Map overlays indicate that the boathouses are completely buried under fill, while the area of pilings on the southeastern edge of the peninsula is likely part of the clubhouse.

Figure 92. Photograph of the shoreline at A52 showing the slag fill (LCMM Collection).

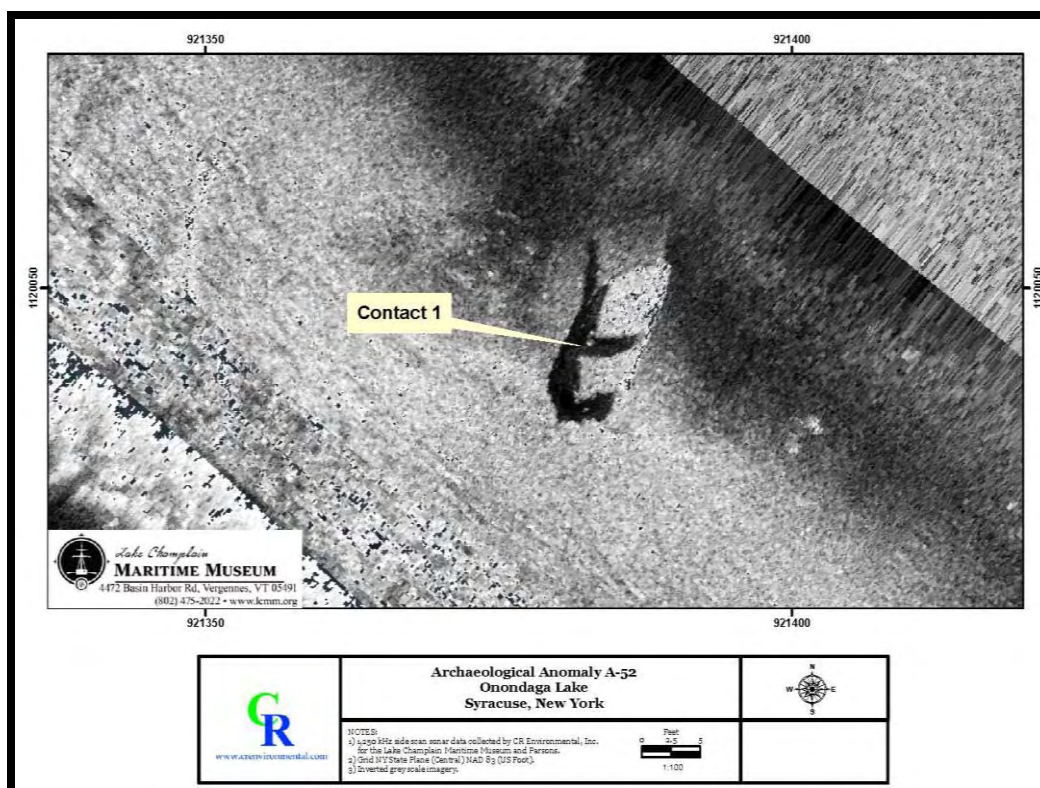
A sunken car is located off the northeastern side of the peninsula in approximately 30 feet (91.m) of water. The vehicle, which is heavily covered in zebra mussels, appears to be a 1970s vintage sedan (Figure 93).

Figure 93. Sonar mosaic from A52 showing a sunken car.

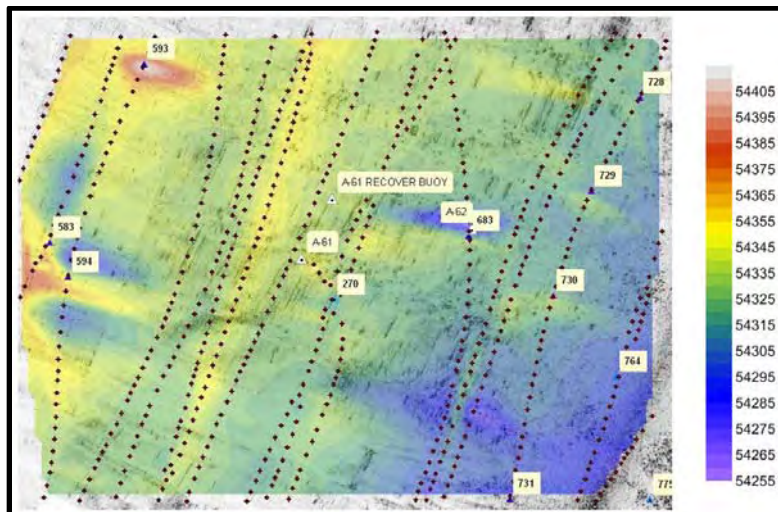
Anomaly 61 was approximately co-located with anomaly #270 digitized from CRE's 2005 data (Figure 96). Water depth was approximately 4 to 6 ft (1 to 2m) (Figure 96). The magnetic anomaly nearest A61 (#270) was characterized as a 200nT monopole. Assuming a distance (range) of 7 to 16ft (2 to 5 m), the ferrous mass of the A61 anomaly might be 71 to 1102lb (32 to 500kg). Side scan sonar data collected in the vicinity of these anomalies in 2005 did not suggest the presence of surficial contacts (debris or structures). In 2011, anomaly 61 was not located despite extensive visual diver examination and metal detecting.

Figure 96. Graphical overlay of fine-scale magnetism and side scan data on A61 and A62 (courtesy CRE).

Anomaly 62 was approximately co-located with anomaly #683 digitized from CRE's 2005 data (see Figure 96). Water depth was approximately 4 to 6 ft (1 to 2m). The anomaly nearest A62 (#683) was characterized as a 71nT dipole. Assuming a distance (range) of 7 to 16ft (2 to 5m), the ferrous mass of the A62 anomaly might be 24 to 397lb (11 to 180 kg). Side scan sonar data collected in the vicinity of these anomalies in 2005 did not suggest the presence of surficial contacts (debris or structures). Anomaly 62 was not located despite extensive visual diver examination and metal detecting.

LCMM recommends no further work on A61.

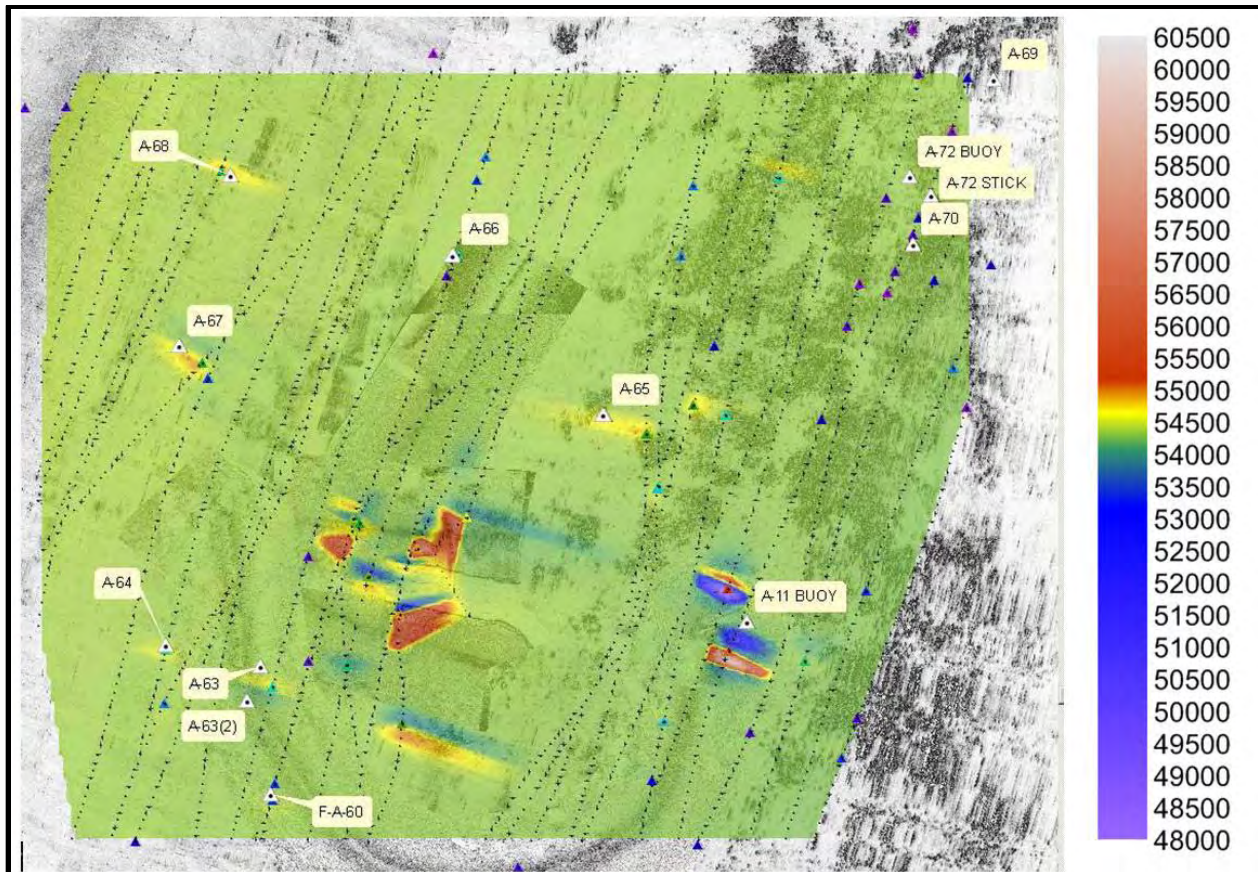
Anomaly 64 was co-located with 2005 magnetic anomaly #584, characterized as a 289nT dipole (Figure 97). It was located in 2-5ft (1-2m) of water. Assuming a distance (range) of 7 to 16ft (2 to 5 m), the ferrous mass of the A64 anomaly might be 101 to 1593lb (46 to 723kg). Side scan sonar contacts were not observed in 2005 data collected at this location. Anomaly 64 was not located despite extensive visual diver examination and metal detecting in 2011.

Figure 97. Graphical overlay of fine-scale magnetism and side scan data for A64, A65, A66, A67, and A70 (courtesy CRE).

Anomaly A65 was co-located with 2005 magnetic anomaly #713, characterized as an 873nT monopole (see Figure 97). It was located in 2 to 5ft (1 of 2m) of water. Assuming a distance (range) of 7 to 16ft (2 to 5m), the ferrous mass of the A64 anomaly might be 309 to 4850lb (140 to 2200kg). The lakebed at this location was obscured by aquatic vegetation in 2005 side scan sonar data. Anomaly 65 was not located despite extensive visual diver examination and metal detecting in 2011.

Anomaly A66 was co-located with 2005 magnetic anomalies #254 and #630 (see Figure 97). Anomaly #254 was characterized as a 24nT dipole. The ferrous mass estimate for this feature would range from 6.6 to 132lb (3 to 60kg) at an assumed range of 7 to 16ft (2 to 5m). Anomaly #630 was characterized as a 395nT dipole. The ferrous mass estimate for this feature would range from 139 to 2182lb (63 to 990kg) at an assumed range of 7 to 16ft (2 to 5 m). The lakebed at this location was obscured by aquatic vegetation in 2005 side scan sonar data. Anomaly 66 was not located despite extensive visual diver examination and metal detecting in 2011.

Anomaly 67 was co-located with 2005 magnetic anomalies #575 and #1142 (see Figure 97). Anomaly #575 was characterized as a 93nT dipole. The ferrous mass estimate for this feature would range from 33 to 507lb (15 to 230kg) at an assumed range of 7 to 16ft (2 to 5m). Anomaly #1142 was characterized as a 630nT dipole. The ferrous mass estimate for this feature would range from 220 to 3527lb (100 to 1600kg) at an assumed range of 7 to 16ft (2 to 5m). The lakebed at this location was obscured by aquatic vegetation in 2005 side scan sonar data. Anomaly 67 was not located despite extensive visual diver examination and metal detecting in 2011.

LCMM recommends no further work on A64.

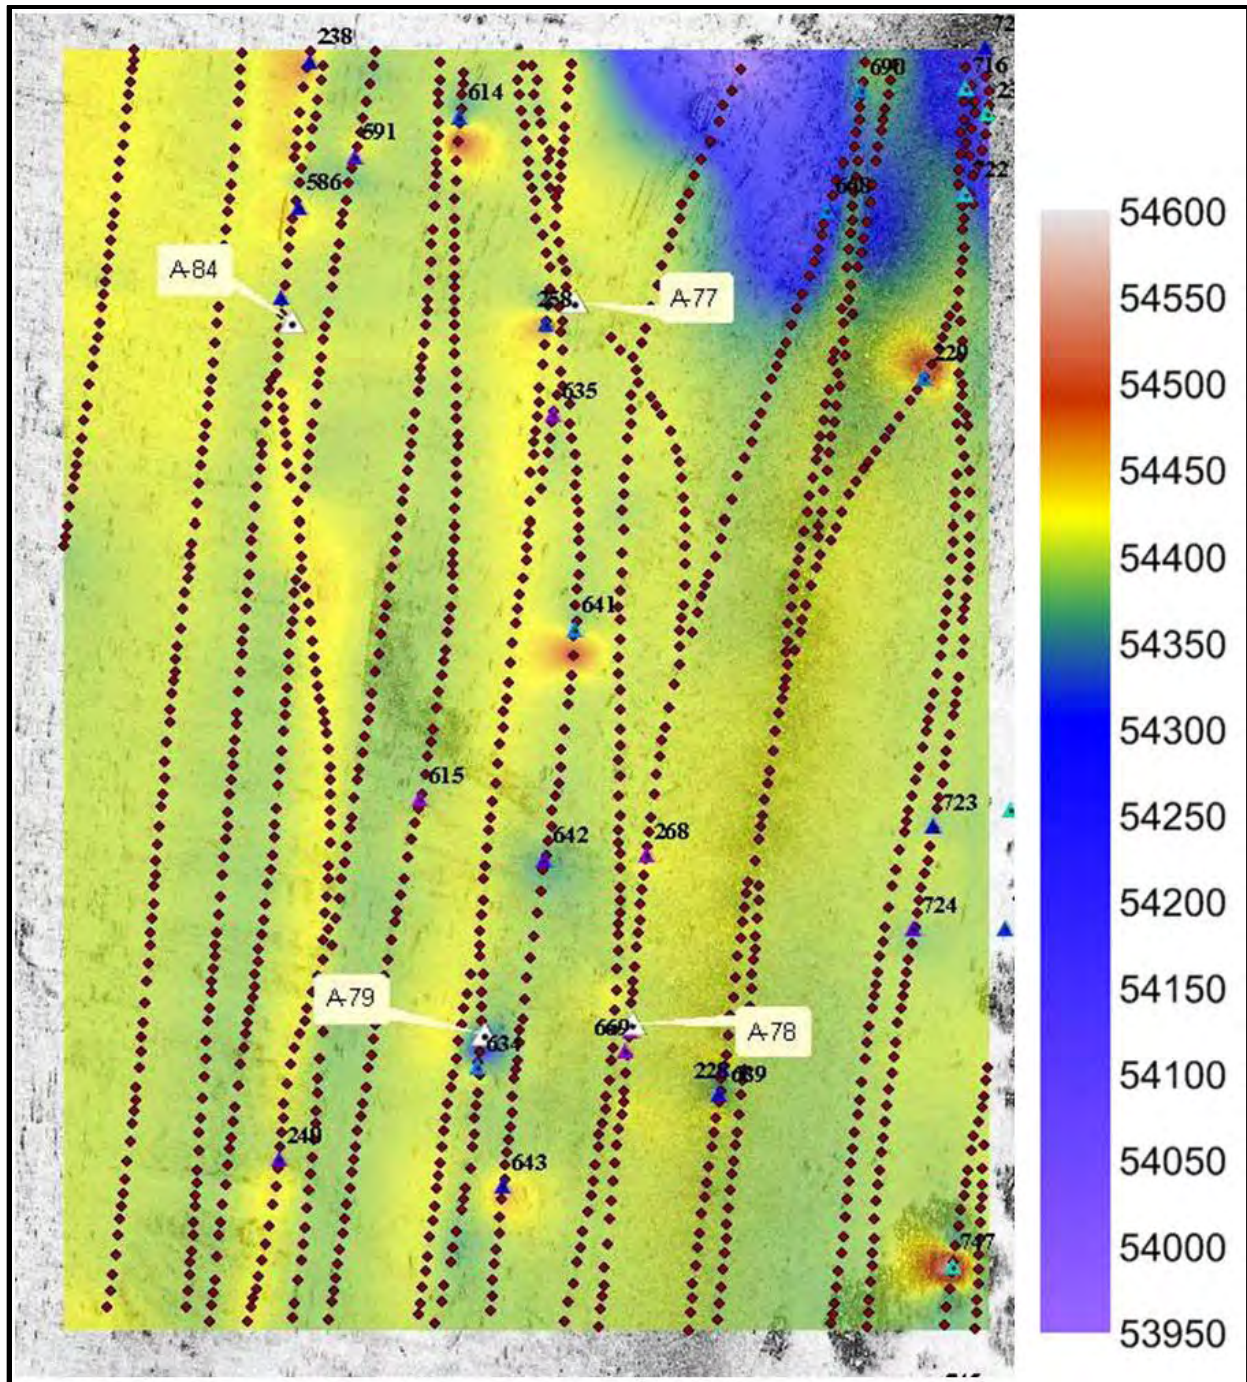
Anomaly 77 was co-located with 2005 magnetic anomaly #258, a 98nT dipole at a depth of approximately 5ft (2m) (Figure 98). The ferrous mass estimate for this feature would range from 35 to 540lb (16 to 245kg) at an assumed range of 7 to 16ft (2 to 5 m). The lakebed was obscured by aquatic vegetation in 2005 side scan sonar data. A77 was investigated by a diver in 2011. The area is filled with metallic trash including a tin can, zinc attachment for a boat and a small metal fragment. Despite extensive visual survey and metal detection, no features were found that were the likely source of the original magnetic anomaly, and therefore the results are inconclusive.

Figure 98. Graphical overlay of fine-scale magnetism and side scan data on A77 and A79 (courtesy CRE).

LCMM recommends no further work for A77.

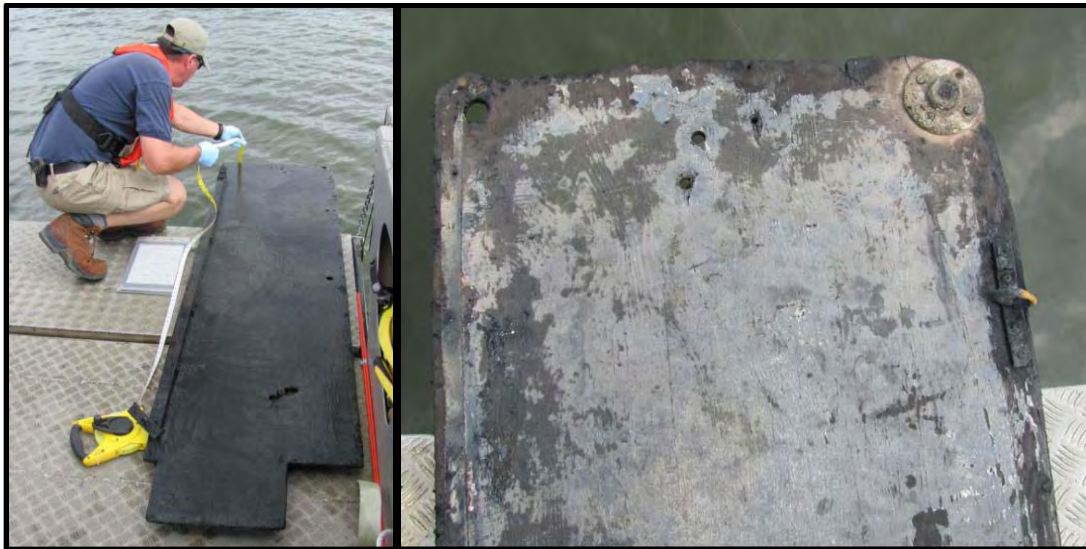
Anomaly 83 was investigated by a diver in 2011. The anomaly consists of a series of disarticulated wood and metal debris. A section of wooden debris was recovered and documented. It consisted of an 8ft (2.4m) sheet of plywood, one side of which has paint on it. There were many fasteners, including two ringbolts and two pipe fittings; it was fastened to adjacent pieces with sheetrock screws. It is likely a fragment from an ice shanty or shed.

Figure 100. LCM archaeologist documents Anomaly 83 (left). Detail of Anomaly 83 showing a pipe fitting and a ring bolt (LCMM Collection) (right).

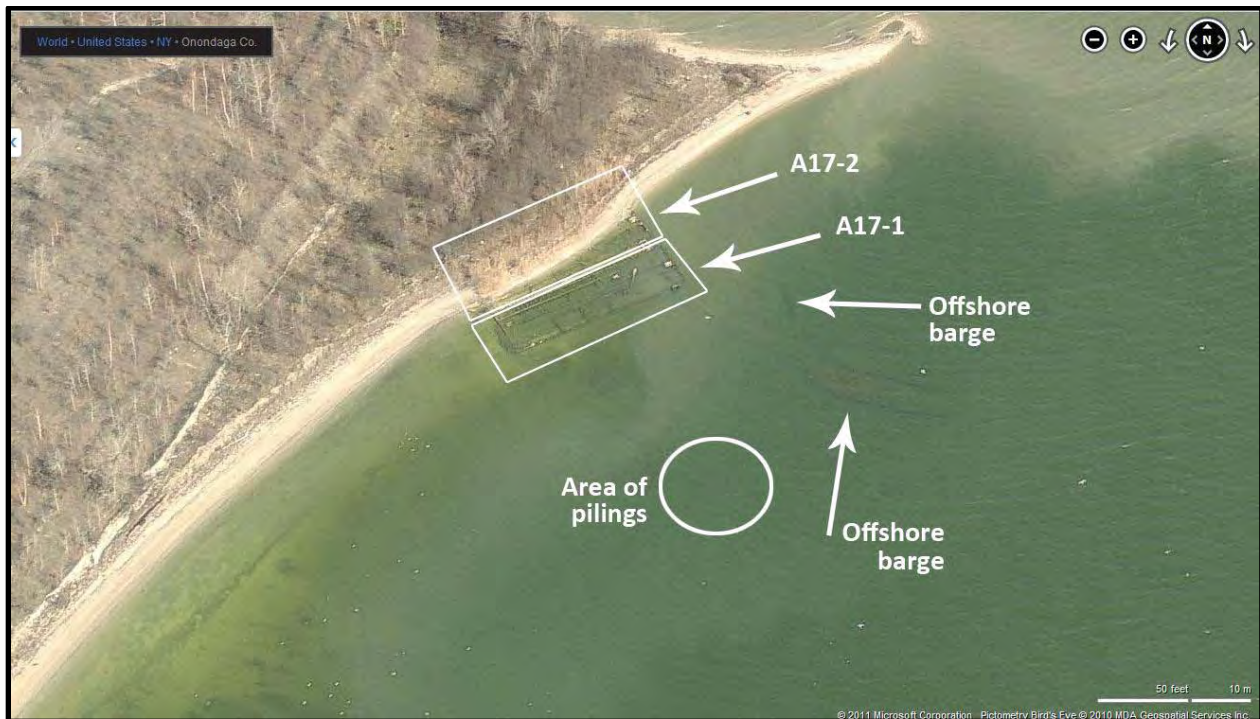
Figure 103. Aerial photograph of A17 spud barges (courtesy Microsoft® Virtual Earth).

LCMM recommends that the shoreline stabilization plan be revised to avoid any adverse effect to the spud barges A17-1 and A17-2.

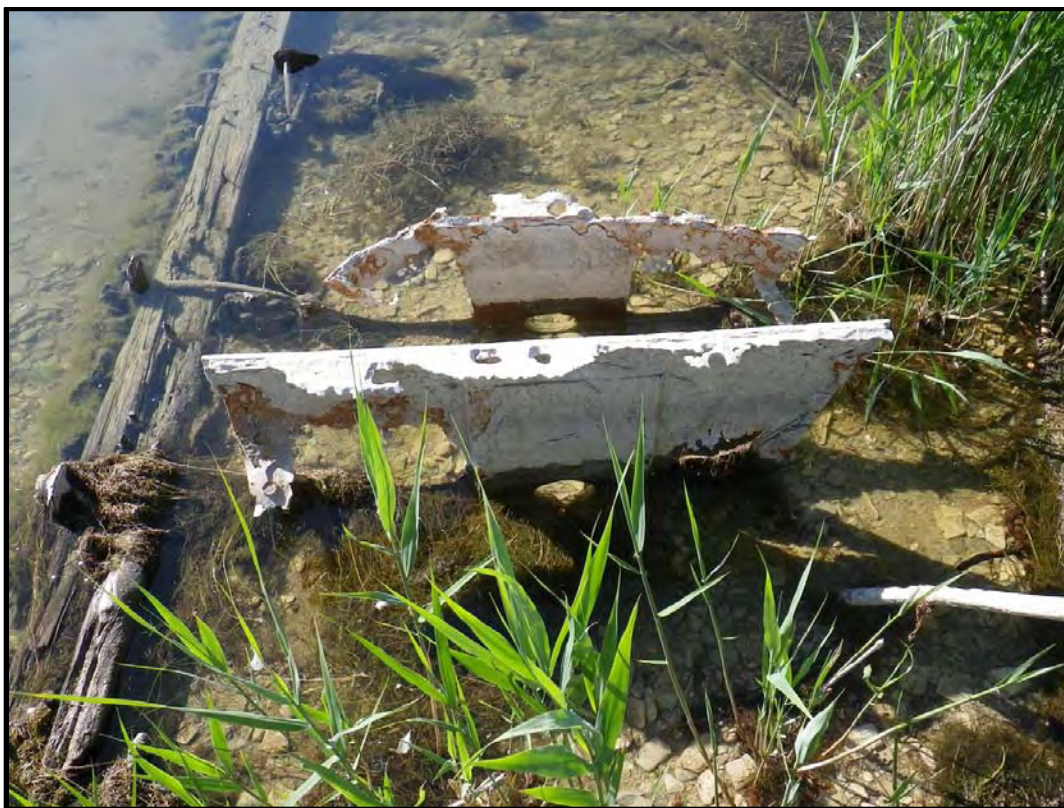
A17-1 is 97ft (29.6m) in length and 34ft (10.4m) in beam. The length on A17-2 is also 97ft (29.6m), and the beam is assumed to be identical to A17-1 at 34ft (10.4m). Each vessel contains two outboard spud holders opposite one another, approximately 36in (91cm) square (Figure 105). The eastern ends of the barges are vertical with vertical planking. The sides are vertical, built plank-on-frame. The western end, opposite the spud holders, is raked with transverse planking. The hull structures consisted of planking, floors, and stringers; these three, all connected, made up the entire depth of hull. The flywheel and other machinery are evident in A17-1, and the mounting brackets for the flywheel are visible on A17-2 (Figure 104).

Figure 104. Flywheel mounting brackets from spud barge A17-2 (LCMM Collection).

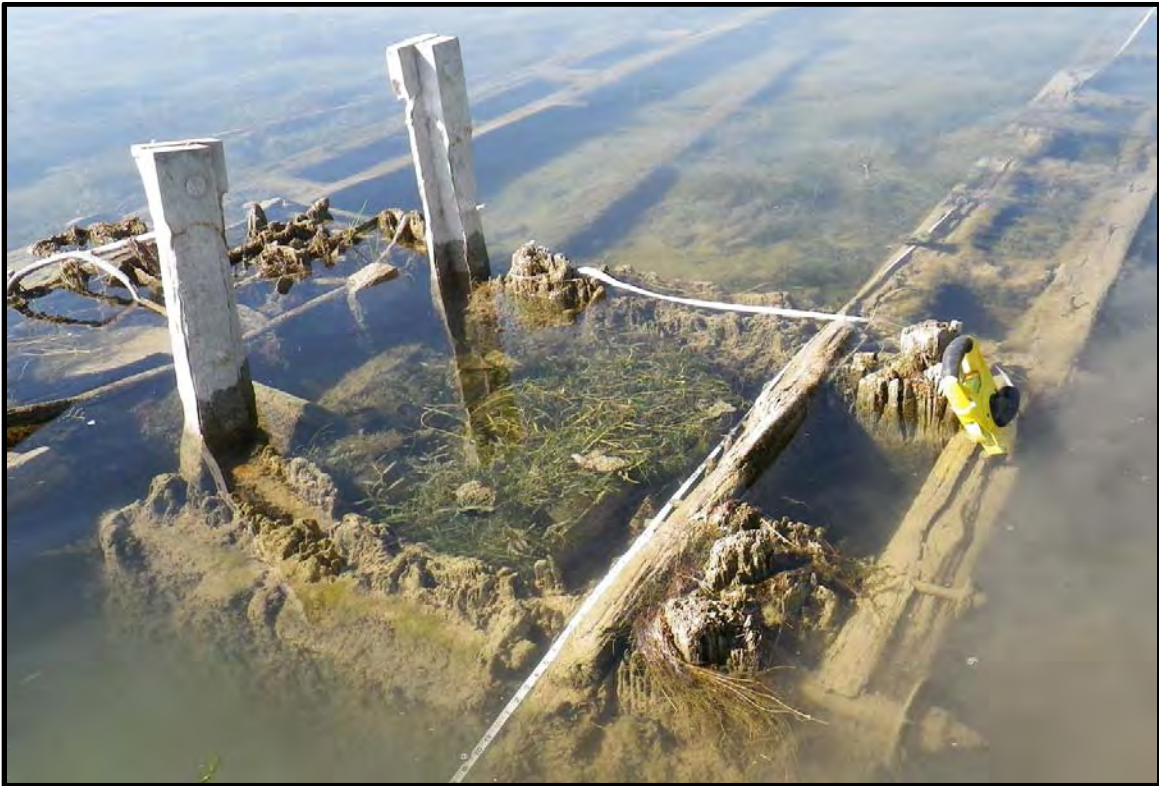
Figure 105. Spud holders on barge A17-2 (LCMM Collection).

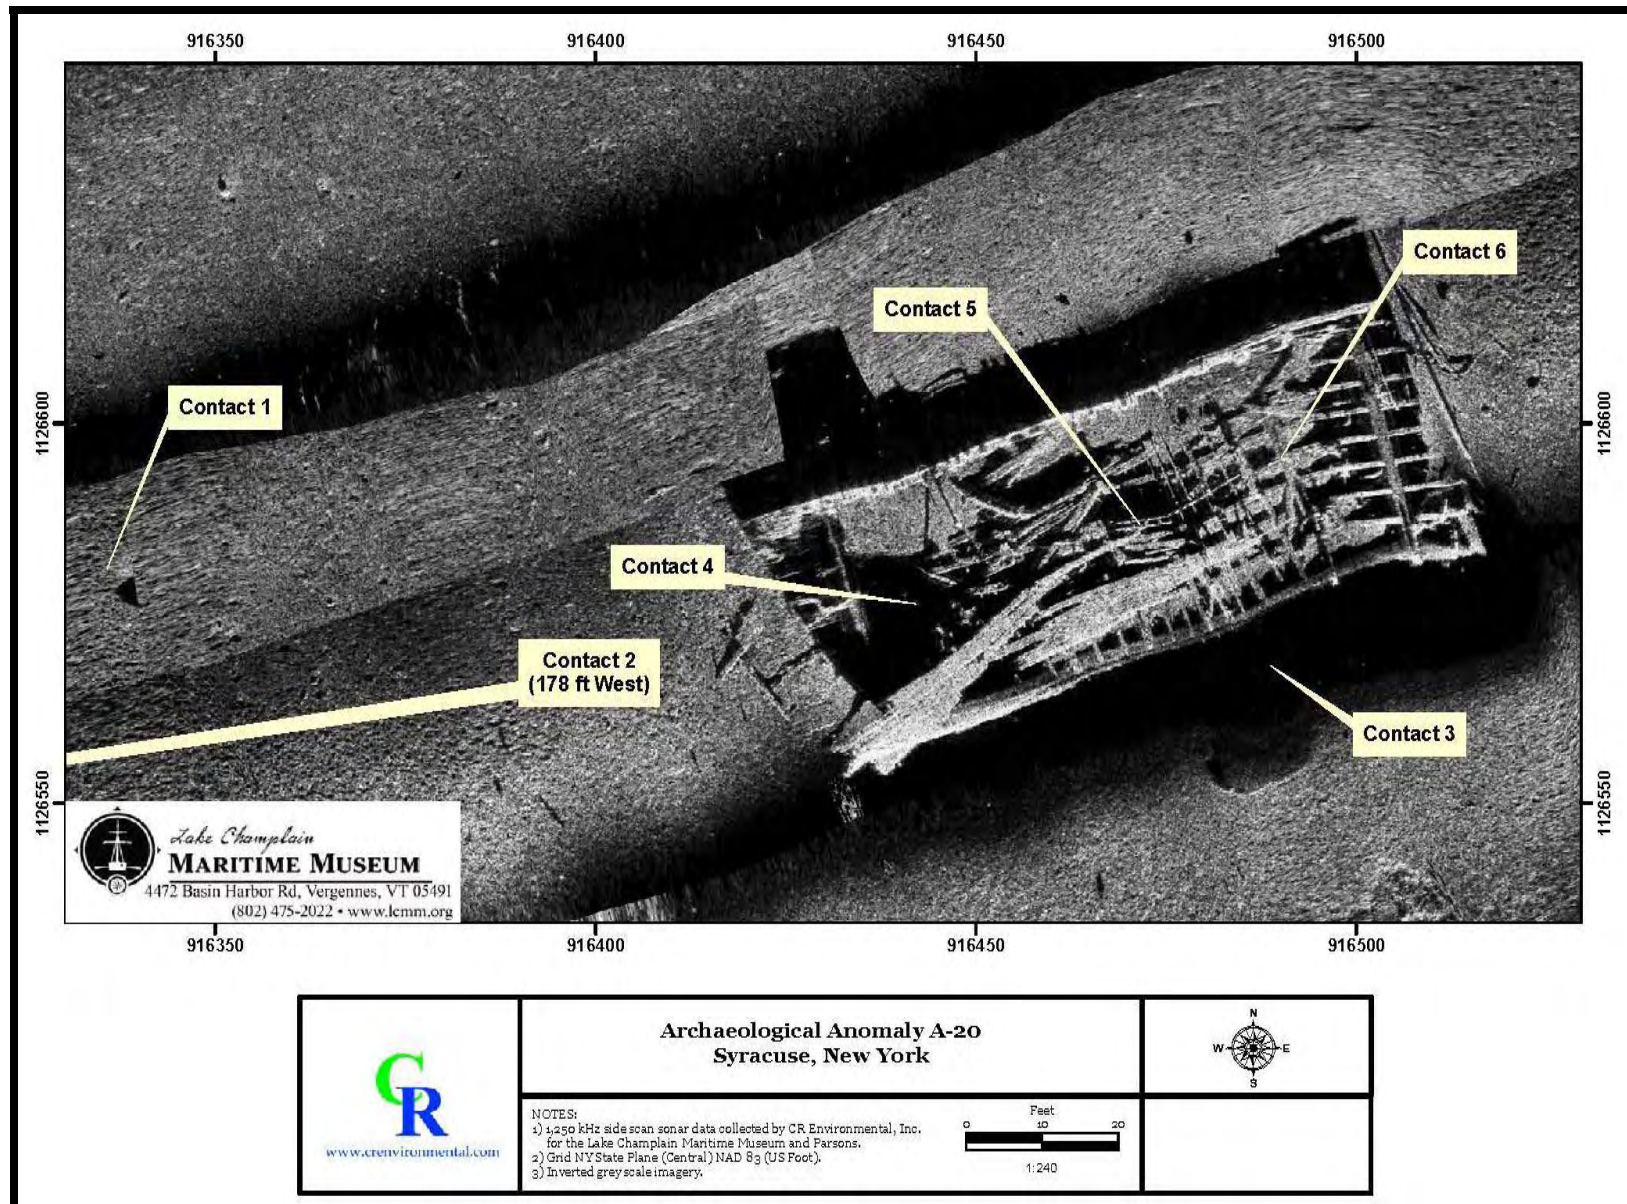
A20 is a well-preserved early twentieth century wooden rock scow resting in approximately 20 feet (6.1m) of water on a hard bottom, with nearly the entire structure exposed above the lake bed. The site was examined with side scan sonar, sector scan sonar and ROV (Figure 108 and Figure 109). The archaeological data, although not conclusive, suggests that A20 is a rock scow. This once commonplace vessel type was used to transport stone and sand throughout the canal system and beyond (Figure 110). Rock scows were similar to flat deck scows; however, the vessels were equipped with high-deck end bulkheads at the bow and stern, and lower longitudinal bulkheads along the side of the hull. The bulkheads served to retain the deck-loaded cargo.

Figure 108. Side scan sonar mosaic showing A20.

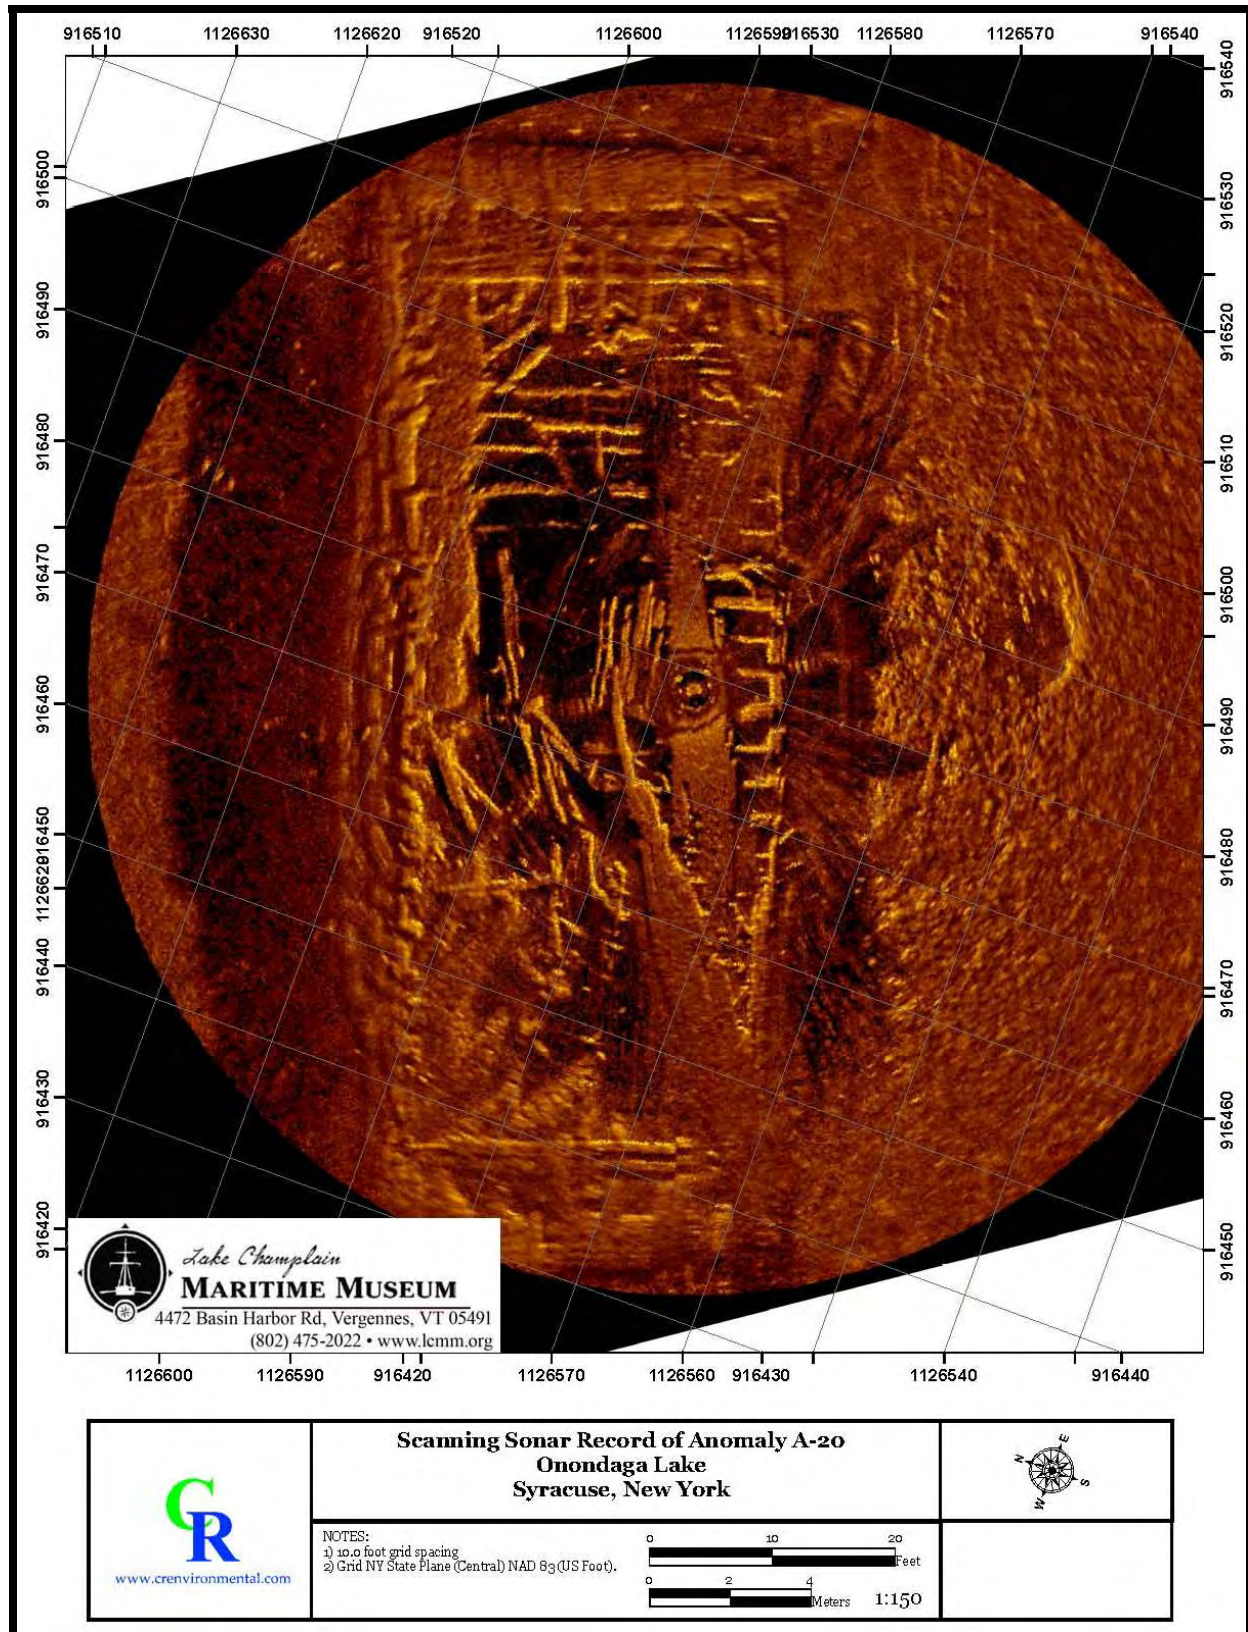
A20 is 91½ feet (27.89m) long by 32½ feet (9.91m) wide, with most of its principal members still extant including the sides, ends, deck beams, hanging and standing knees, stringers, and framing. The vessel also retains some decking and the high deck-end bulkheads and longitudinal retaining bulkheads are displaced, but lying near or on the wreck. The hull is characterized by vertical edge-fastened sides and scow ends. The ends are framed with rake timbers. Most of A20's deck beams are still in place with most still retaining vertical knees at the outboard ends for longitudinal retaining bulkheads. The high deck-end bulkheads are believed to be lying against the side of the hull at the scow's eastern end and on the bottom adjacent to the western end (Figure 111). A20 has a small section of intact decking amidships along its southern side. Overall the site retains approximately 90% of the vessel's original structure.

Figure 109. Scanning sonar image of A20.

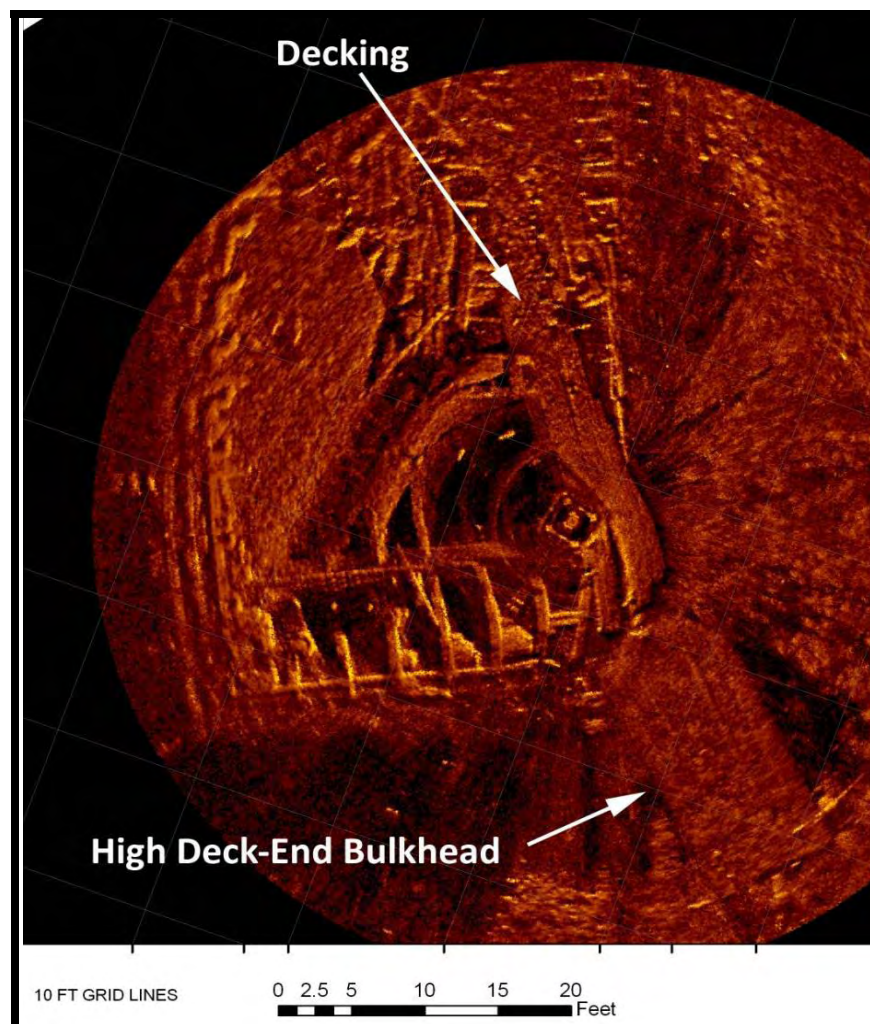
Figure 111. Sector scan sonar detail showing the displaced high deck-end bulkhead and the decking.

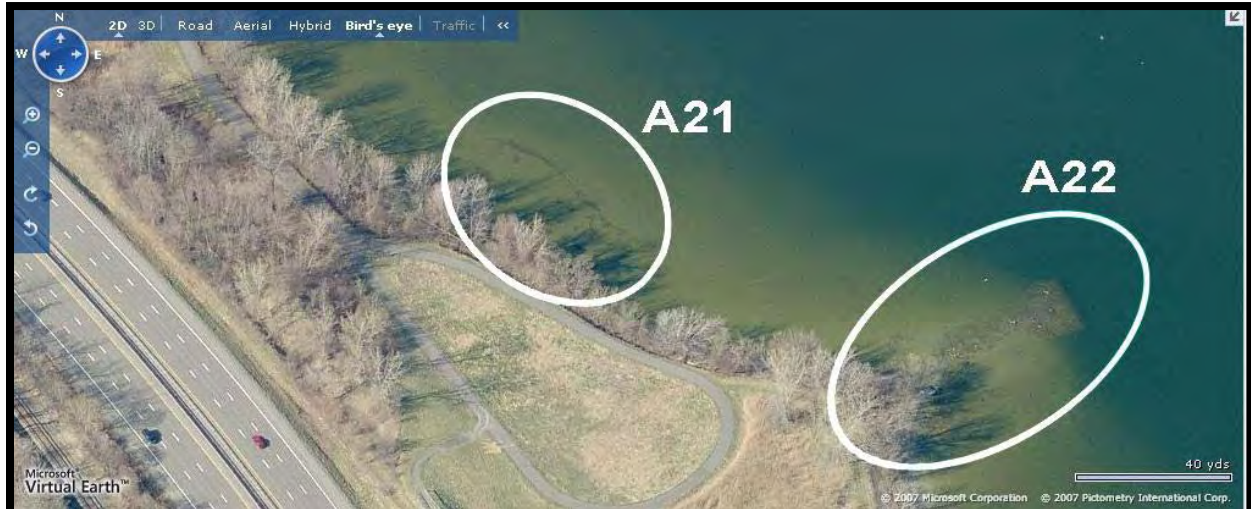
The pier 150 feet (45.7m) long and 20 feet (96.1m) wide with a 50 foot (15.2m) long T at the end (Figure 112). The pier was built using timber cribbing and rock fill. The structure is well preserved, with the portions of the end T retaining an original stone or concrete decking surface.

Figure 112. Aerial view showing pier remnants at Anomaly 22 (courtesy Microsoft® Virtual Earth).

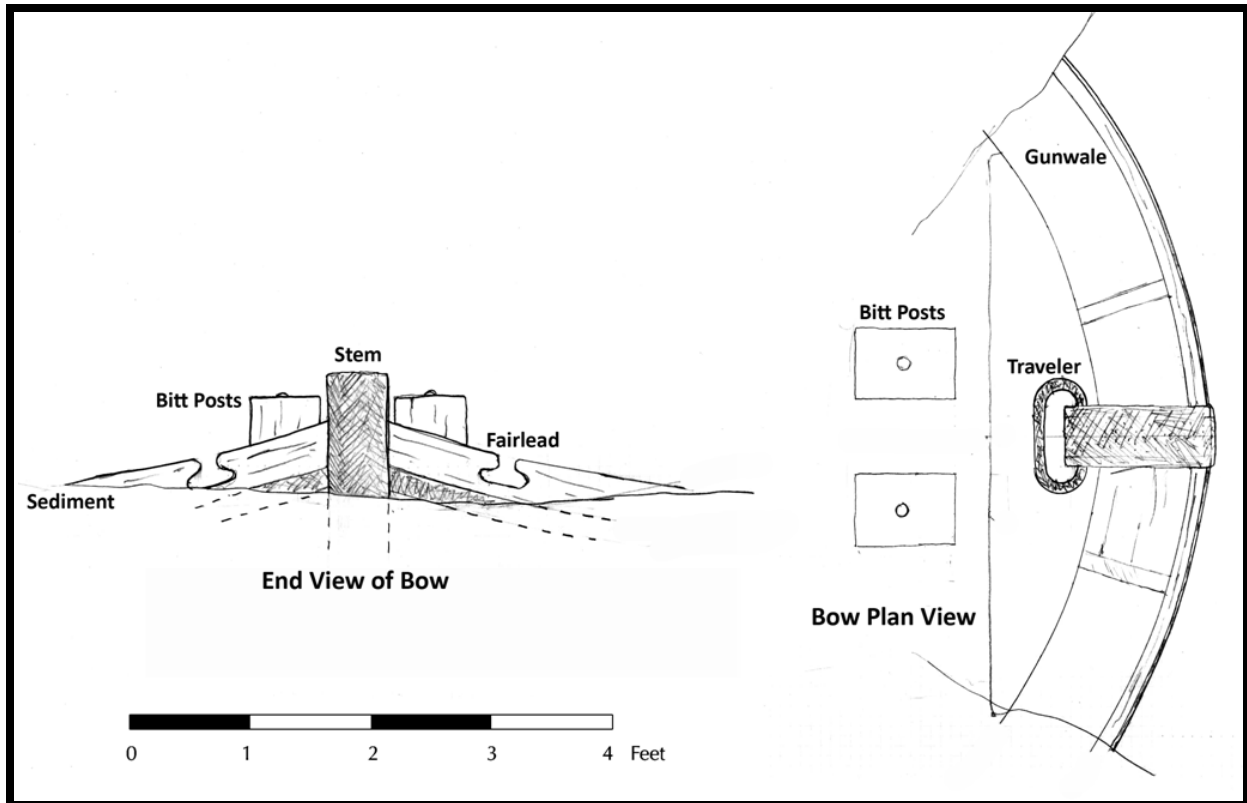
The archaeological data collected from A33, although limited due to the sediment deposition, conclusively illustrates that the site is a buried canal boat. The remains that are visible (stem, tiller) represent the highest points on the vessel, with the exception of the cabin trunk and roof. The preservation of these elements indicates that the buried portion of the site is intact. A canal boat the size of A33 was 8 to 10 feet (2.4 to 3.1m) tall, suggesting the bottom of the vessel rests below 10 to 12 feet (3.1 to 3.7m) of sediment (Figure 114).

Figure 113. Scale drawing of A33 showing the visible bow remains (Adam Kane, LCMM Collection).

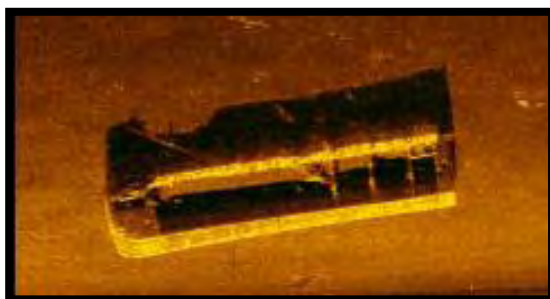
Figure 115. Sonar image from 2005 showing Anomaly 13 (courtesy CRE).

The eligibility of A13 for the NRHP remains unevaluated; however, given its intact nature it is likely eligible. Although the site is outside the remediation areas, LCMM recommends that additional steps be taken during the remediation to prevent any inadvertent impact to the site. A 50-foot (15m) buffer around the wreck site should be marked with seasonal buoys as a no anchorage site during the remediation, and watercraft operators on site should be informed of the site's location and protocols.

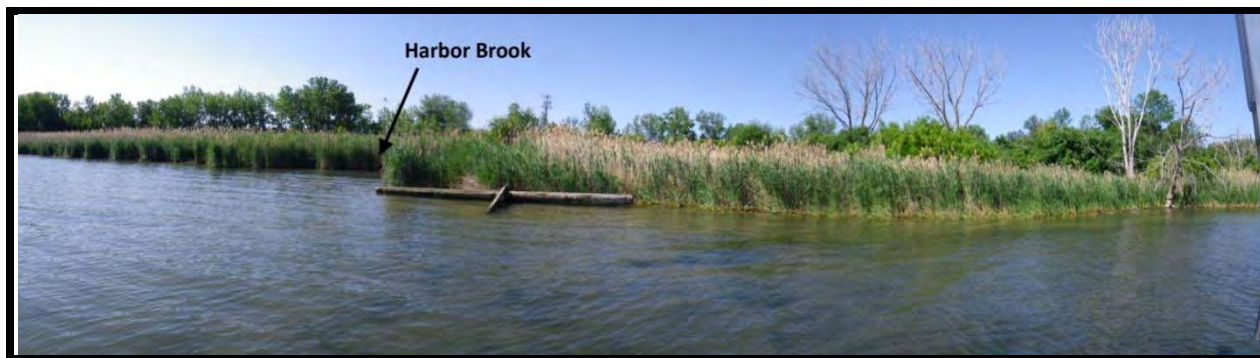
During the June 2010 fieldwork, an inspection of the shoreline near Harbor Brook revealed the presence of wooden structural remains (Figure 116). This structure, lying immediately west of the mouth of Harbor Brook, was designated A54.

Figure 116. Photograph of A54 with the mouth of Harbor Brook to the left (LCMM Collection).

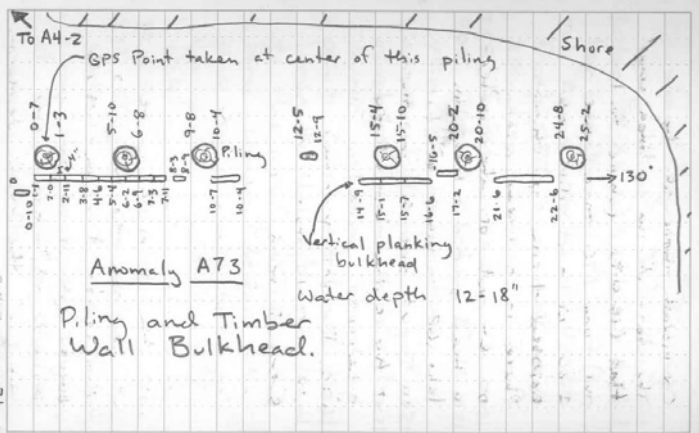
survey area. A pier feature was located in the northern corner of the survey area. This pier feature is designated A73. The pier consists of seven pilings with each standing approximately six inches above the bottom. The tops of the pilings were flat, i.e. cut, meaning that the upper surfaces are the tops of the pilings as exposed during its use life. There is a linear arrangement of vertically oriented planks paralleling the pilings, but located 4" south of the line of pilings. The interior of the piling behind the bulkhead is filled with stones (based on probing). The structures (pilings and bulkhead) stand 2 to 8" above the bottom. A GPS point was taken at the piling farthest from the shore and the orientation was 130.
	1305	AK out of the water.
A71	1329	CS into the water to dive verify A71 and visually survey the area from A71 south. At A71, nothing was found with the metal detector CS visually surveyed the shallow water area along the shoreline (shore to 150' out) from A70 to a point +/- 200' north of the inner harbor entrance. Nothing found in this area.

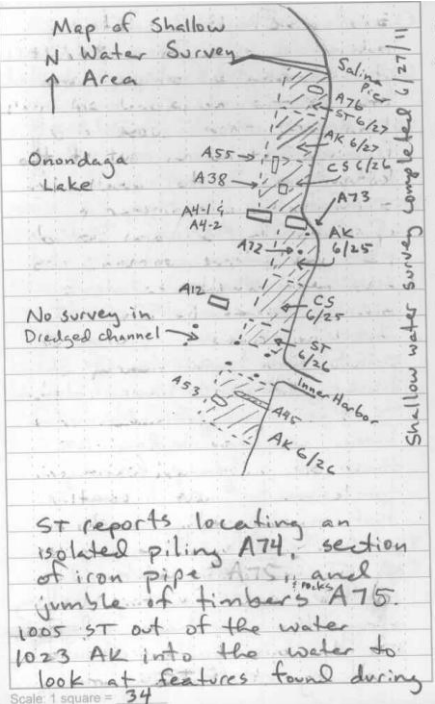
<p>ST reports locating an isolated piling A74, section of iron pipe A75, and jumble of timbers A76.</p> <p>1005 ST out of the water</p> <p>1023 AK into the water to look at features found during</p> <p>Scale: 1 square = 34</p>
	1015	ST out of the water.
	1023	AK into the water to look at features found during ST's dive. The isolated piling is exactly that (A74). It is likely a piling from one of the adjacent dolphins that has torn loose and is now standing out of the bottom at a 45 degree angle. The piling has a diameter of approximately 12" and stands 12" above the bottom. A75 was determined to be a pile of rocks. The pile was one layer deep. It could be probed through in nearly all places. The stones were limestone. The pipe was examined. It was an isolated cast iron pipe, 12" in diameter approximately 10' long. It was located 50' immediately in shore of A75. It was not given a number designation due to the isolated nature of the find.

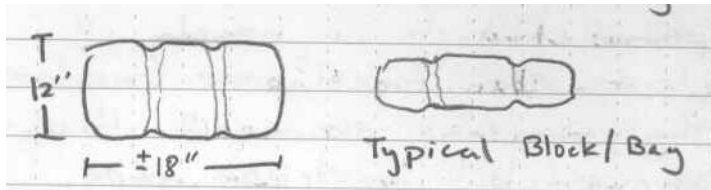
A45		<p>showed the site to be constructed of bags of concrete. Each concrete block was pillow shaped with two indentations from band that went around the bags.</p>

<p>The breakwater was clearly built by throwing bags of concrete into the water. A53 was found during the survey. The remains were consistent with what was shown during ROV/sonar work and what was stated in the report. Numerous pieces of A53 were located around the wreck, particularly to the southeast. Disarticulated pieces included several frame sections, which were of cocked hat construction like the wreck itself. Each disarticulated piece was examined in detail to make sure it was not a larger section or a new wreck.</p>
	1211	AK swaps out tanks so that this area can be completed.
	1217	AK back into the water. AK finishes the southeastern portion of the SMHD.
	1300	AK out of the water.
A74 A75	1310	Depart and go back to area of A74 & A75 to record locations. Three points taken for A75.

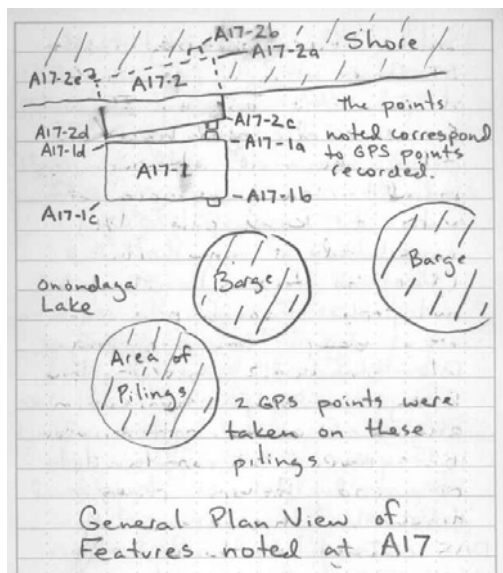
that end of the barge, likely as ballast for the spuds and machinery on the other end. It was likely pulled out and dumped so that the vessel could be pulled into shallow water next to A17-2. While departing A17, a series of pilings were seen from the boat with tops about 4' from the surface. Visual examination elsewhere around A17 showed that there were at least two other offshore barges, however, extremely dense vegetation (particularly inside the barges) make it impossible to conclusively determine the extent of the barge remains. The pilings appear to correspond with the two barges onshore indicating that the barges formed the shore end of a pier structure.
