Phase 3 Underwater Archaeological Report for the Onondaga Lake Bottom, Subsite of the Onondaga Lake Superfund Site, Onondaga County, New York

September 2014

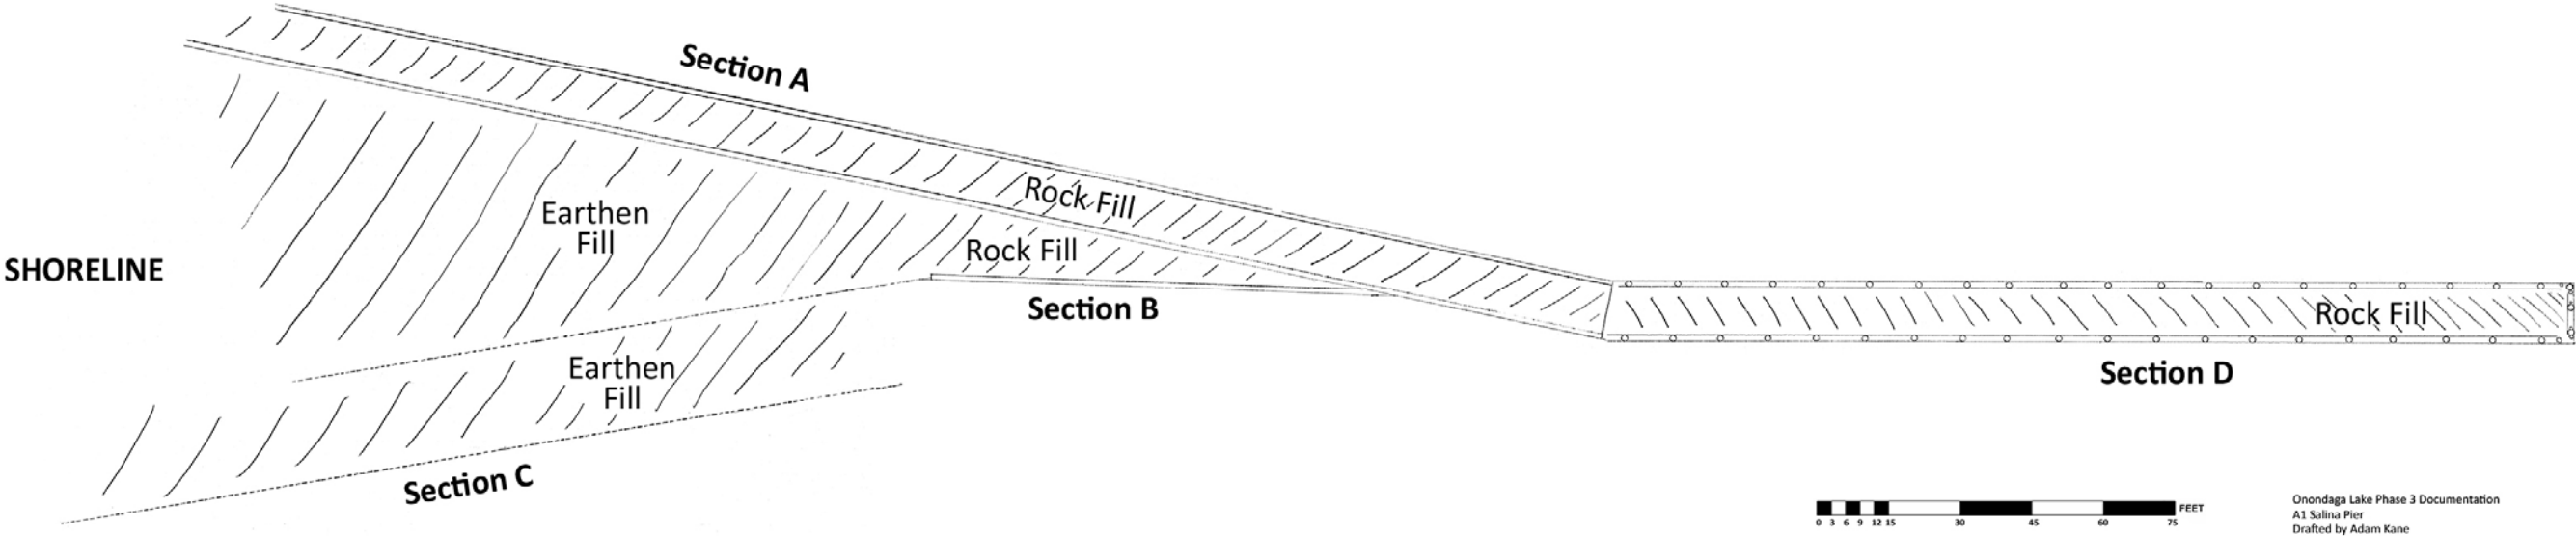
Figure 34: Site plan of Salina Pier (A1/2), drafted by Adam Kane (LCMM Collection).

The extant pier remains are 483 feet (147m) long. The pier remnants are divided into four sections, A-D (Figure 34). Section A is the pier's central leg, while section B is an expansion that expands the inshore portion of Section A thereby increasing the width of the Pier. Section C represents poorly preserved inshore remains found north of the Sections A and B. Section D is the westernmost leg which extends

furthest out into the lake. The archaeological data suggests that the building sequence is A to D; therefore that order will be used to describe the sections.

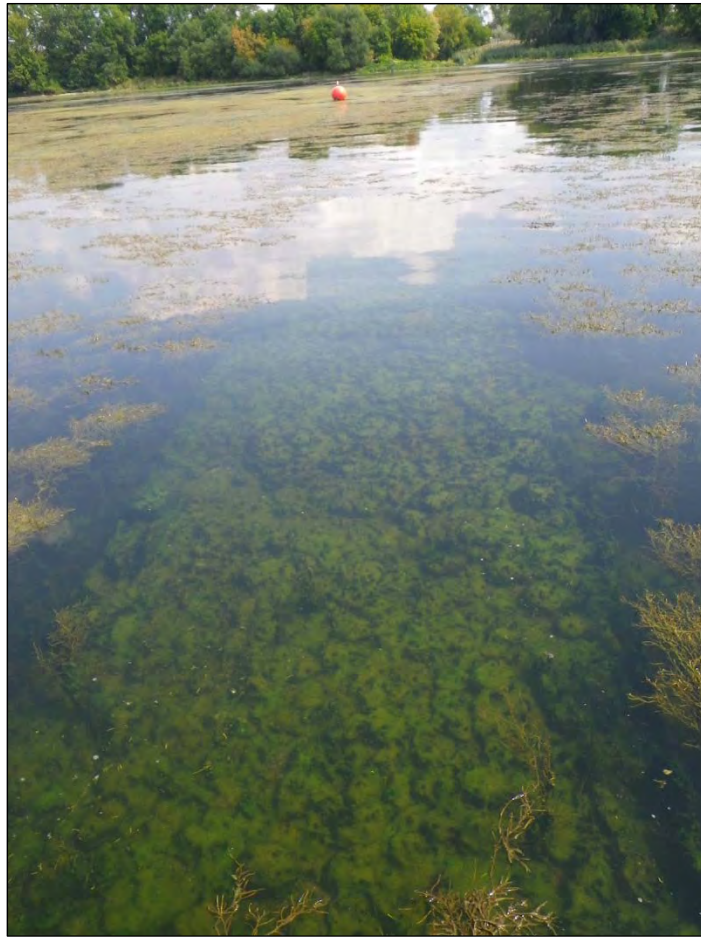
Section A is the original finger of Salina Pier (Figure 35). The remains are 283 feet long (86m) and 8 feet (2.4m) wide, and stand 2 to 3 feet (0.6 to 0.9m) above the surrounding bottomlands. Each side of Section A is characterized by two rows of parallel vertical planks. The individual planks are 8 to 12 inches (20 to 30cm) in width and 1 inch (2.5cm) in thickness. These planking rows are separated by approximately a 12 inch (30.5cm) gap. The interior of the pier is filled with 2 to 6 inch (5.1 to 15.2cm) diameter rip-rap. The outside walls of the pier are buttressed by 8 to 12 inch (20 to 30cm) diameter rip-rap.

Figure 35: Water conditions occasionally permitted views of Salina Pier from the surface, looking east at Section A (LCMM Collection).

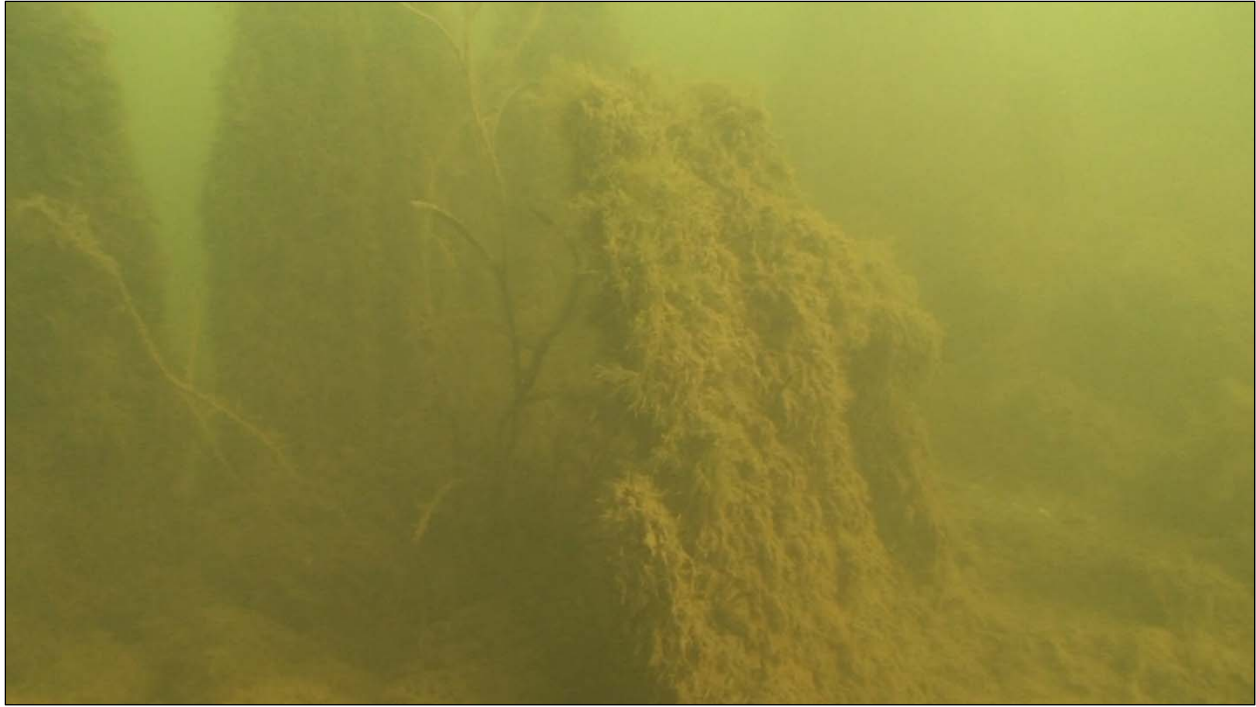
Section C is a T-shaped arrangement of single walled vertical planking in 2 to 3 feet (0.6 to 0.9m) of water (Figure 36). This planking formed the wall of a bulkhead. The vertical planking extends 1 to 2 feet (0.3 to 0.6m) above the bottom with individual planks 8 to 12 inches (20.3 to 30.5cm) in length and 1

inch (2.5cm) in width. The top of the T, which parallels the Sections A and B, is 93.5 feet (28.5m) long, while the portion which connects Section C to B is 23.5 feet (7.1m) in length. The interior of Section C was filled with mixed sediments including small cobbles, slag, coal ash and soil. Unlike all other section of the pier, this area was not filled with a specific rock matrix, rather its fill was a mix of soils and debris.

Figure 36: Sections of Salina Pier (A1/2) were characterized by vertical planking (LCMM Collection).

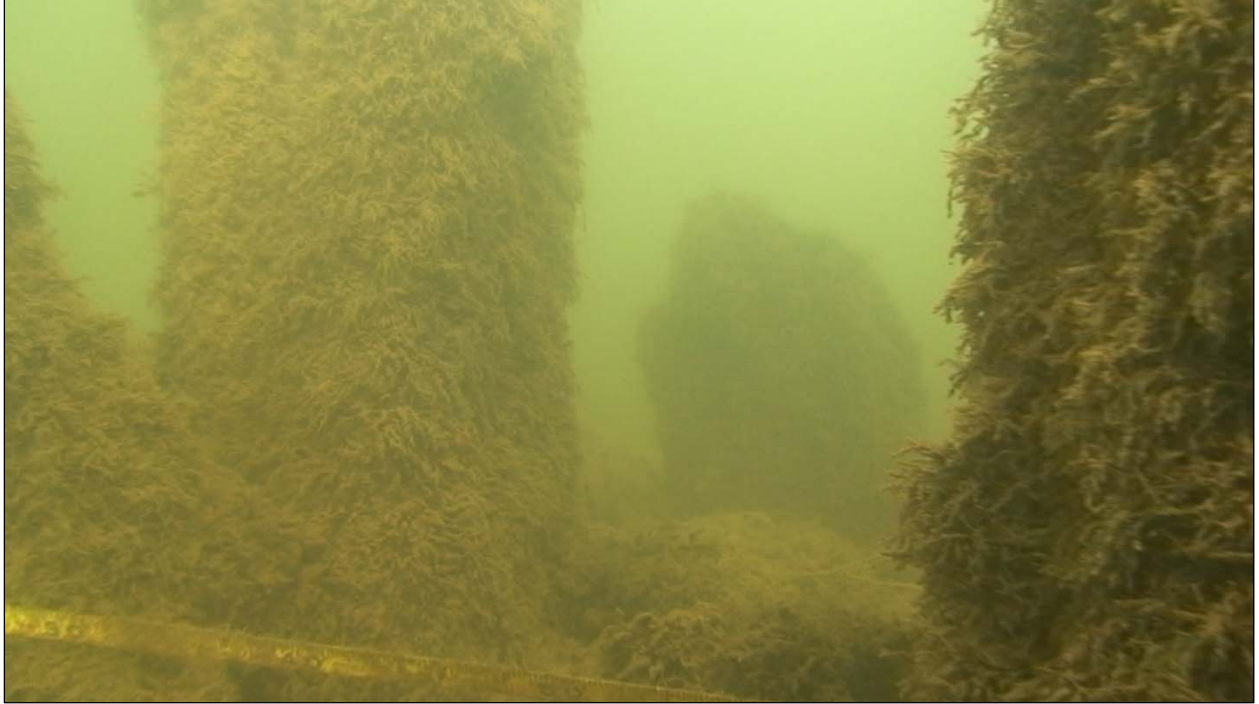
Section D is the westernmost leg of the pier and is angled at a 12° offset from Section A. Section D is 10 feet 4 inches (3.1m) wide, 200 feet long (61.0m) and stands 3 to 4 feet (0.9 to 1.2m) above the surrounding bottomlands. Each side of Section D is characterized by two rows of parallel vertical planks. The individual planks are 6 to 12 inches (15.2 to 30.5cm) in width and 1 inch (2.5cm) in thickness. These planking rows are separated by approximately a 12 inch (30.5cm) gap. The gap contains a sequence of pilings spaced at intervals of 8 to 12 feet (2.4 to 3.7m). The interior of the pier is filled with 8 to 16 inch (20.3 to 40.6cm) diameter rip-rap. The corners of the westernmost end of the pier are flanked by clumps of pilings (Figure 37).

Figure 37: Vertical pilings at Salina Pier held back rip-rap, cobbles, or other fill (LCMM Collection).

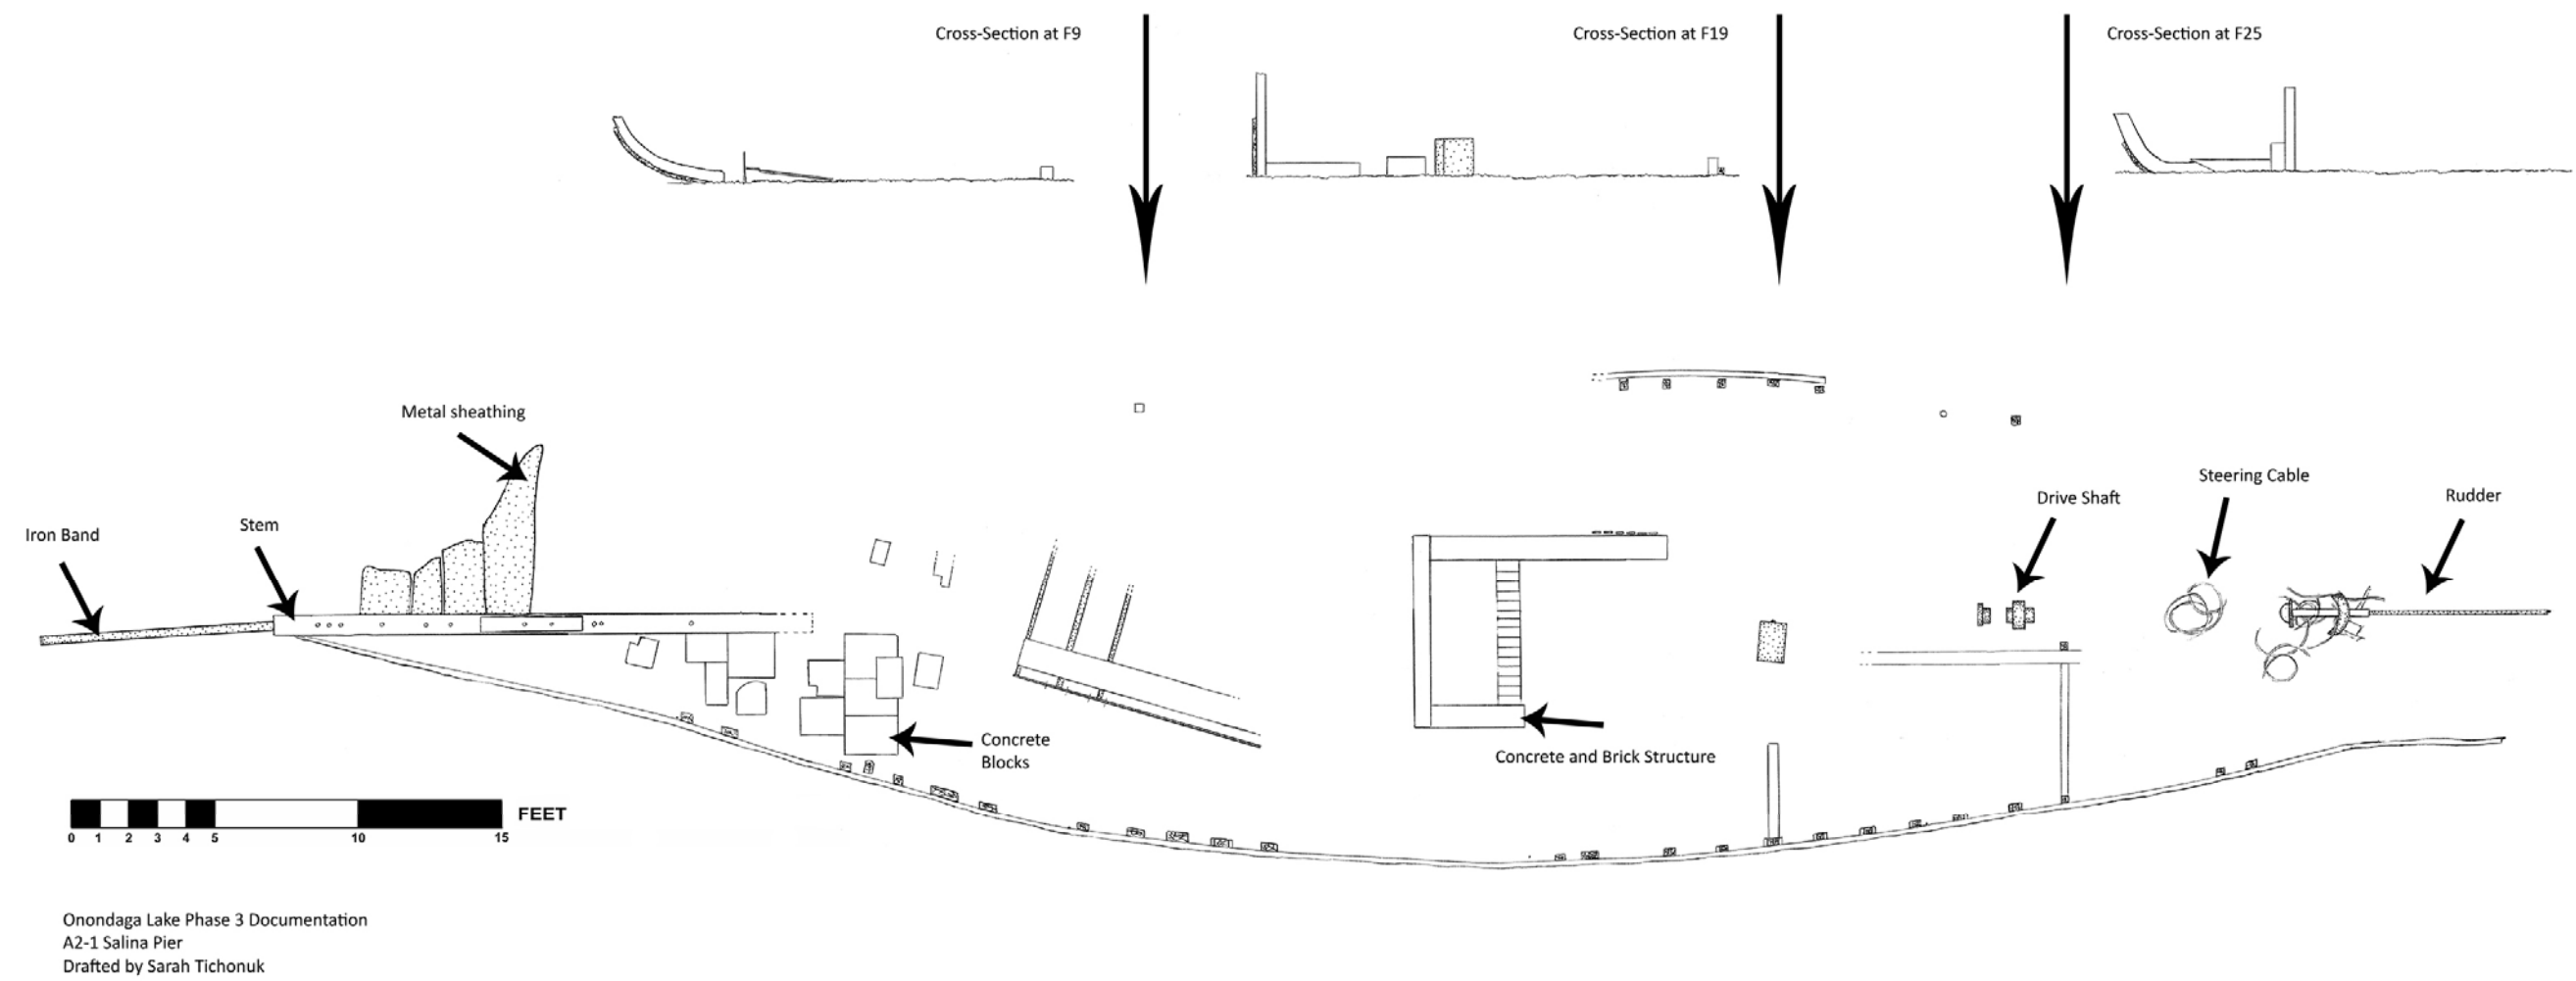
Figure 38: Plan and cross sectional views of A2-1 (LCMM Collection).

A2-1 represents the remains of the bottom hull of a wooden steam-powered tugboat or launch (Figure 38). The site rests in 8 to 12 feet (2.4 to 3.7m) of water abutting the submerged remains of Salina Pier (A1/2). It is unclear whether the vessel accidentally sank or was intentionally disposed of at this location. The vessel remains lean to starboard, exposing some of its port side features, but leaving much of its starboard side buried. Study of the vessel was limited to the remains exposed above the lakebed due to the potentially contaminated nature of the sediments. To date, archival research has yielded no historic accounts of this vessel or its deposition. The vessel construction likely dates to the late-nineteenth or early twentieth century based on construction details such as the iron rudder, and threaded bolt fasteners.

The visible remains of A2-1 represent 15-20% of the vessel's original structure, which has resulted in an incomplete understanding of the site (Figure 38). Another 10% of the vessel is likely present below the sediment, which was not excavated due to the potential contaminants in the lake bottom. The visible remains are 88 feet 8 inches (27 m) in length and 20 feet 9 inches (6.3 m) in beam. The exposed vessel remains include portions of the stem and bow, port side frames and planking, scattered frame heads on the starboard side, and the rudder, rudder post, and portions of the steering mechanism were found in the stern. There are also several features of note in the interior hull of the wreck.

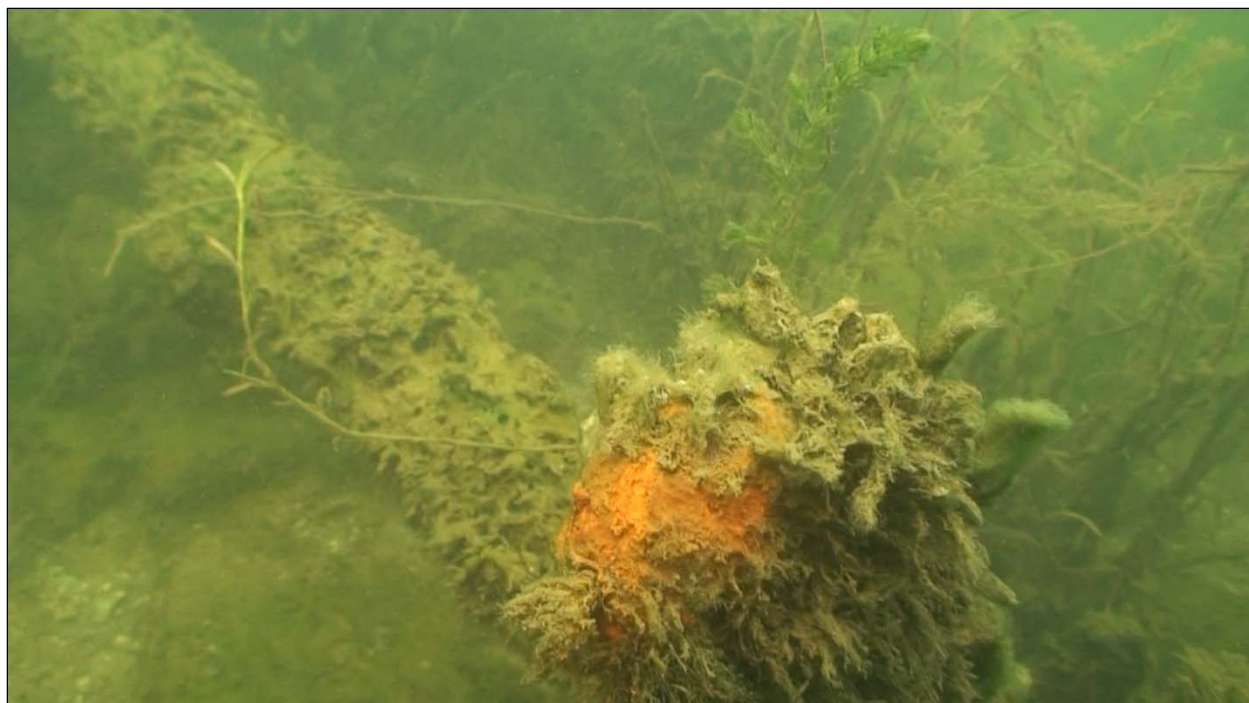
The stem is well-preserved on A2-1. The timber is made of White Oak (*Quercus alba*), approximately 7 inches (17.8cm) moulded and 8 inches (20.3cm) sided, and stands 42 inches (106.7cm) off the bottom at its highest and forward-most point. It extends for a length of 7 feet 10 inches (2.4m) before transitioning into a keelson chock, both of which are also composed of White Oak (*Quercus alba*). Iron bolts are present running down the stem; three of them 2 feet (0.6m) from the forward-most point clustered 5 inches (12.7cm) apart, and crossed. A 3 ½ inch (8.9cm) wide iron band, which originally protected the forward surface of the stem, which has fallen away from the timber, extends forward beyond the stem for a distance of 8 feet 4 inches (2.5m) (Figure 39).

Figure 39: Iron band in bow of A2-1 (LCMM Collection).

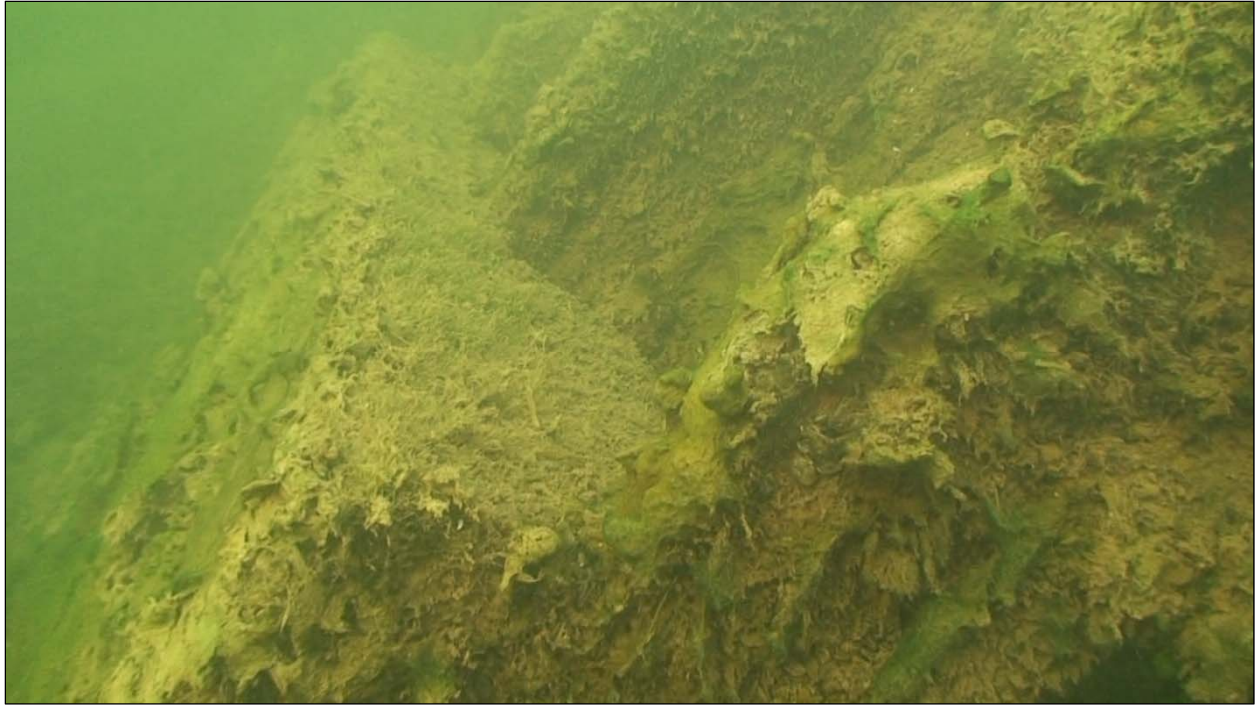
One interesting feature of A2-1 is a group of 14 concrete blocks that appear to have been molded to, and fit snugly between, the port side frames as ballast (Figure 40). Eight of these blocks are T-shaped, between 15 and 18 inches (38.1 to 45.7cm) thick. Blocks are only present in the forward section of the vessel, and likely would have provided counter-ballast for the steam boiler and engine located amidships, and the iron rudder shaft assembly located in the stern.

Figure 40: Concrete blocks in between frames on the port side of A2-1 (LCMM Collection).

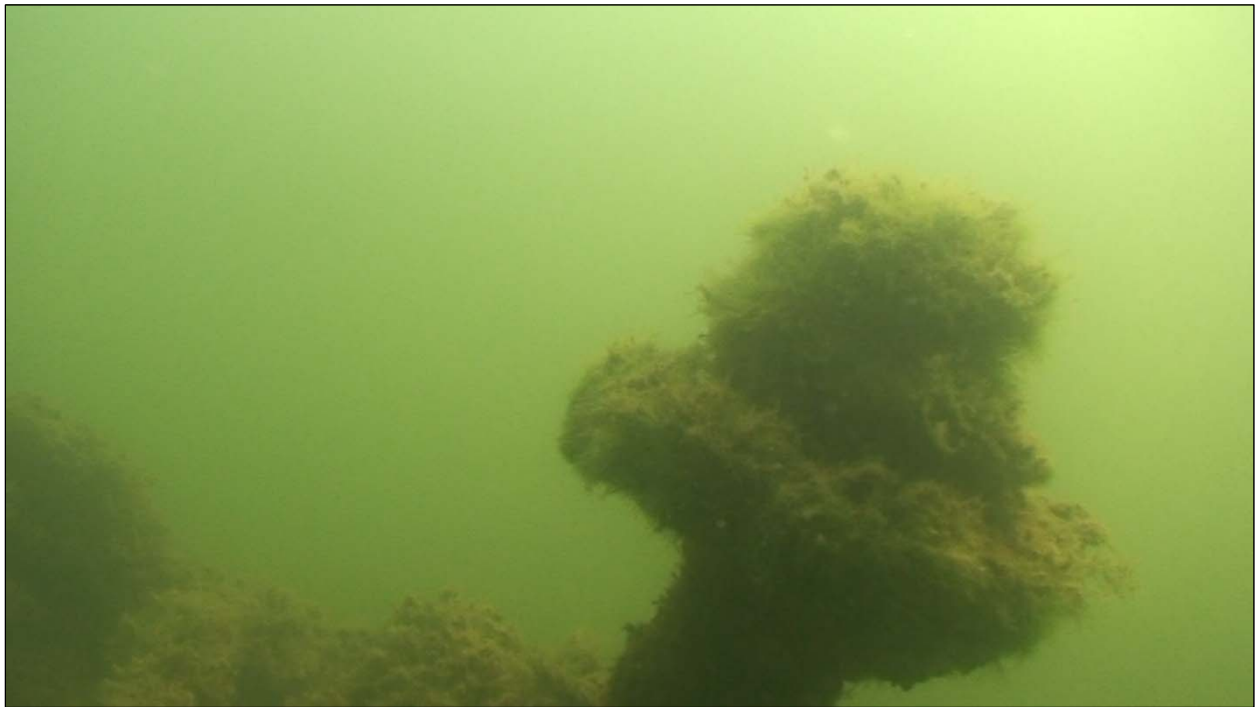
A significant portion of the stern assembly is present on site, but it is canted forward approximately 35 degrees and jumbled with steering cable, stray planking, and other small construction fragments. The 8 inch (20.3 cm) diameter iron rudderpost is visible from the jumble, at a height of 4 foot 6 inches (1.4m) off the lake bottom (Figure 41). A portion of the wire rope steering cable is wrapped around the assembly and steering cog, and more coils of wire rope are visible farther forward (Figure 42). Half of the iron rudder is visible above the sediment, extending perpendicular from the rudderpost 46 inches (116.0cm), and measuring 60 inches (152.4cm) long. The deadwood remains extend forward from the rudderpost another 24 inches (61.0cm) before plunging into the sediment. Also present in this stern jumble is an iron towing bit that is 8 inches (20.3 cm) in diameter.

Figure 41: Top of rudder post in stern of A2-1 (LCMM Collection).

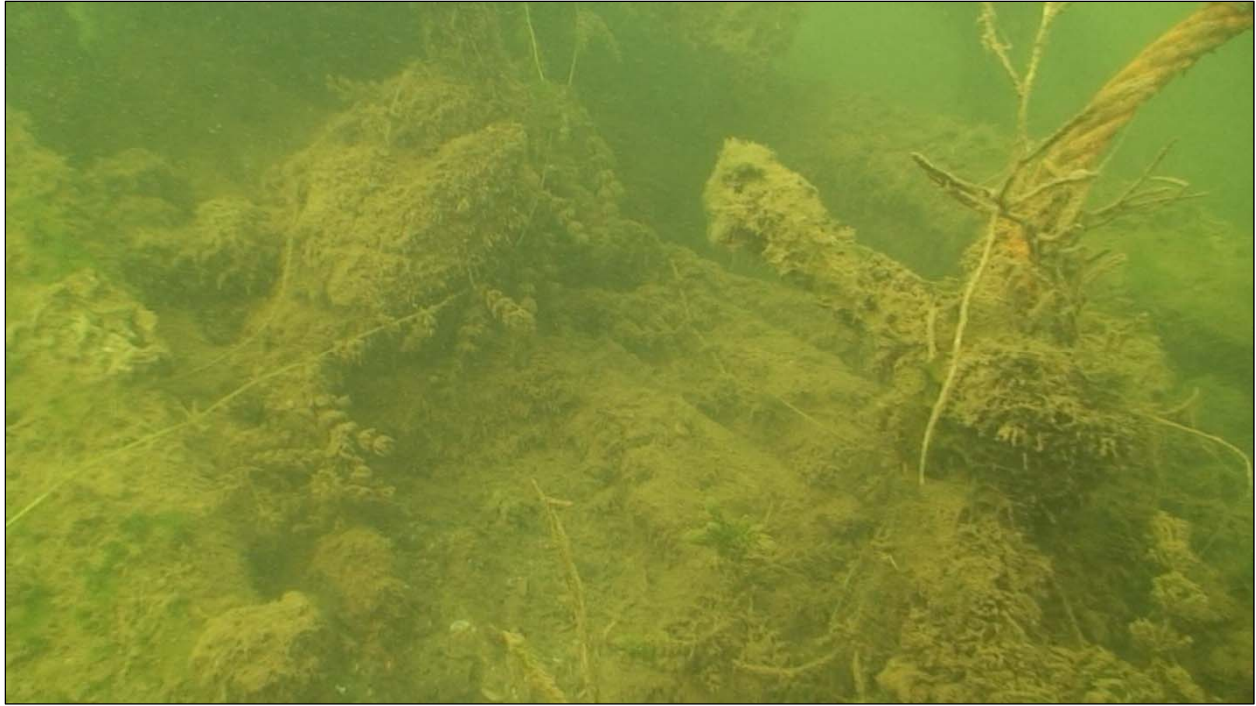
Figure 42: Metal cable (right) lay in a jumble at the stern of A2-1 (LCMM Collection).

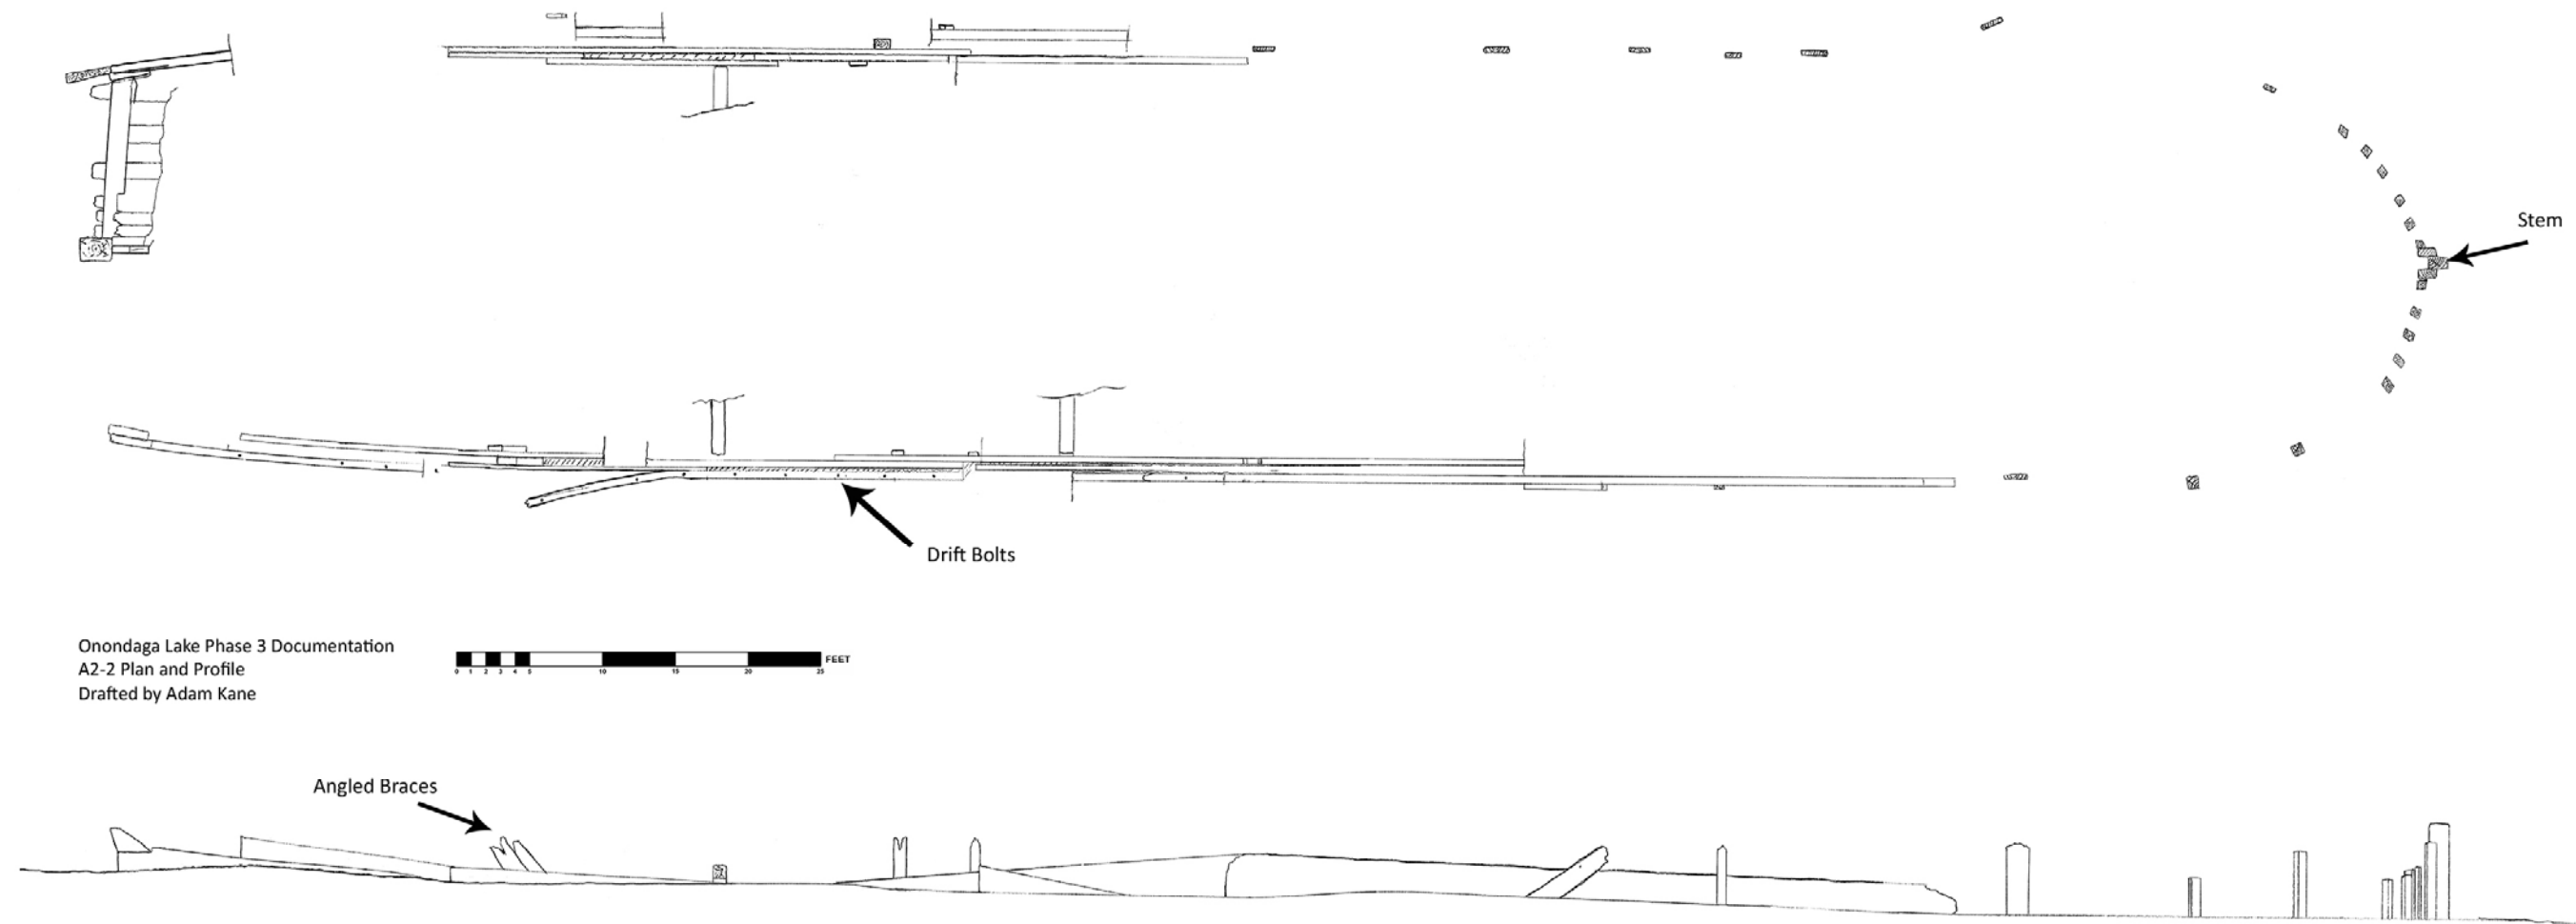
Figure 43: Plan and profile views of A2-2 (LCMM Collection).

The visible remains of A2-2 represent only 5 to 10% of the boat's original structure, which has resulted in only a fragmentary understanding of the site (Figure 43). Although little of the site is visible, perhaps 50% of the boat's original structure is still present below a layer of loosely packed Solvay waste and coal ash. Due to the potential contaminants in the lake bottom sediments, these buried portions of the site were not investigated. The visible remains are 80 feet 4 inches (24.5m) in length and 15 feet 4 inches (4.7m) in beam.

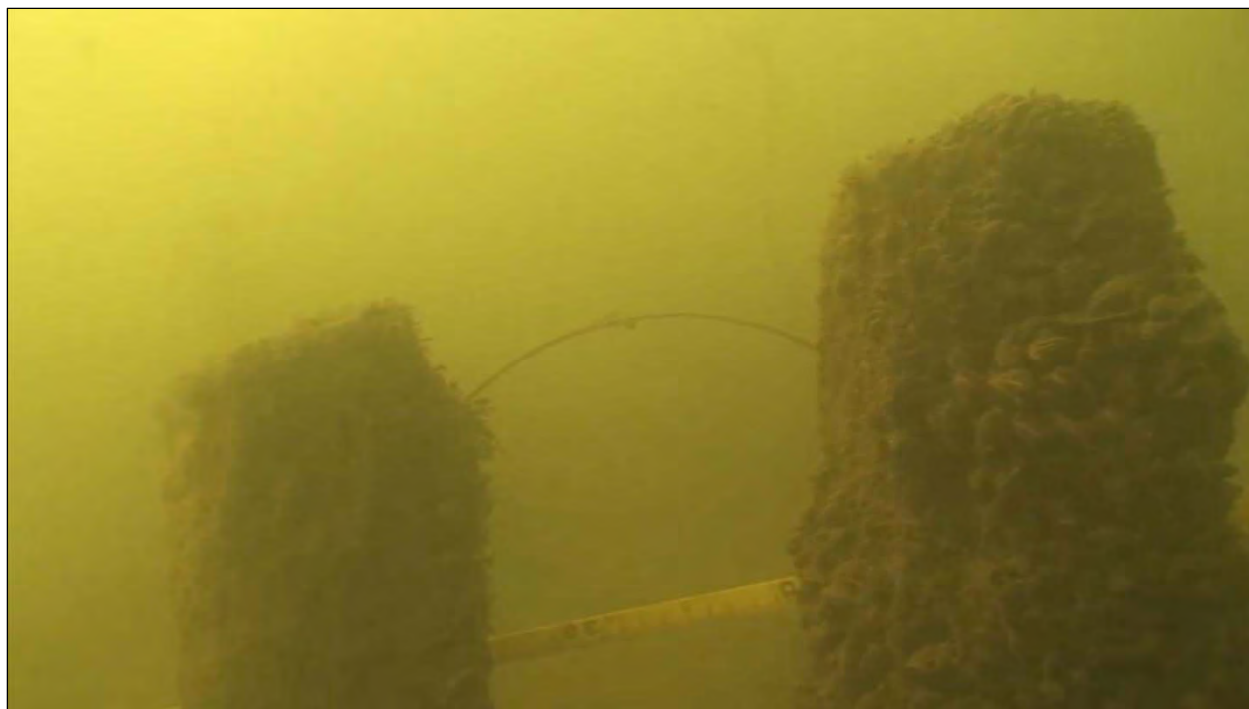
The trapezoidially shaped bow frames radiate port and starboard from the stem with their heights relative to the stem descending moving aft. The frames are 3 to 4 inches moulded (7.6 to 10.1cm) and 2 to 3 inches (5.1 to 7.6cm) sided. The visible portions are oriented vertically. The heights of the frame tops above the bottom decrease from 21½ inches (54.6cm) adjacent to the stem to 16 inches (40.6cm) moving aft as the bow frames meet the side of the hull. This decreasing height from forward to aft creates the upward sheer of the bow. The first frames are fastened directly to the port and starboard sides of the composite stem. The sides of the stem appear to lack a rabbet; this feature is created by the forward face of the first bow frames.

Figure 44: Bow frames characterize the bow of A2-2 (LCMM Collection).

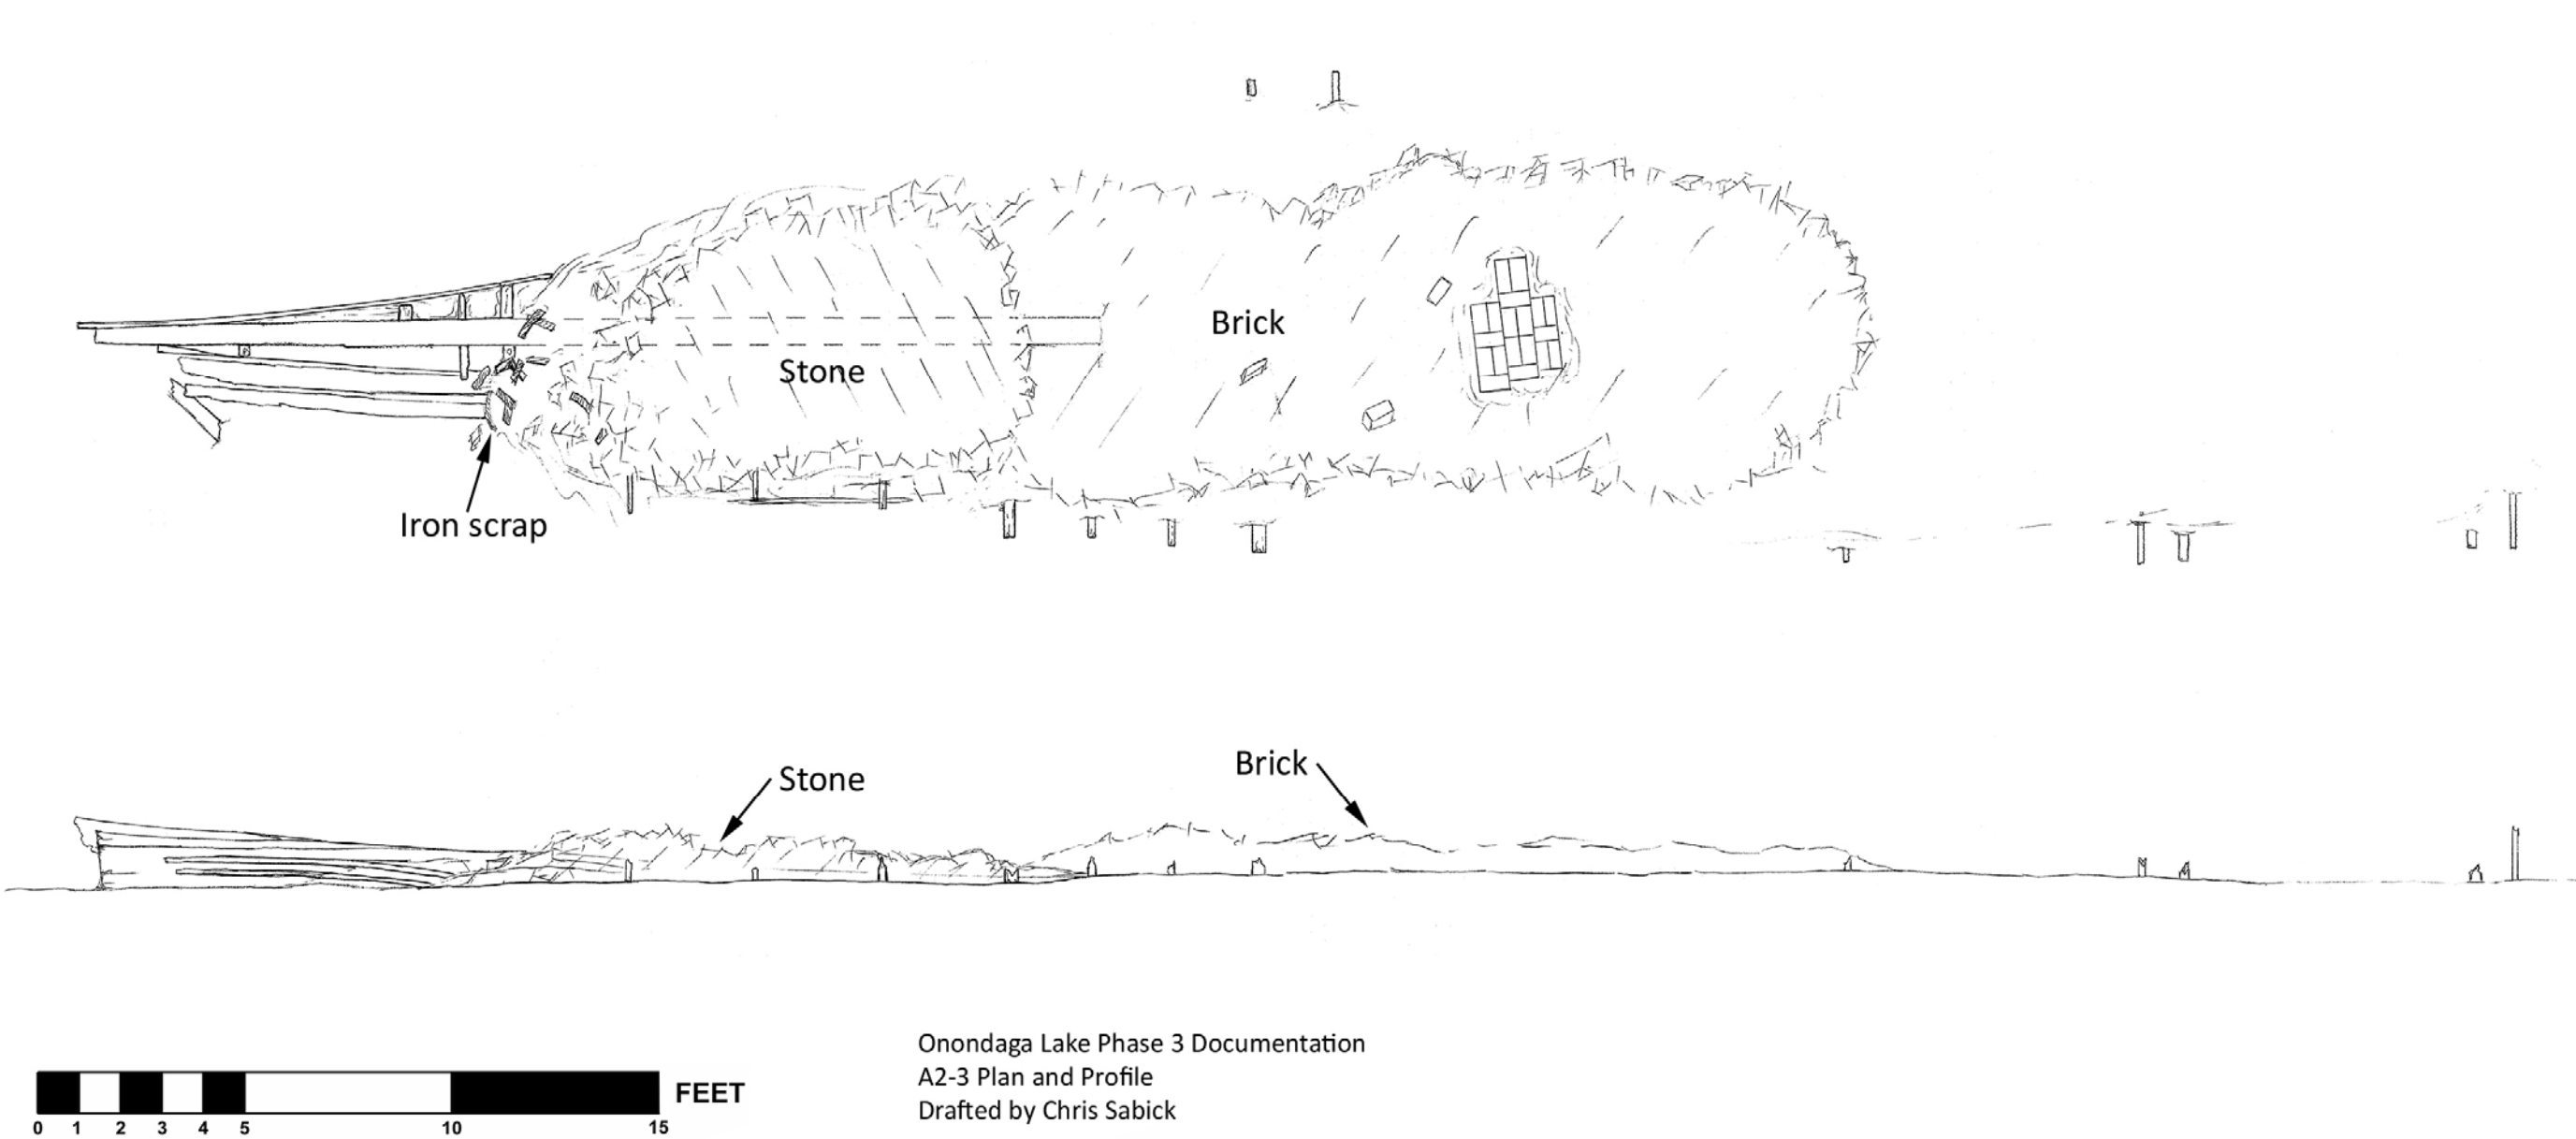
Figure 46: Plan and sectional views of A2-3 (LCMM Collection).

The visible remains of A2-3 represent a very small portion of the vessel's original structure, perhaps 5-10% (Figure 46). This has resulted in a fragmentary understanding of the site. Substantial portions of the vessel are buried under the lake sediment and debris in the hull. Due to the potential contaminants in the bottom sediment, these buried portions were not investigated. The visible remains are 24 feet (7.3 m) in length and have a maximum width of 12 feet 9 inches (3.9 m), though frame heads are noted for a length of 43 feet (13.1m). The remains of the abutting site A2-2 obscure the remainder of A2-3.

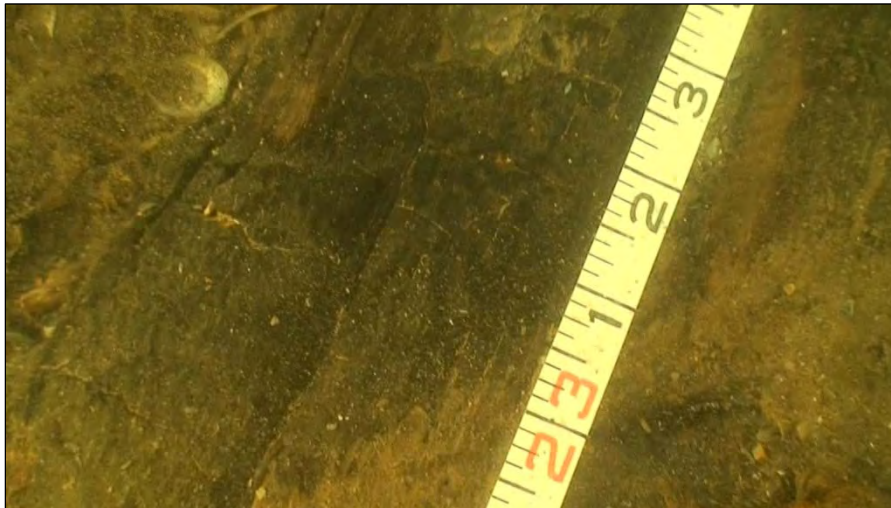
The central structural timbers of the exposed stern section of site A2-3 are its keel and keelson. Only a small portion of the keel is visible. It is mostly obscured by the keelson, hull planking, and the lake bottom sediments. The exposed portion is 12 inches (30.5cm) moulded and 6 inches (15.2cm) sided at the stern end, though presumably the sided dimension swells to approximately 8 inches (20.3cm) similar to that of the keelson. At the stern the keelson, constructed of white cedar, is also sided 6 inches (15.2cm) but swells to 8 inches (20.3cm) 2 feet (0.6m) forward of that and it retains this dimension for its remaining exposed length. The keelson extends forward and remains visible until it disappears under the lake bottom sediments 24 feet (7.3m) forward of the stern. It was noted that the last 2 feet (0.6m) of exposed keelson show evidence of extensive charring on its upper surface (Figure 47).

Figure 47: Evidence of charring was visible on the keelson of A2-3 (LCMM Collection).

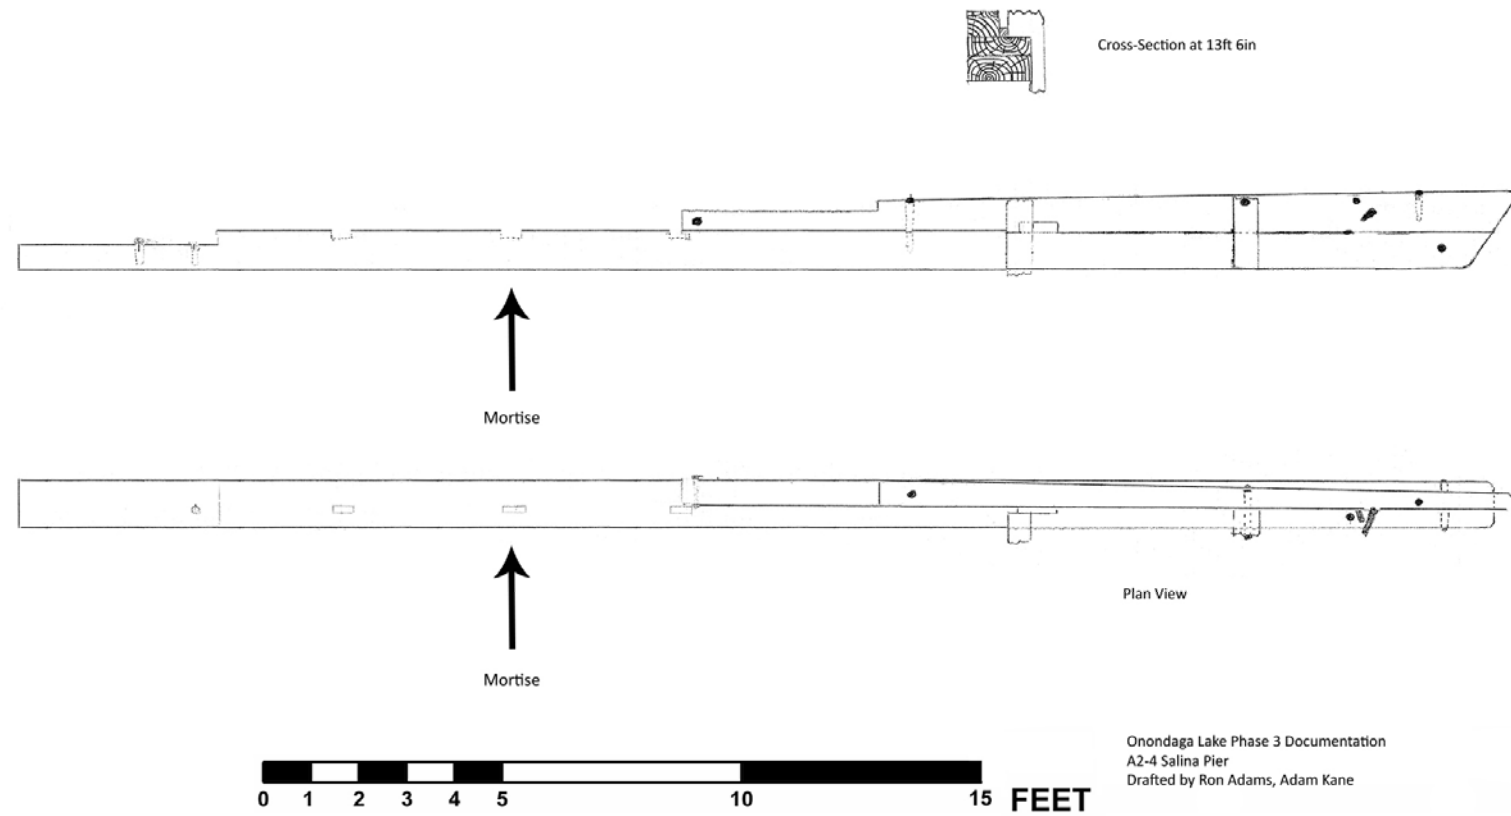
Figure 49: Plan and sectional views of A2-4 (LCMM Collection).

The visible remains of A2-4 appear to be a portion of side structure from a work barge (Figure 49). The fragment is made up of two principal timbers, the largest of which is 30 feet 6 inches (9.3m) long, moulded 11 inches (27.9cm) and sided 12 inches (30.5cm). This timber has three 6 inch (15.2cm) long and 2 inch (5.1cm) wide mortises cut into its upper surface (Figure 50). A second timber is attached to the top of the larger structural element; it continues for 17 feet 3 inches (5.3m) before ending in an angled cut like the timber below it. The second timber is considerably smaller with a sided dimension of only 6 inches (15.2cm). The two timbers are fastened together with 1 inch (2.5 cm) iron bolts. All wood samples taken indicated Hard pine (Southern yellow pine).

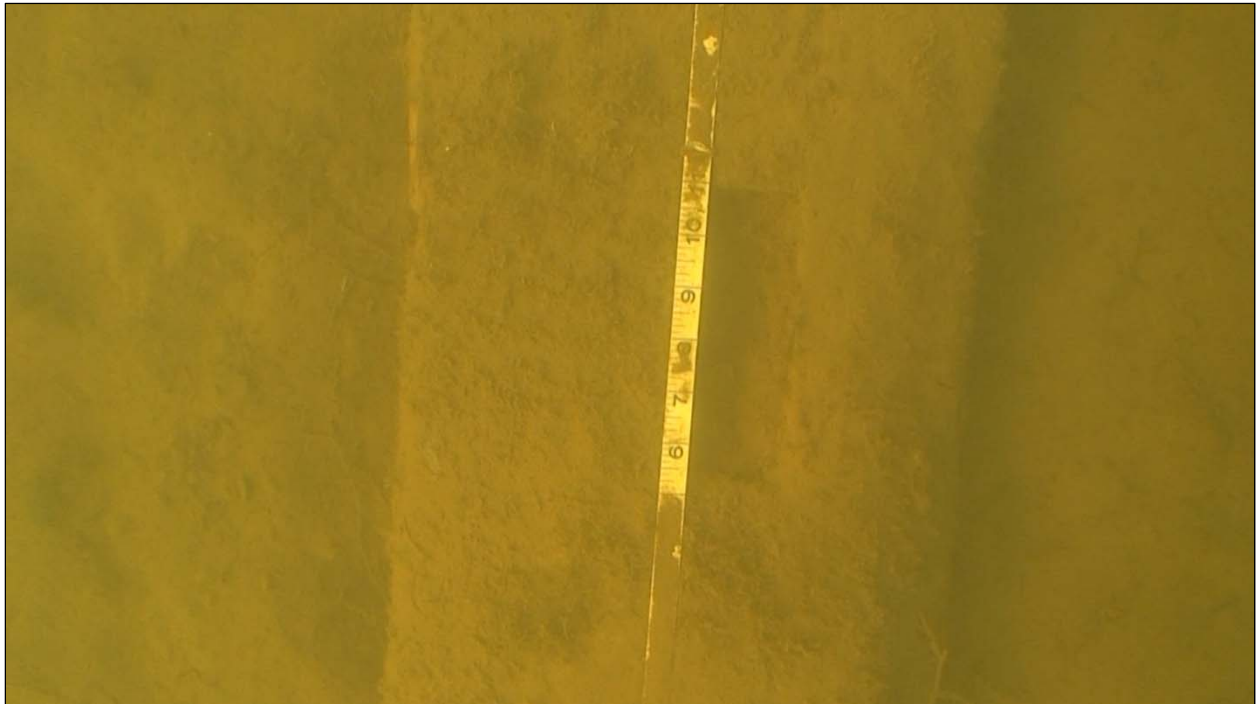
Figure 50: Mortises characterize a timber on A2-4 (LCMM Collection).
