Phase 3 Underwater Archaeological Report for the Onondaga Lake Bottom, Subsite of the Onondaga Lake Superfund Site, Onondaga County, New York

September 2014

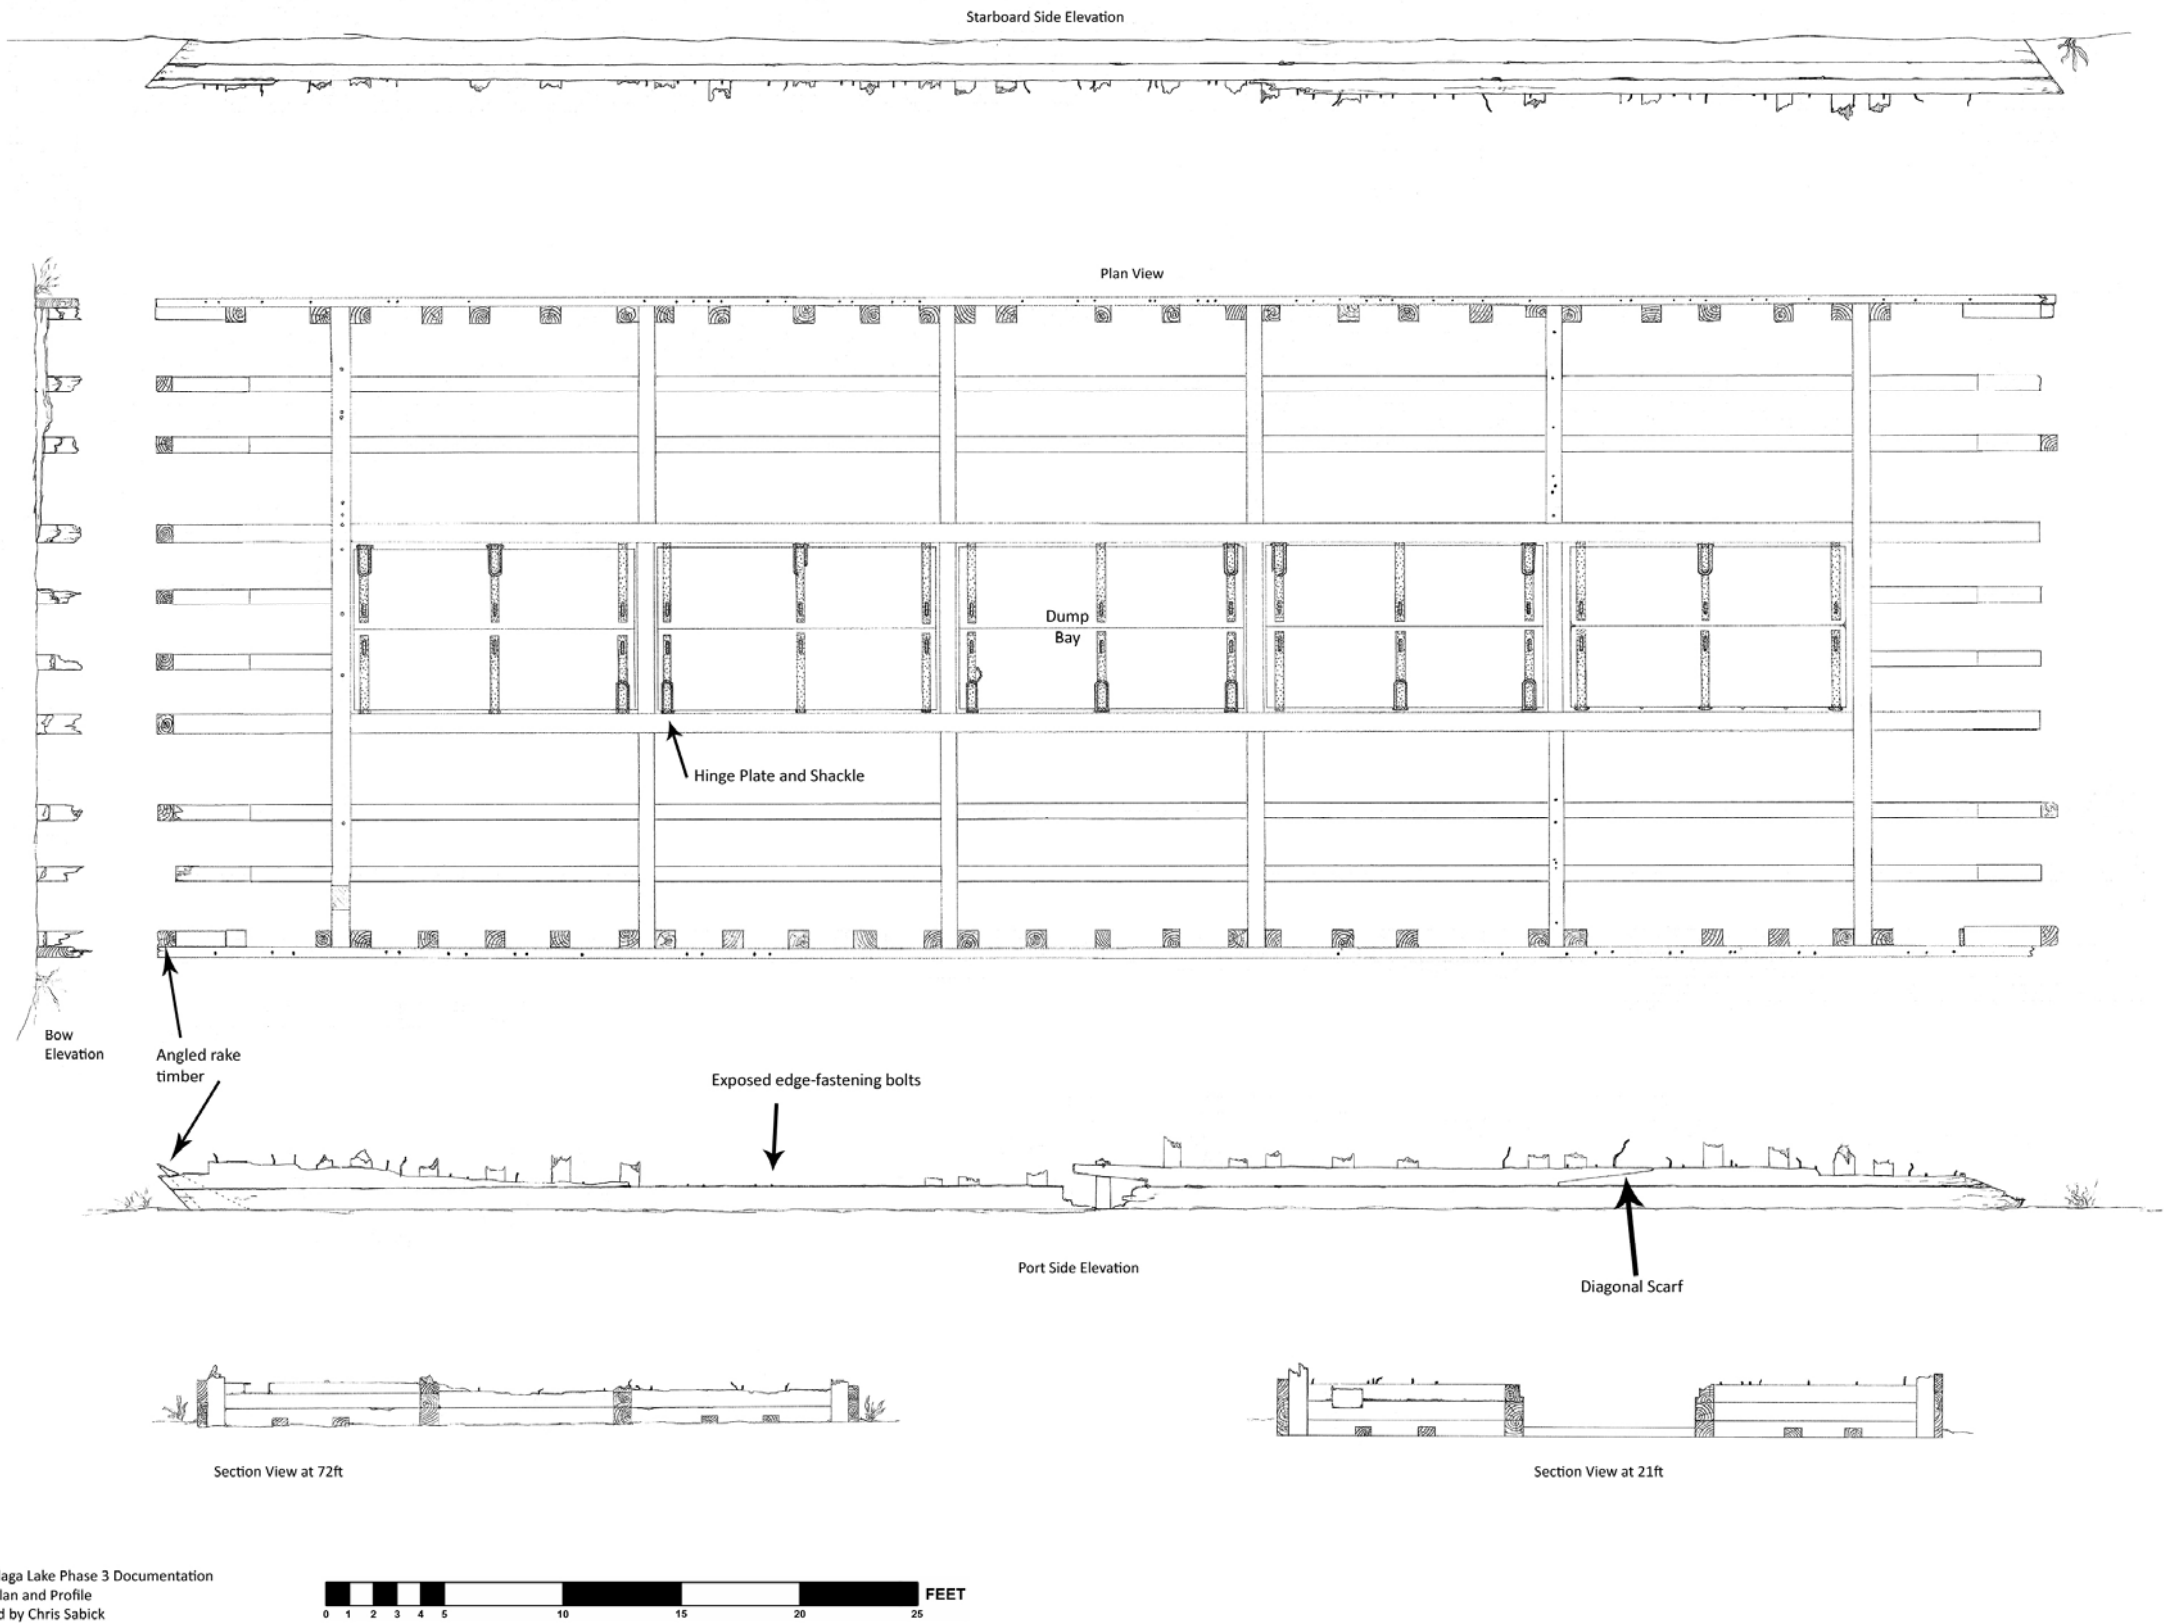
Figure 51: Plan and sectional views of A4-1 (LCMM Collection).

The visible remains of A4-1 represent 60-70% of the vessel's original structure. Lake sediments cover the interior and bottom of the vessel obscuring some details of the bottom planking and structure; however this represents a small portion of the overall remains. Due to the potential contaminants in the lake bottom sediments, these buried portions of the site were not investigated. The visible remains are 79 feet 6 inches (24.2m) in length and 28 feet (8.5m) in beam.

A4-1 lies in 3 to 5 feet (0.9 to 1.5m) of water in the southeastern corner of Onondaga Lake. The natural and cultural processes at this location have been a significant factor in its state of preservation. The site is in shallow water and has therefore been subjected to damage from ice and wave action as well as from biological growth on the vessel remains. This southeastern portion of the lake is subject to wave action due to the 4.5 miles (7.2km) of fetch which unfold to the northwest. Direct wave action on the wreck has led to damage occurring on the upper portions of the remains which is exacerbated by impacts from ice flows during the winter months. Additionally, annual aquatic vegetation growth and die-off is another means of mechanical degradation to the site.

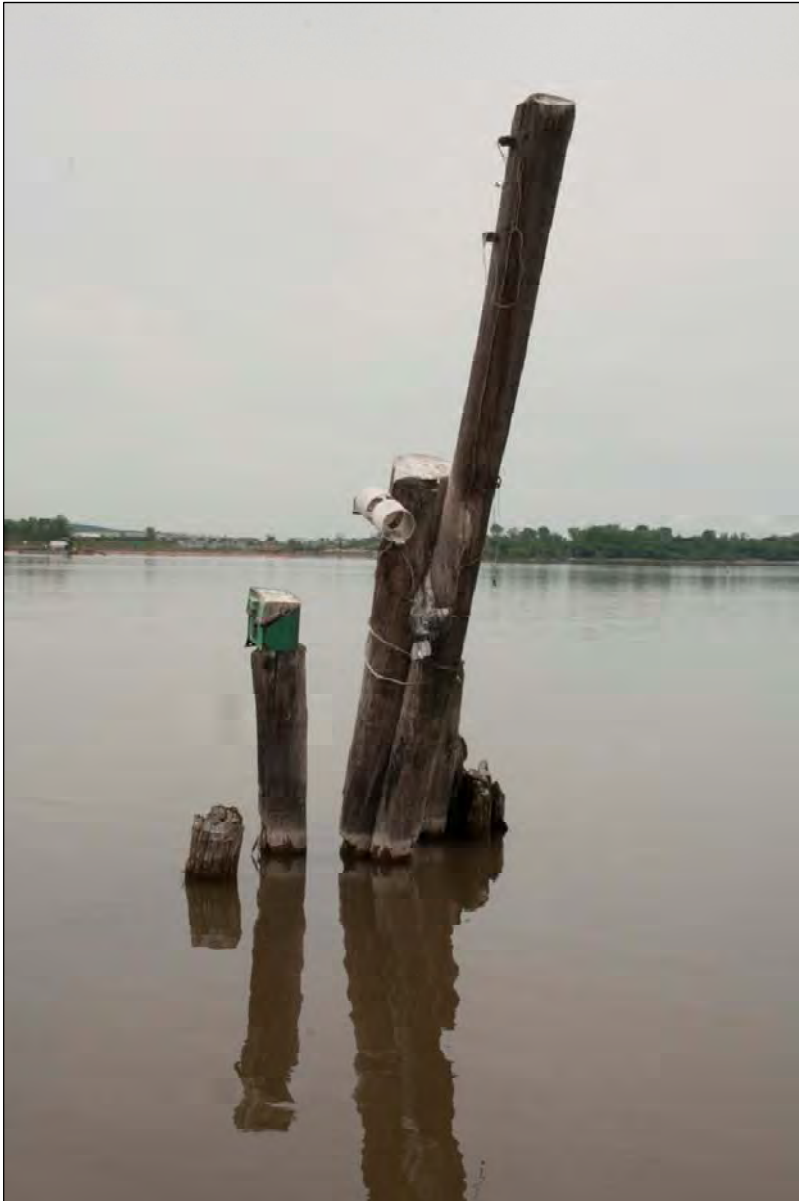
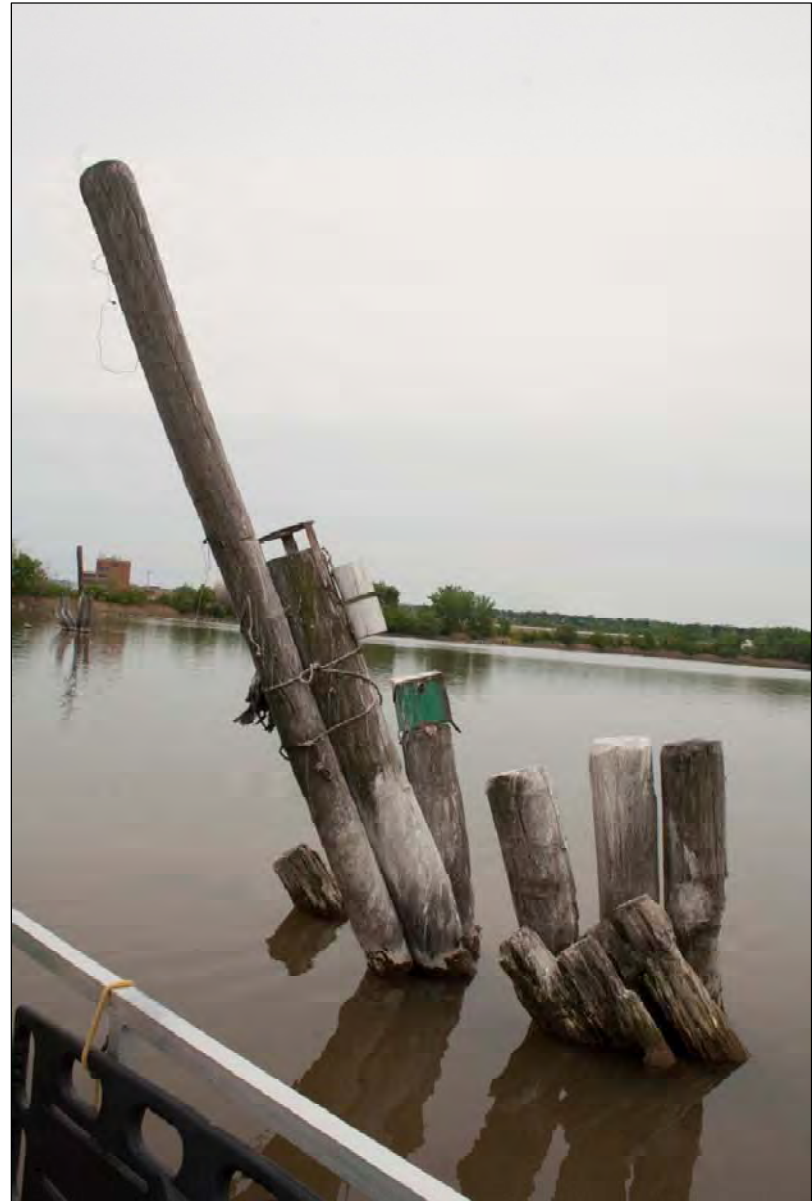
Clump 1: Clump 1 consists of ten pilings, most of which are tilted over into the channel. The clump has a green box, possibly for a battery. Two of the pilings are significantly taller than the others, and are bound together with cable (Figure 59 and Figure 60).

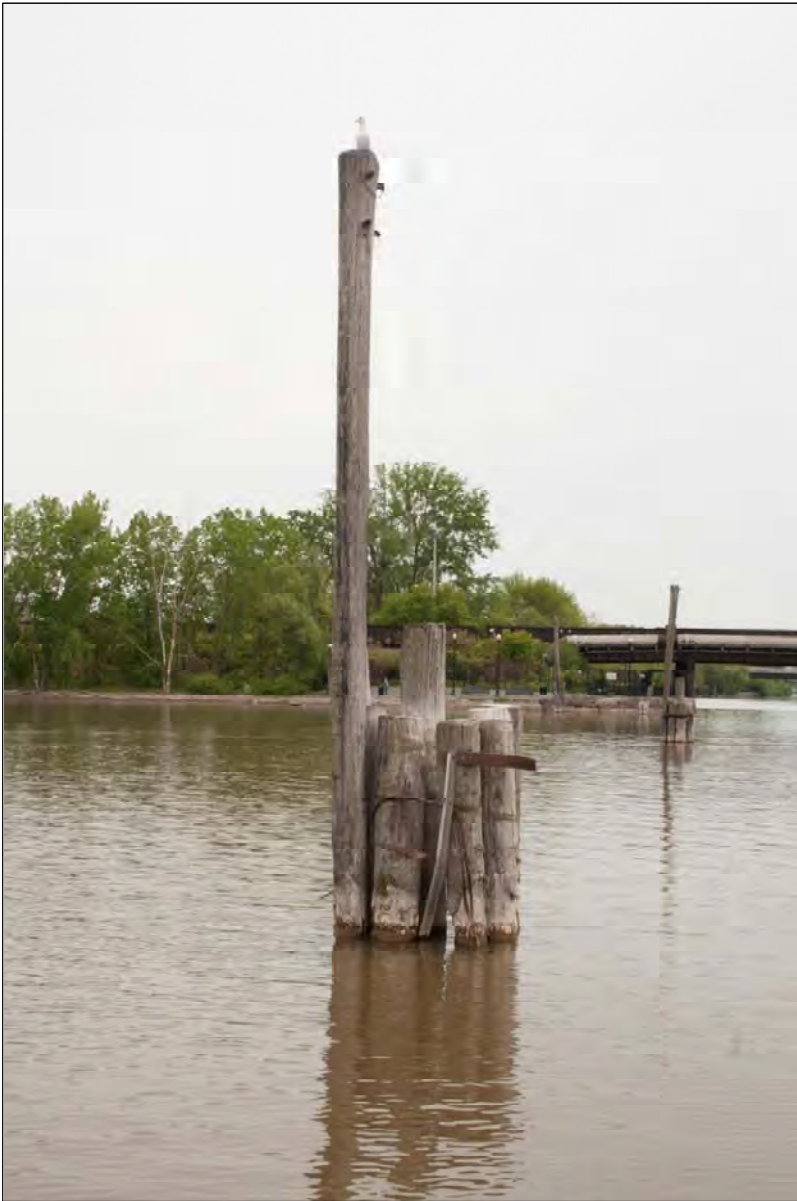
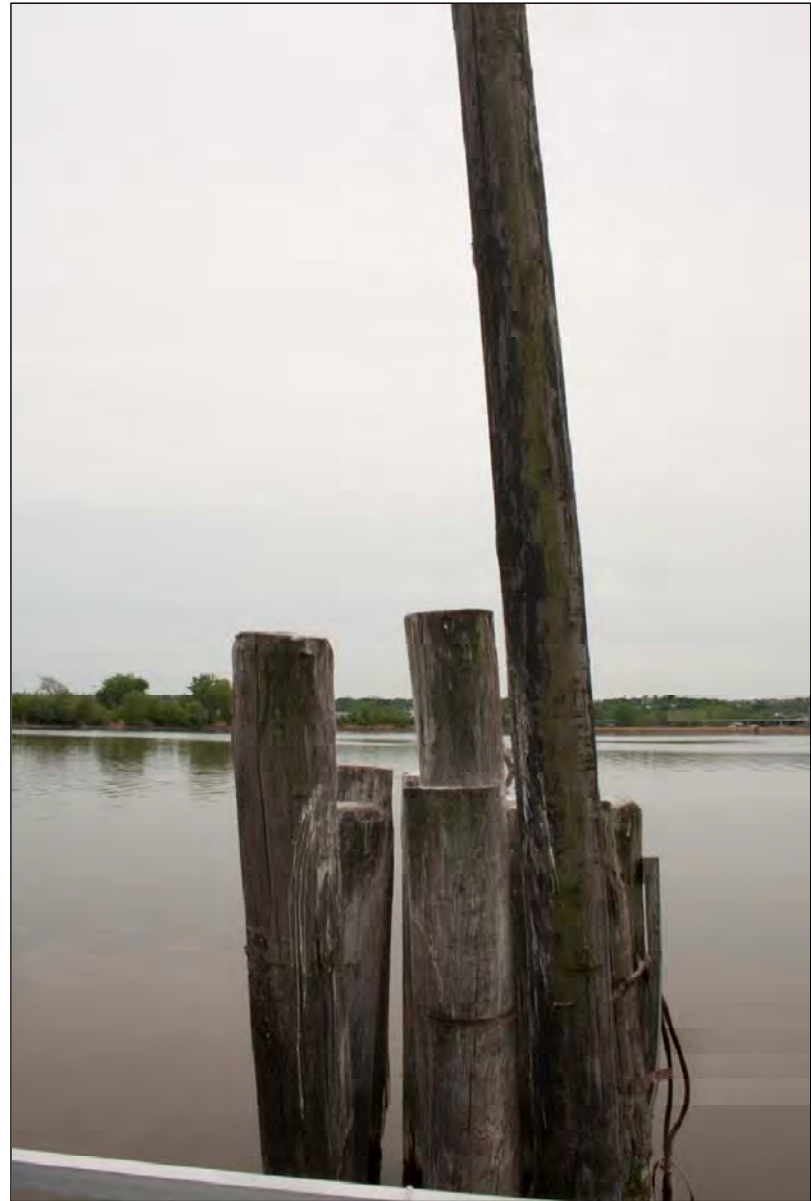
Clump 2: Clump 2 consists of ten pilings, seven of which are low, two of medium height, and one of which is significantly taller than the rest and which contains an electrical connection. At one time a cable connected them; it is now broken. There is a metal plate that may have held a box similar to the one on clump 5 (Figure 61 and Figure 62).

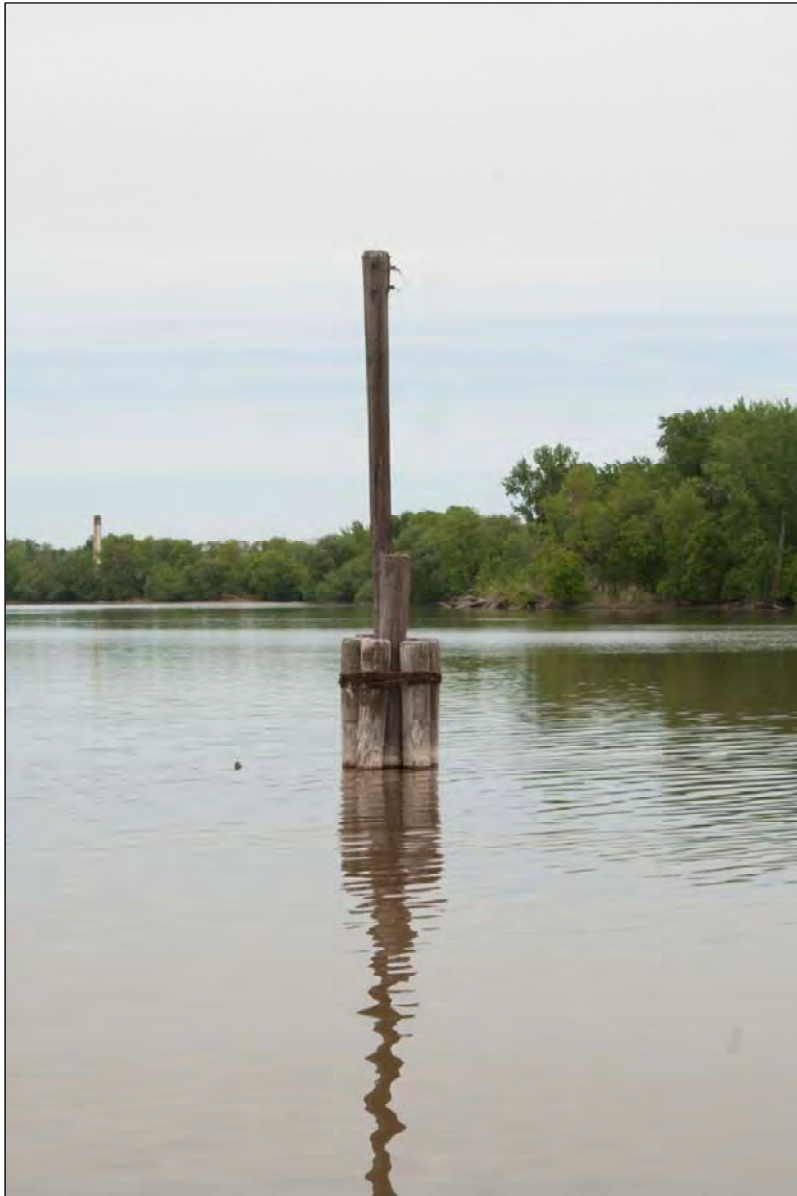
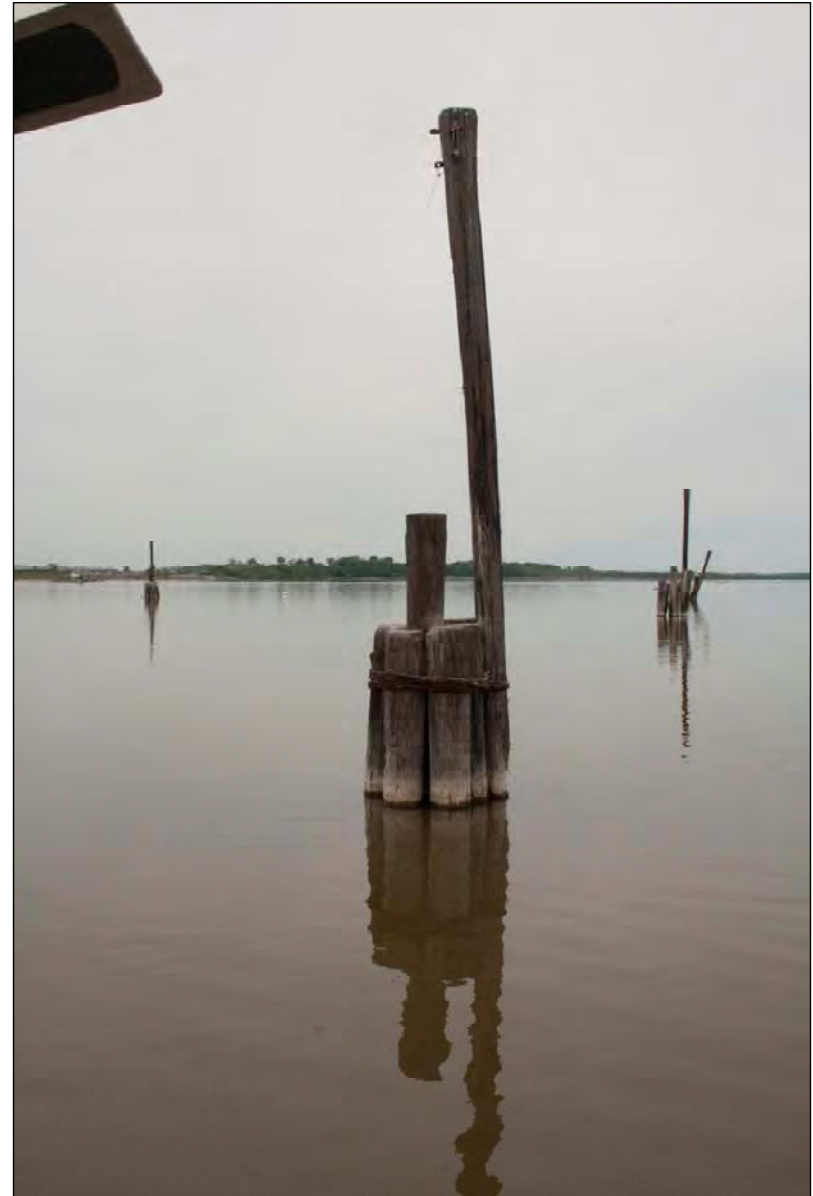
Clump 3: Clump 3 consists of eight pilings, six of which are low, one of which is of medium height, and one of which is taller than the rest and which contains an electrical connection. They are cabled together. An additional piling clump is submerged adjacent to these (Figure 63 and Figure 64).

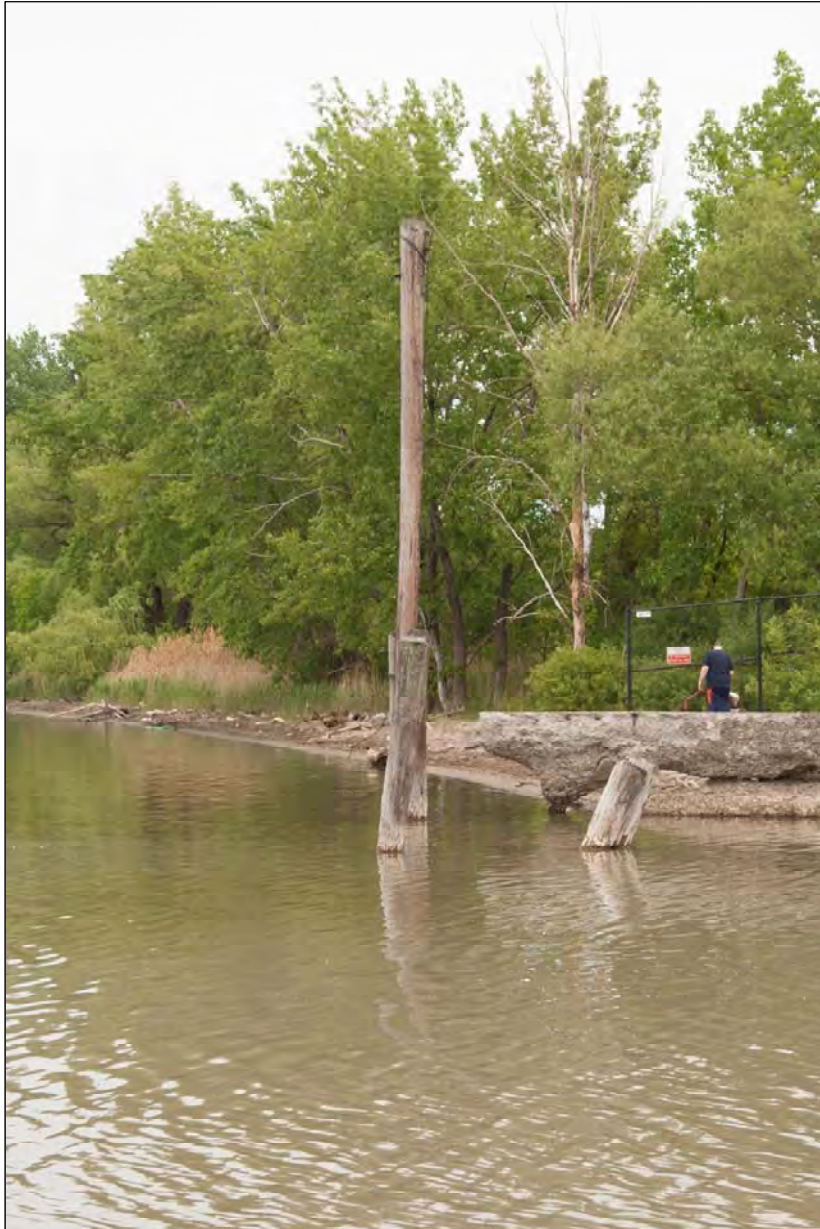
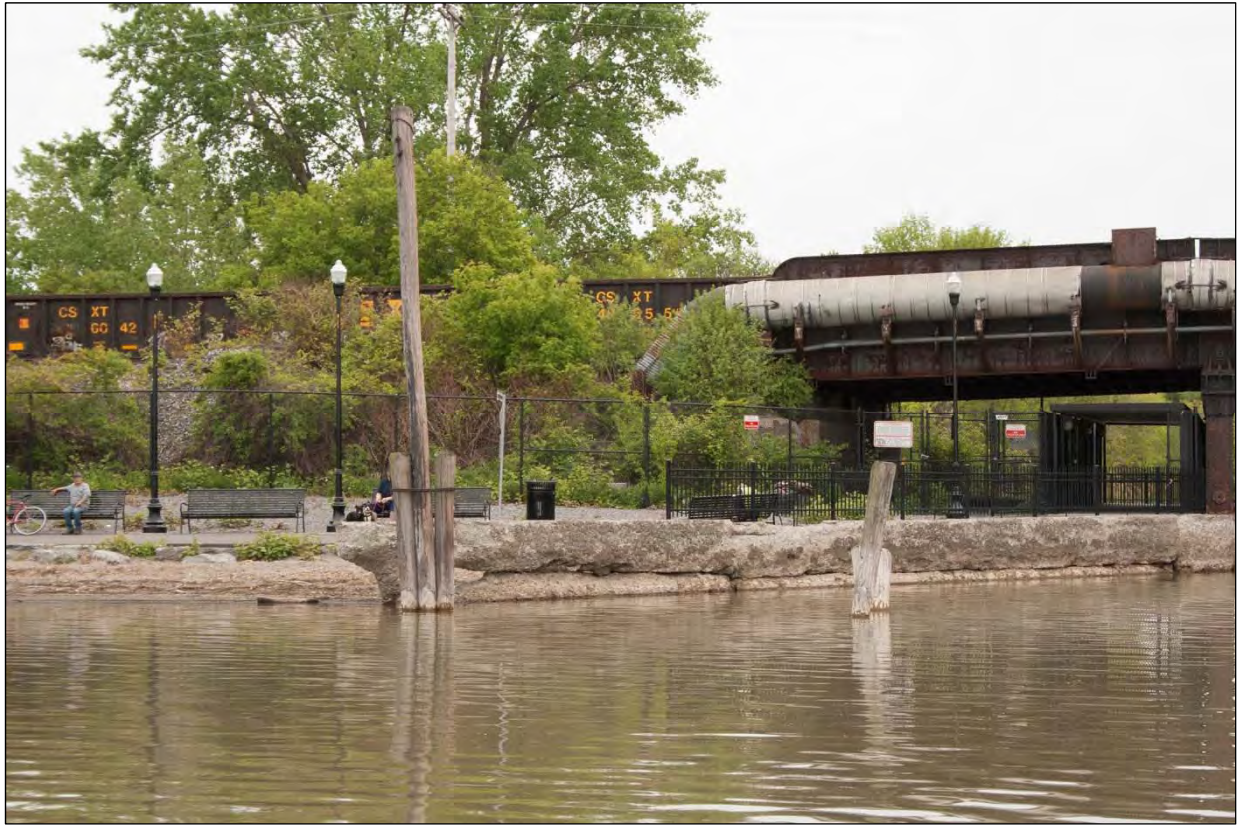
Clump 4: Clump 4 is the closest clump to the inlet. It consists of three pilings cabled together with electrical connections on tallest pile. Two piles rest beside the main clump, and are tilted over (Figure 65 and Figure 66).

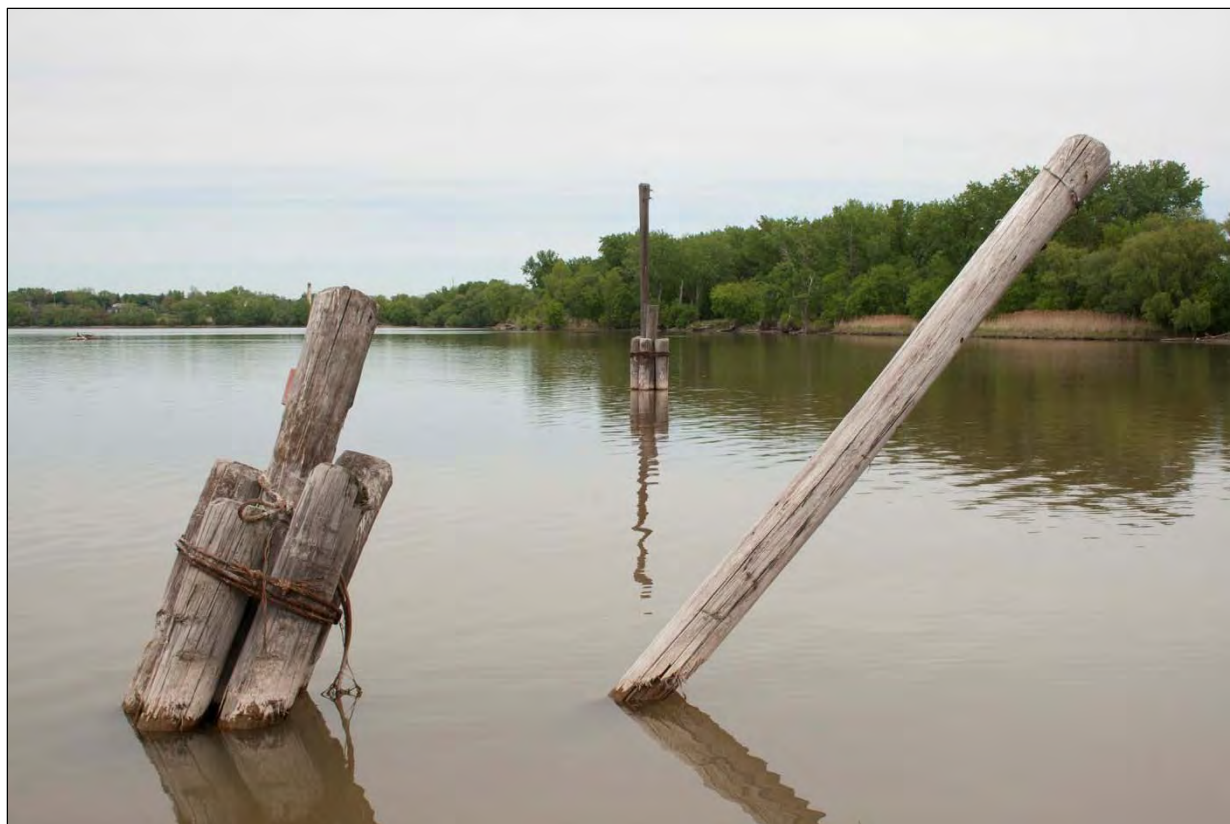
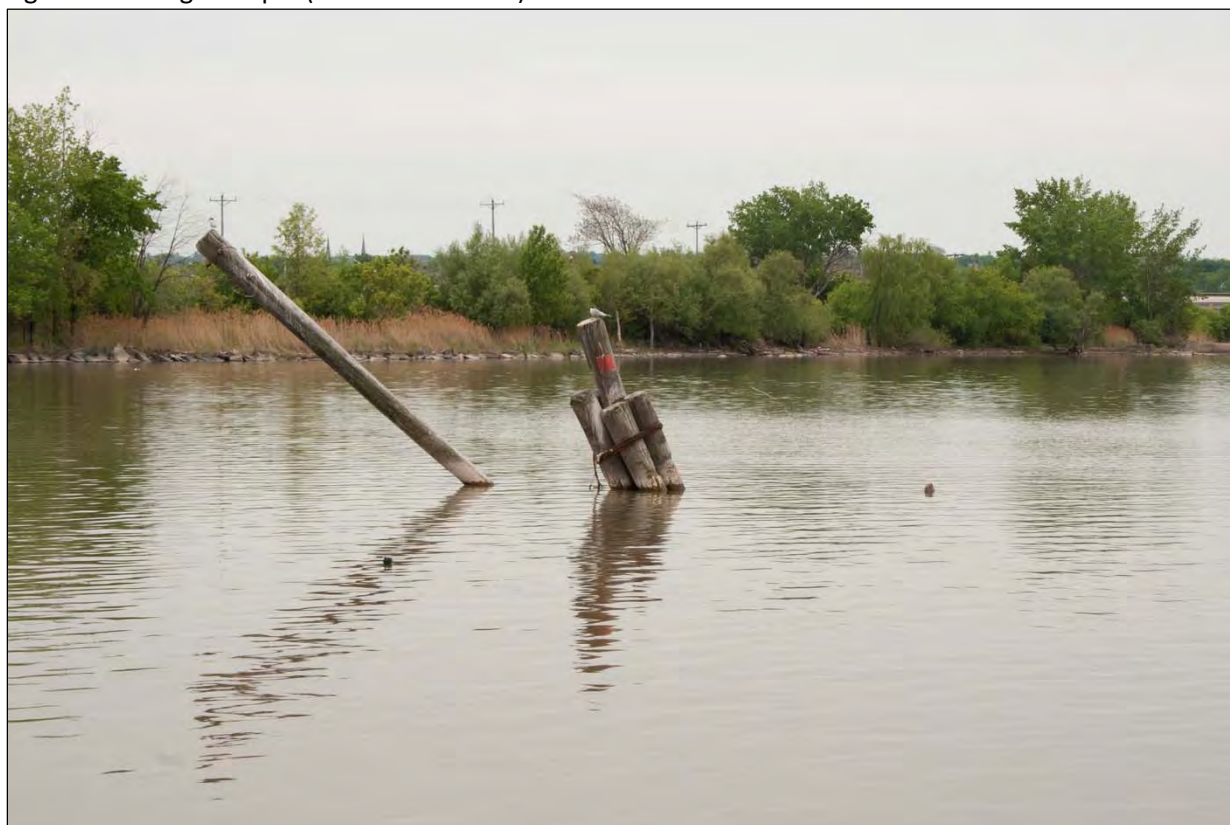
Clump 7: The seven pilings that make up Clump 7 are cabled together, and all tilted over. A red navigation light sits atop one of the shorter pilings. There are six pilings in the main clump, and one tall one to which is fastened an electrical connector. There is a smaller old clump adjacent to the main assemblage (Figure 71 and Figure 72).

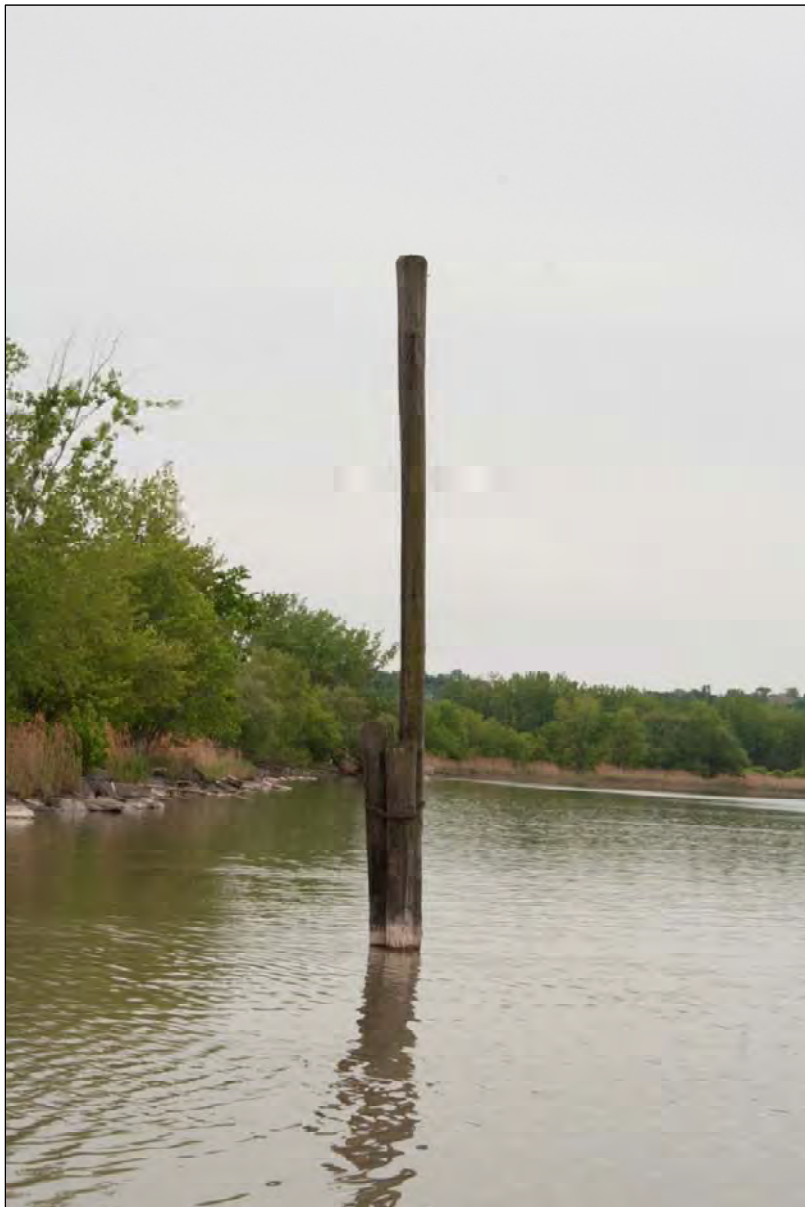
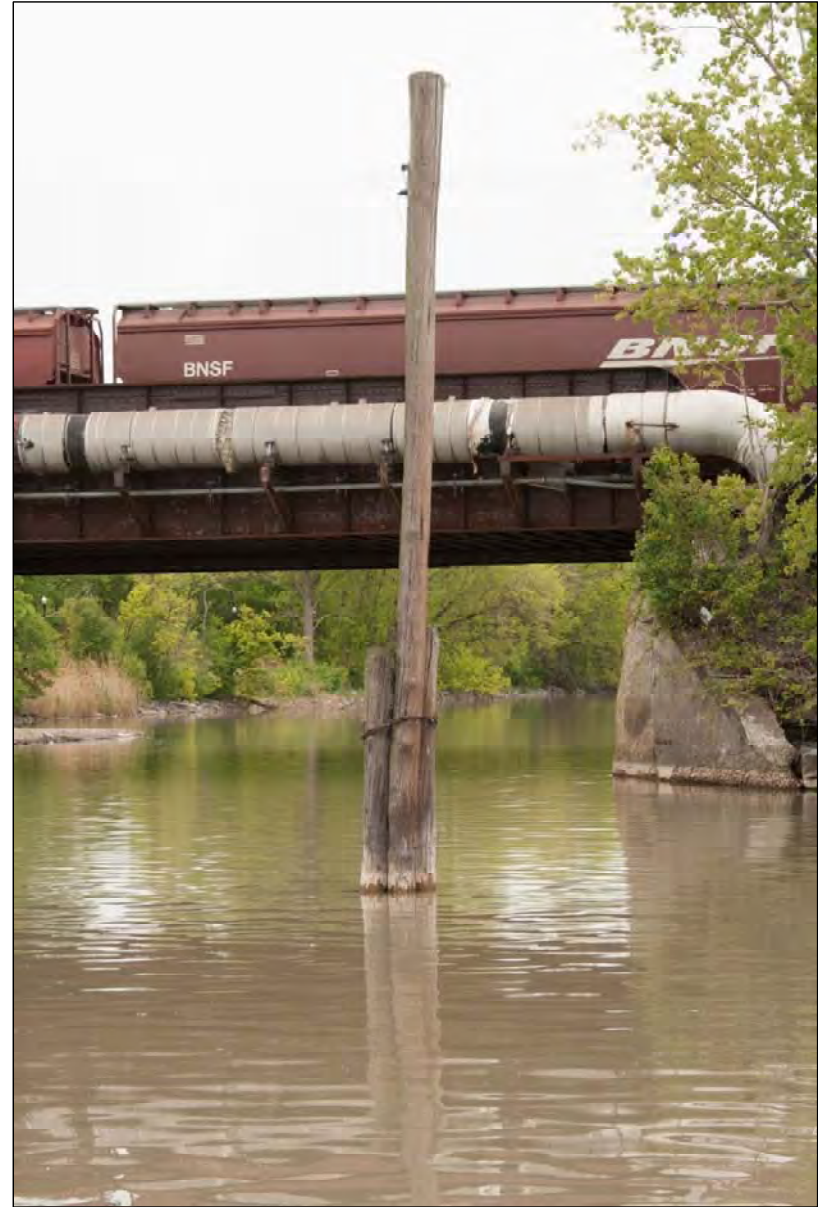
Clump 8: This assemblage consists of three pilings, cabled together. An old electrical connection is fastened to the central piling, which is also the tallest (Figure 74 and Figure 73).

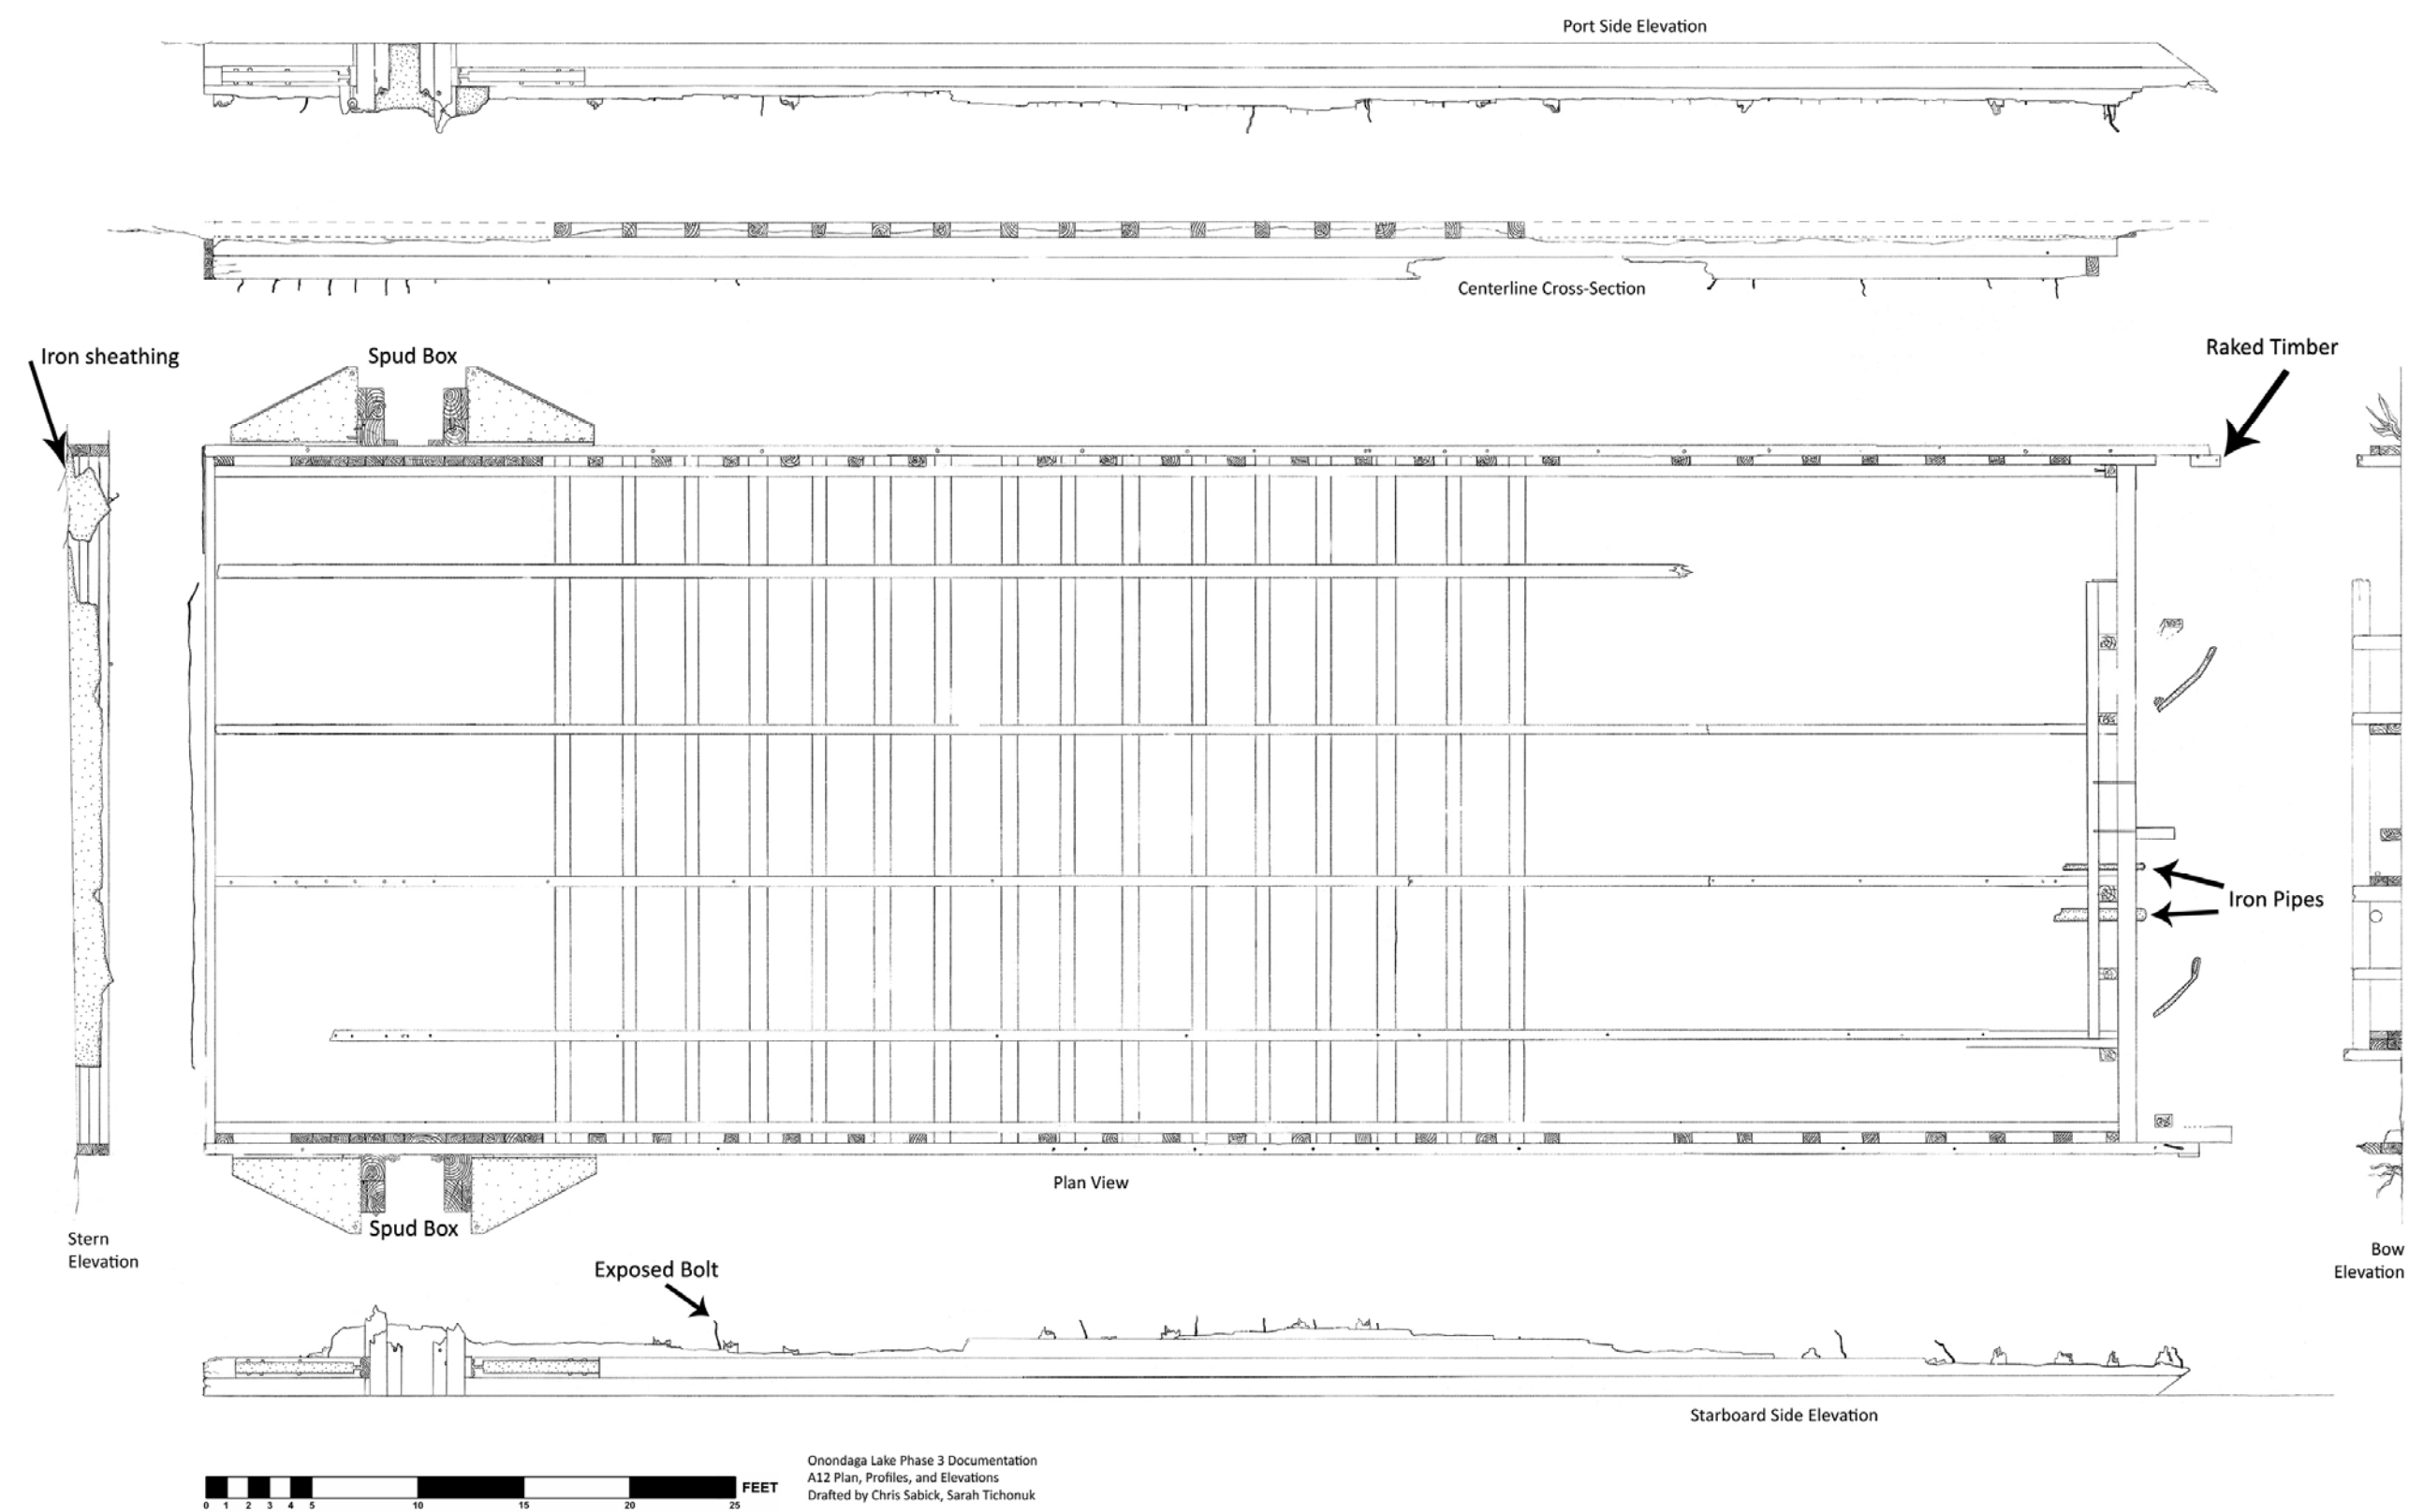
The visible remains of A12 represent 70-80% of the vessel's original structure (Figure 78). Lake sediments cover the interior and bottom of the vessel obscuring the details of the bottom planking and structure; this is particularly evident in the interior of the bow and stern. Due to the potential contaminants in the lake bottom sediments, these buried portions of the site were not investigated. The visible remains are 93 feet 8 inches (28.5m) in length with a maximum beam of 40 feet (12.2m), 32 feet 6 inches (9.9m) excluding the spud holders.

Figure 78: Plan and sectional views of A12 (LCMM Collection).

A12 lies in 3 to 4 feet (0.9 to 1.2m) of water in the southeastern corner of Onondaga Lake. The natural and cultural processes at this location have been a significant factor in its state of preservation. The site is in shallow water and has therefore been subjected to damage from ice and wave action as well as from biological growth on the vessel remains. This southeastern portion of the lake is subject to wave action due to the 4.5 miles (7.2km) of fetch which unfold to the northwest. Direct wave action on the wreck has led to damage occurring on the upper portions of the remains which is exacerbated by impacts from ice flows during the winter months. Additionally, annual aquatic vegetation growth and die-off is another means of mechanical degradation to the site.

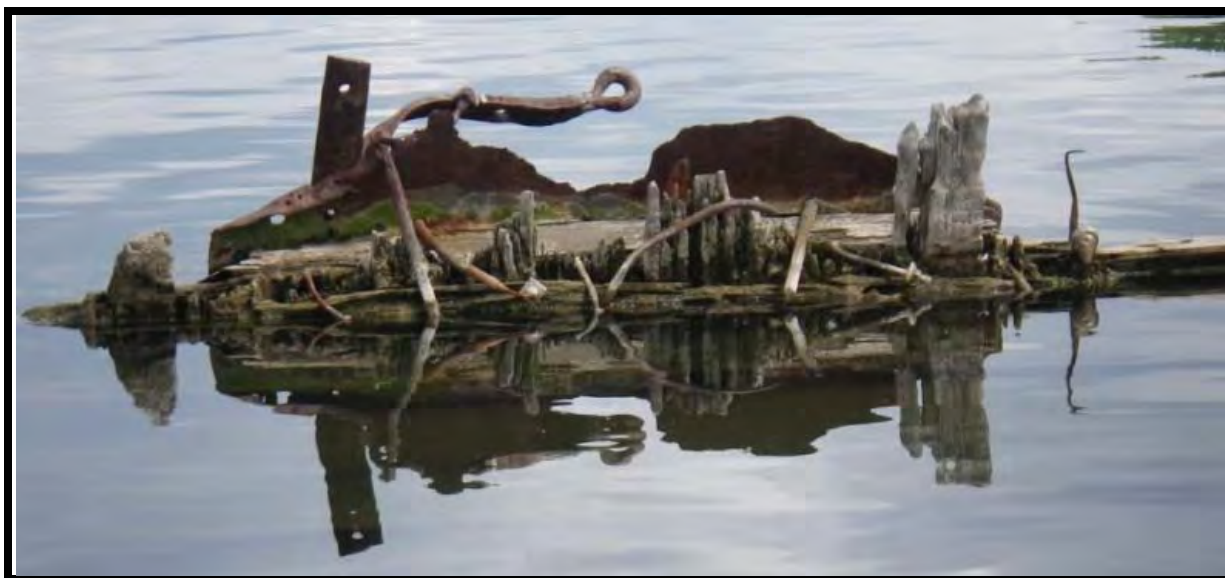
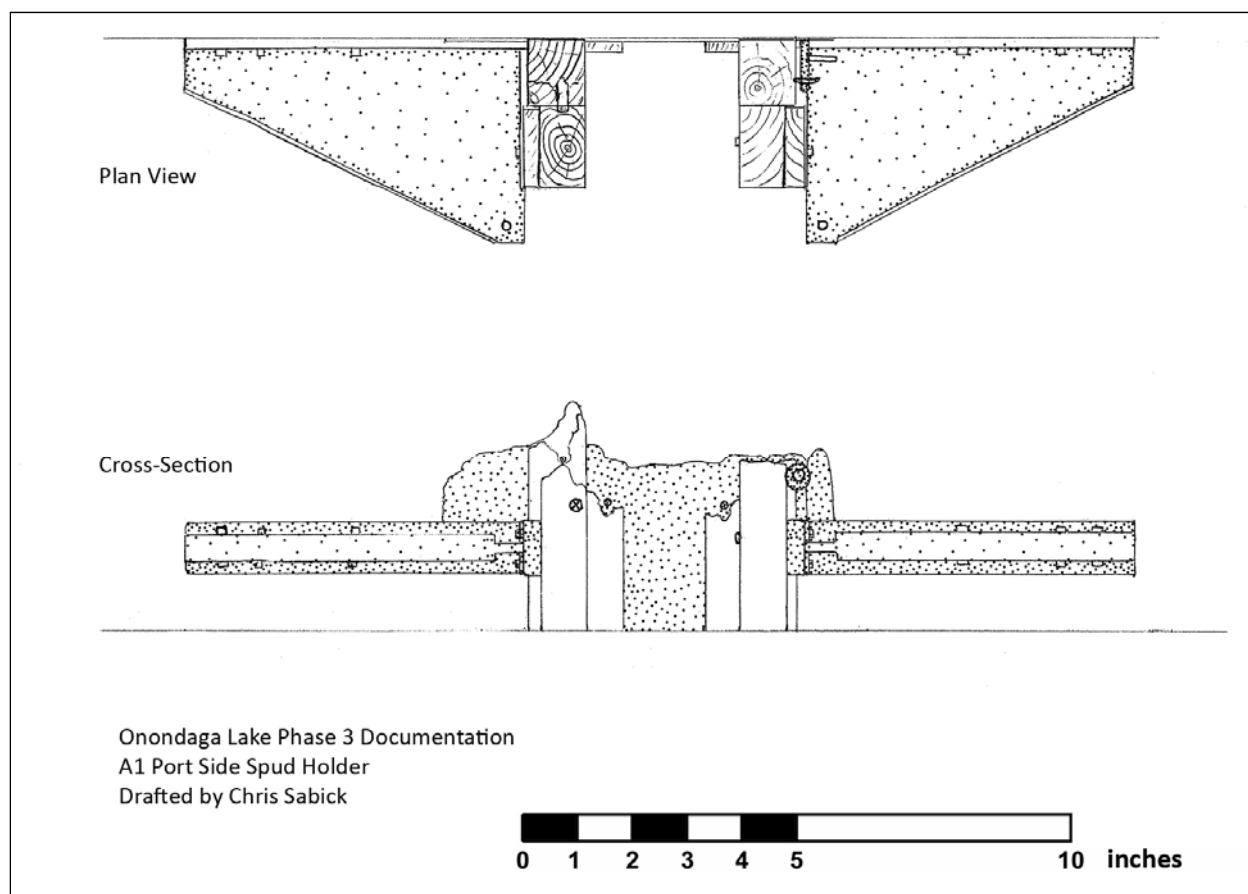
A feature unique to A12 is the spud boxes which are located on both sides of the stern (Figure 79 and Figure 80). These substantial features once supported the large spuds that were used to hold the dredge in position while the derrick was in use. The remains of the spud boxes suggest that they could have accommodated spuds up to 32 inches (81.3cm) square. In order to support such massive anchoring posts, the spud boxes were extensively reinforced. The main upright timbers of each holder consist of a pair of timbers 12 inches (30.5cm) sided and 15 inches (38.1cm) moulded. These are additionally strengthened by timbers that are 12 inches (30.5cm) sided and 18 inches (45.7cm) moulded. The upright timbers also are supported by large iron buttresses that extend forward and aft of the spud holders. These roughly triangular buttresses extend 6 feet (1.8m) to either side of the holders and extend out from the sides 45 inches (114.3cm). These structures consist of a heavy iron plate approximately 2 inches (5.1cm) thick that is fastened to the sides of the vessel and spud holder uprights by flanges and numerous threaded iron bolts 1 inch (2.5cm) in diameter. The planking of the barge in the area behind the spud holders is protected by a ¼ inch (0.6cm) thick piece of sheet iron. This would have prevented the spuds from damaging the planking when they were raised and lowered through the spud holders. No evidence of the spuds themselves was found on the site.

Figure 79: Inboard side of Anomaly A12's spud box (LCMM Collection).

Figure 80: A12 Port Side Spud box (LCMM Collection).
